**EMERGENCY TRANSPORTATION INFRASTRUCTURE RECOVERY**  
**WATER BASIN ASSESSMENT**  
**AND FLOOD HAZARD MITIGATION ALTERNATIVES**

**EAST CANADA CREEK**  
**HERKIMER COUNTY, NEW YORK**

April 2014

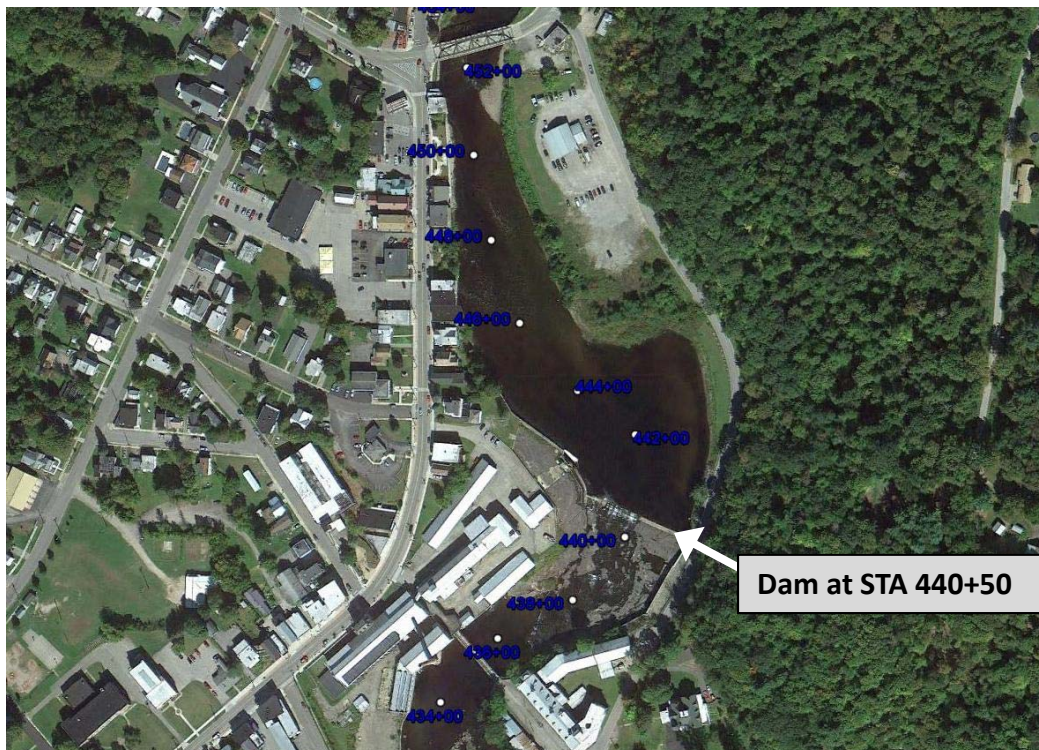
**Site Description:** Located in the Village of Dolgeville is a dam that contribute to local flooding issues. The dam at STA 440+50 increases water surface elevations and is the site of ice jams.

- It may be possible to reduce or “draw down” water levels behind the dam by opening a low flow outlet or removing weirs or flashboards when high flow events are forecast.
- Similarly, there may be opportunities to reduce occurrences of ice jams by altering the operations of the dam during periods when ice jams are prone to occur.
- Strategies such as these would require entering into a dialogue with the owners of the dam. A comprehensive understanding of the operation of the dam will be required in order to determine whether a modified operational plan would reduce ice jams and flooding.
- Removal or physical modification of the dam would mitigate flooding by lowering water surface elevations and reducing the frequency and severity of ice jams.

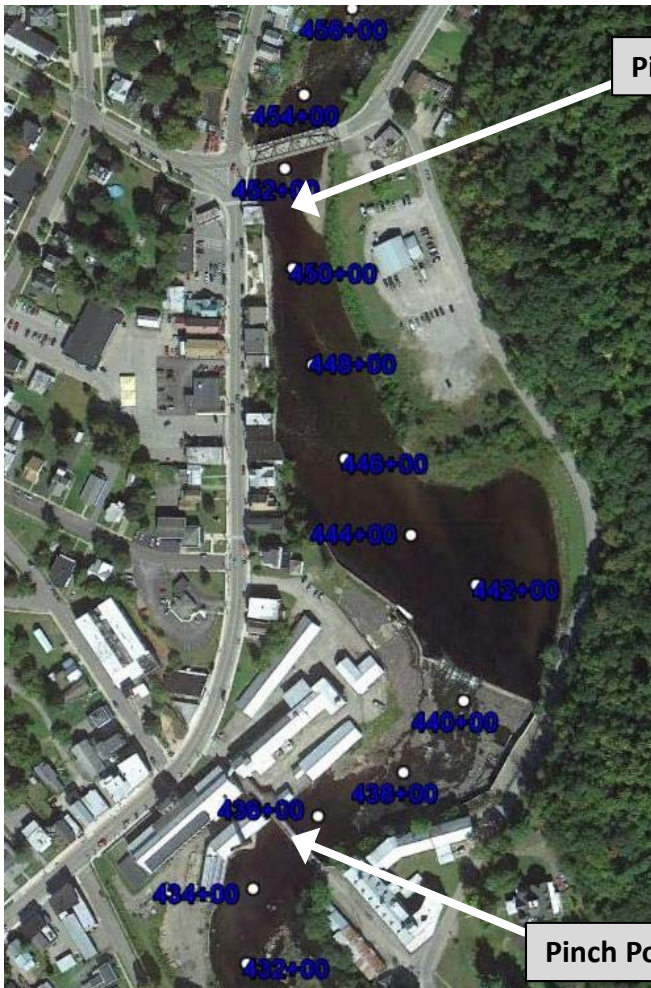
Pinch Point #1 at STA 450+20

- 1) The bank to bank measurement narrows to 150 feet at STA 450+20, downstream of the Route 29 Bridge. The right creek bank consist of a vertical wall; the left bank consists of a riprap slope.
- 2) At the pedestrian walkway (STA 435+25), the channel narrows to a width of 145 feet, and is confined between vertical walls on both banks with no floodplain.

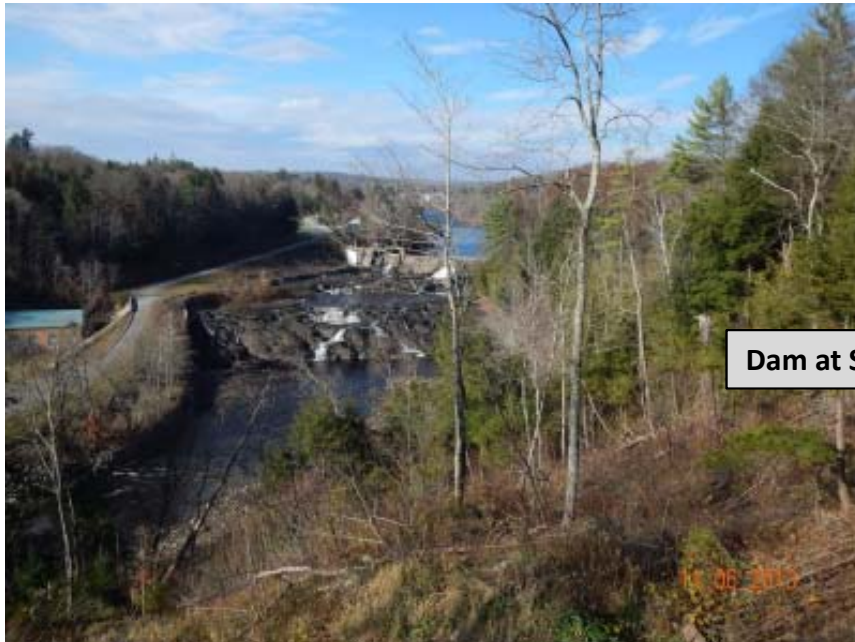
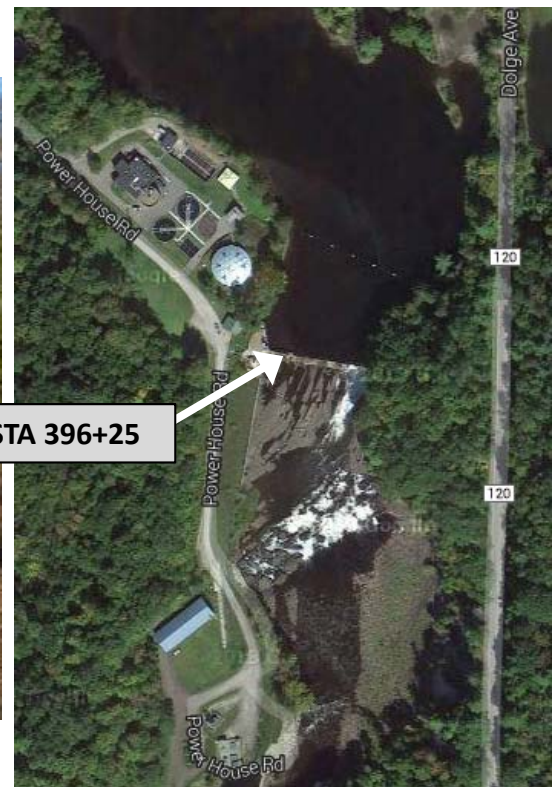
**Site Description:** Downstream of the Village of Dolgeville is the hydroelectric dam and wastewater treatment plant. This area is prone to ice jamming, causing flooding of homes along Van Buren Street and Dolge Avenue.

- There may be opportunities to reduce occurrences of ice jams by altering the operations of the dam during periods when ice jams are prone to occur.
- Strategies such as this will require entering into a dialogue with the owners of the dam. A comprehensive understanding of the operation of the dam will be required in order to determine whether a modified operational plan would reduce ice jams.
- Removal or physical modification of the dam would mitigate flooding by reducing the frequency and severity of ice jams.

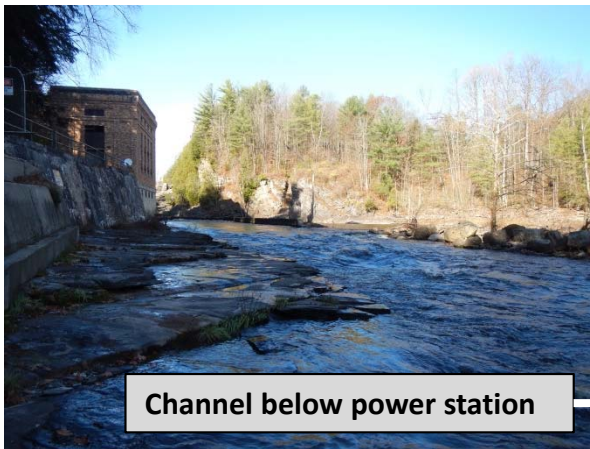
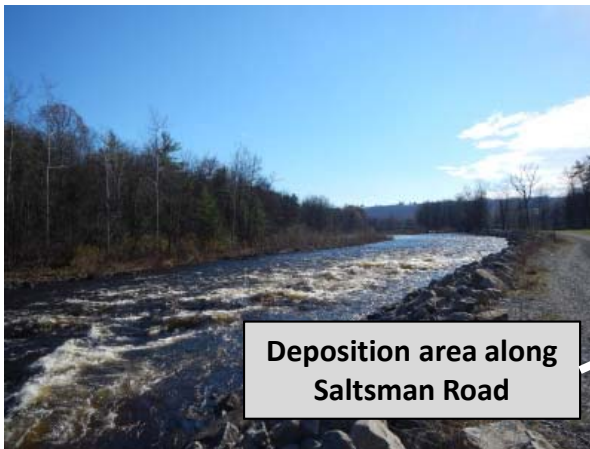
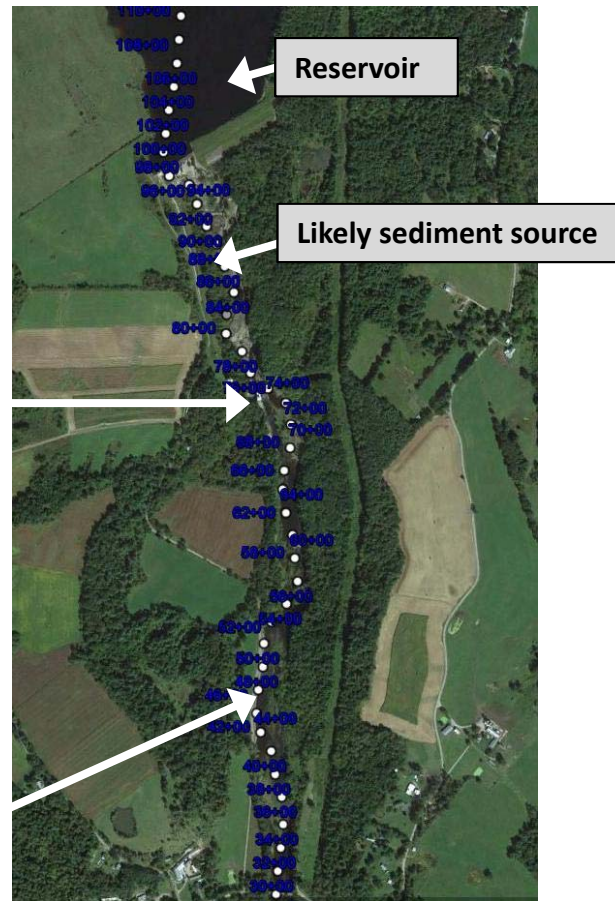
**Site Description:** Along Saltsman Road (STA 52+00 to STA 42+00), a sediment bar has formed in the channel at a similar elevation to the road. This acts to constrict the channel, resulting in overtopping of the road during high flow events.

During high flow events when the capacity of the conduit at the power station is exceeded, overflows run through a section of bedrock channel between STA 97+00 and STA 78+00, which remains dry under normal flow conditions. A likely scenario is that flows running through this section of channel at a high velocity act to scour the weathered bedrock, producing coarse grained sediments that are then deposited along Saltsman Road as the channel widens and flow velocities decrease.

- A dialogue will need to be initiated with the owners of the hydroelectric station, reservoir and dam in order to evaluate the feasibility of altering the operation of the facility to reduce the occurrence and severity of scour in this section of channel.
- Periodic maintenance should be undertaken to remove deposited sediments along Saltsman Road.

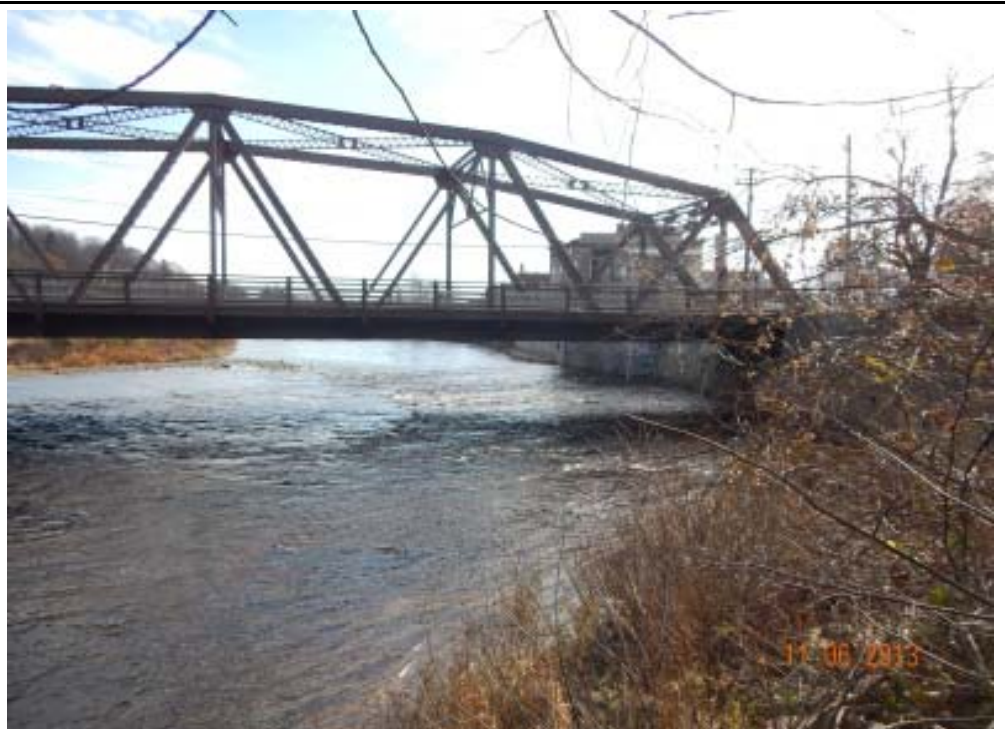
Looking downstream from approximate STA 454+00, this is the Route 29 bridge crossing in Dolgeville that is prone to ice jamming and associated flooding in the town.

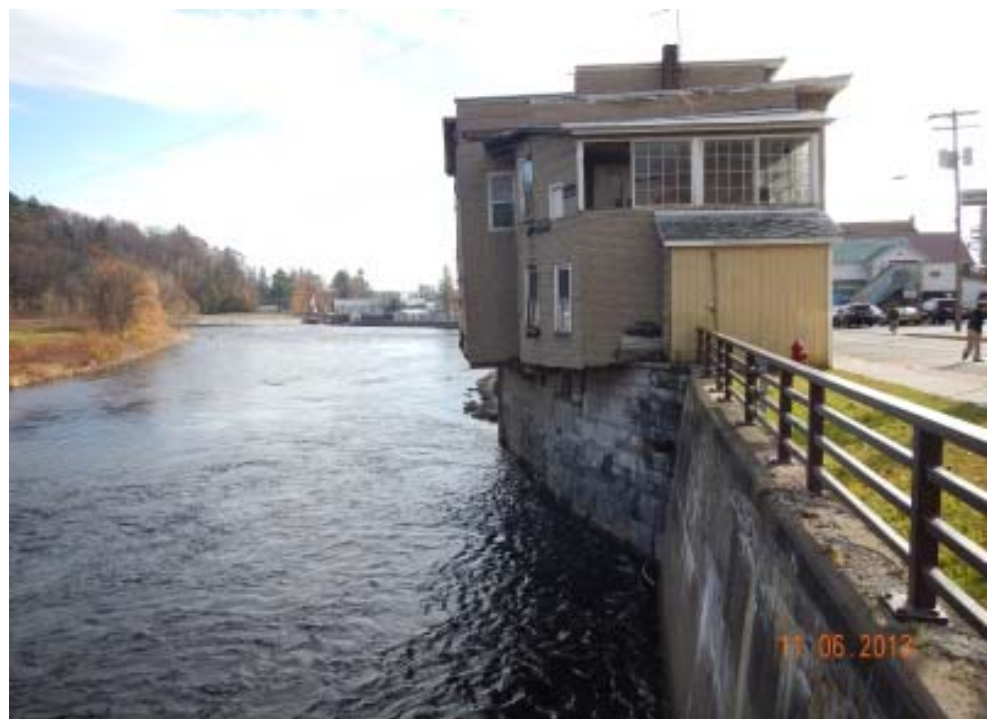
**2**

Viewing from the Route 29 bridge, this photo shows the impounded area above the dam located at STA 440+50.

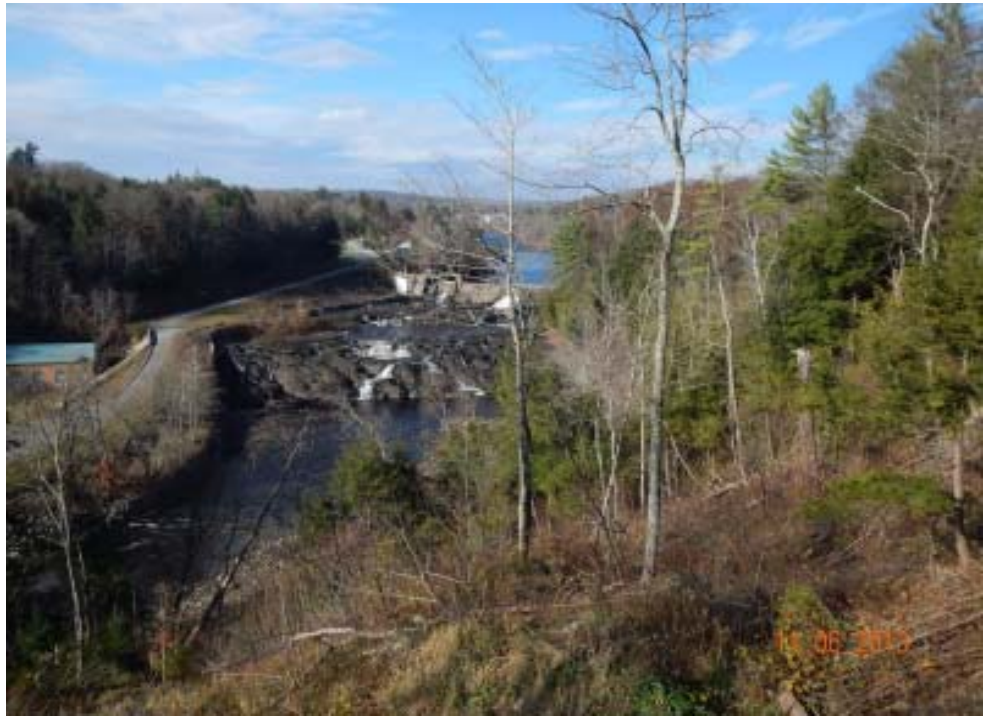
Looking upstream, the hydroelectric dam at STA 396+25 can be seen, identified as High Risk Area #2.

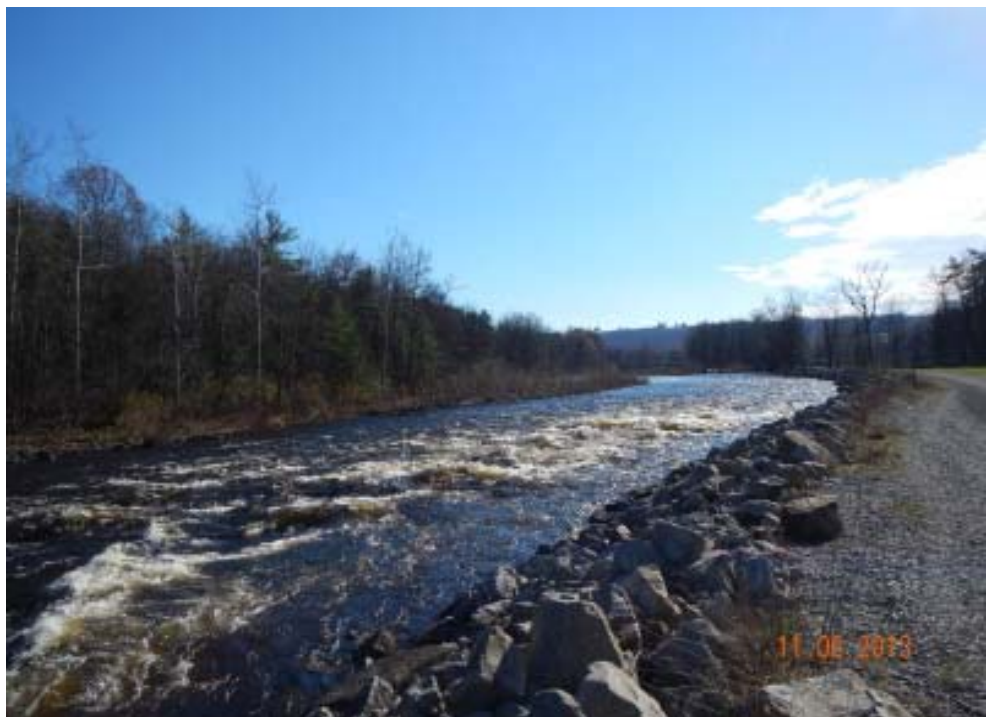
**4**

Viewing from approximate STA 49+00, this is a look from upstream along Saltsman Road with the accumulated sediment bar along the left bank of the river identified in High Risk Area #3.
