EMERGENCY TRANSPORTATION INFRASTRUCTURE RECOVERY
WATER BASIN ASSESSMENT
AND FLOOD HAZARD MITIGATION ALTERNATIVES

MALTANNER CREEK
HERKIMER COUNTY, NEW YORK

April 2014

MMI #5231-01

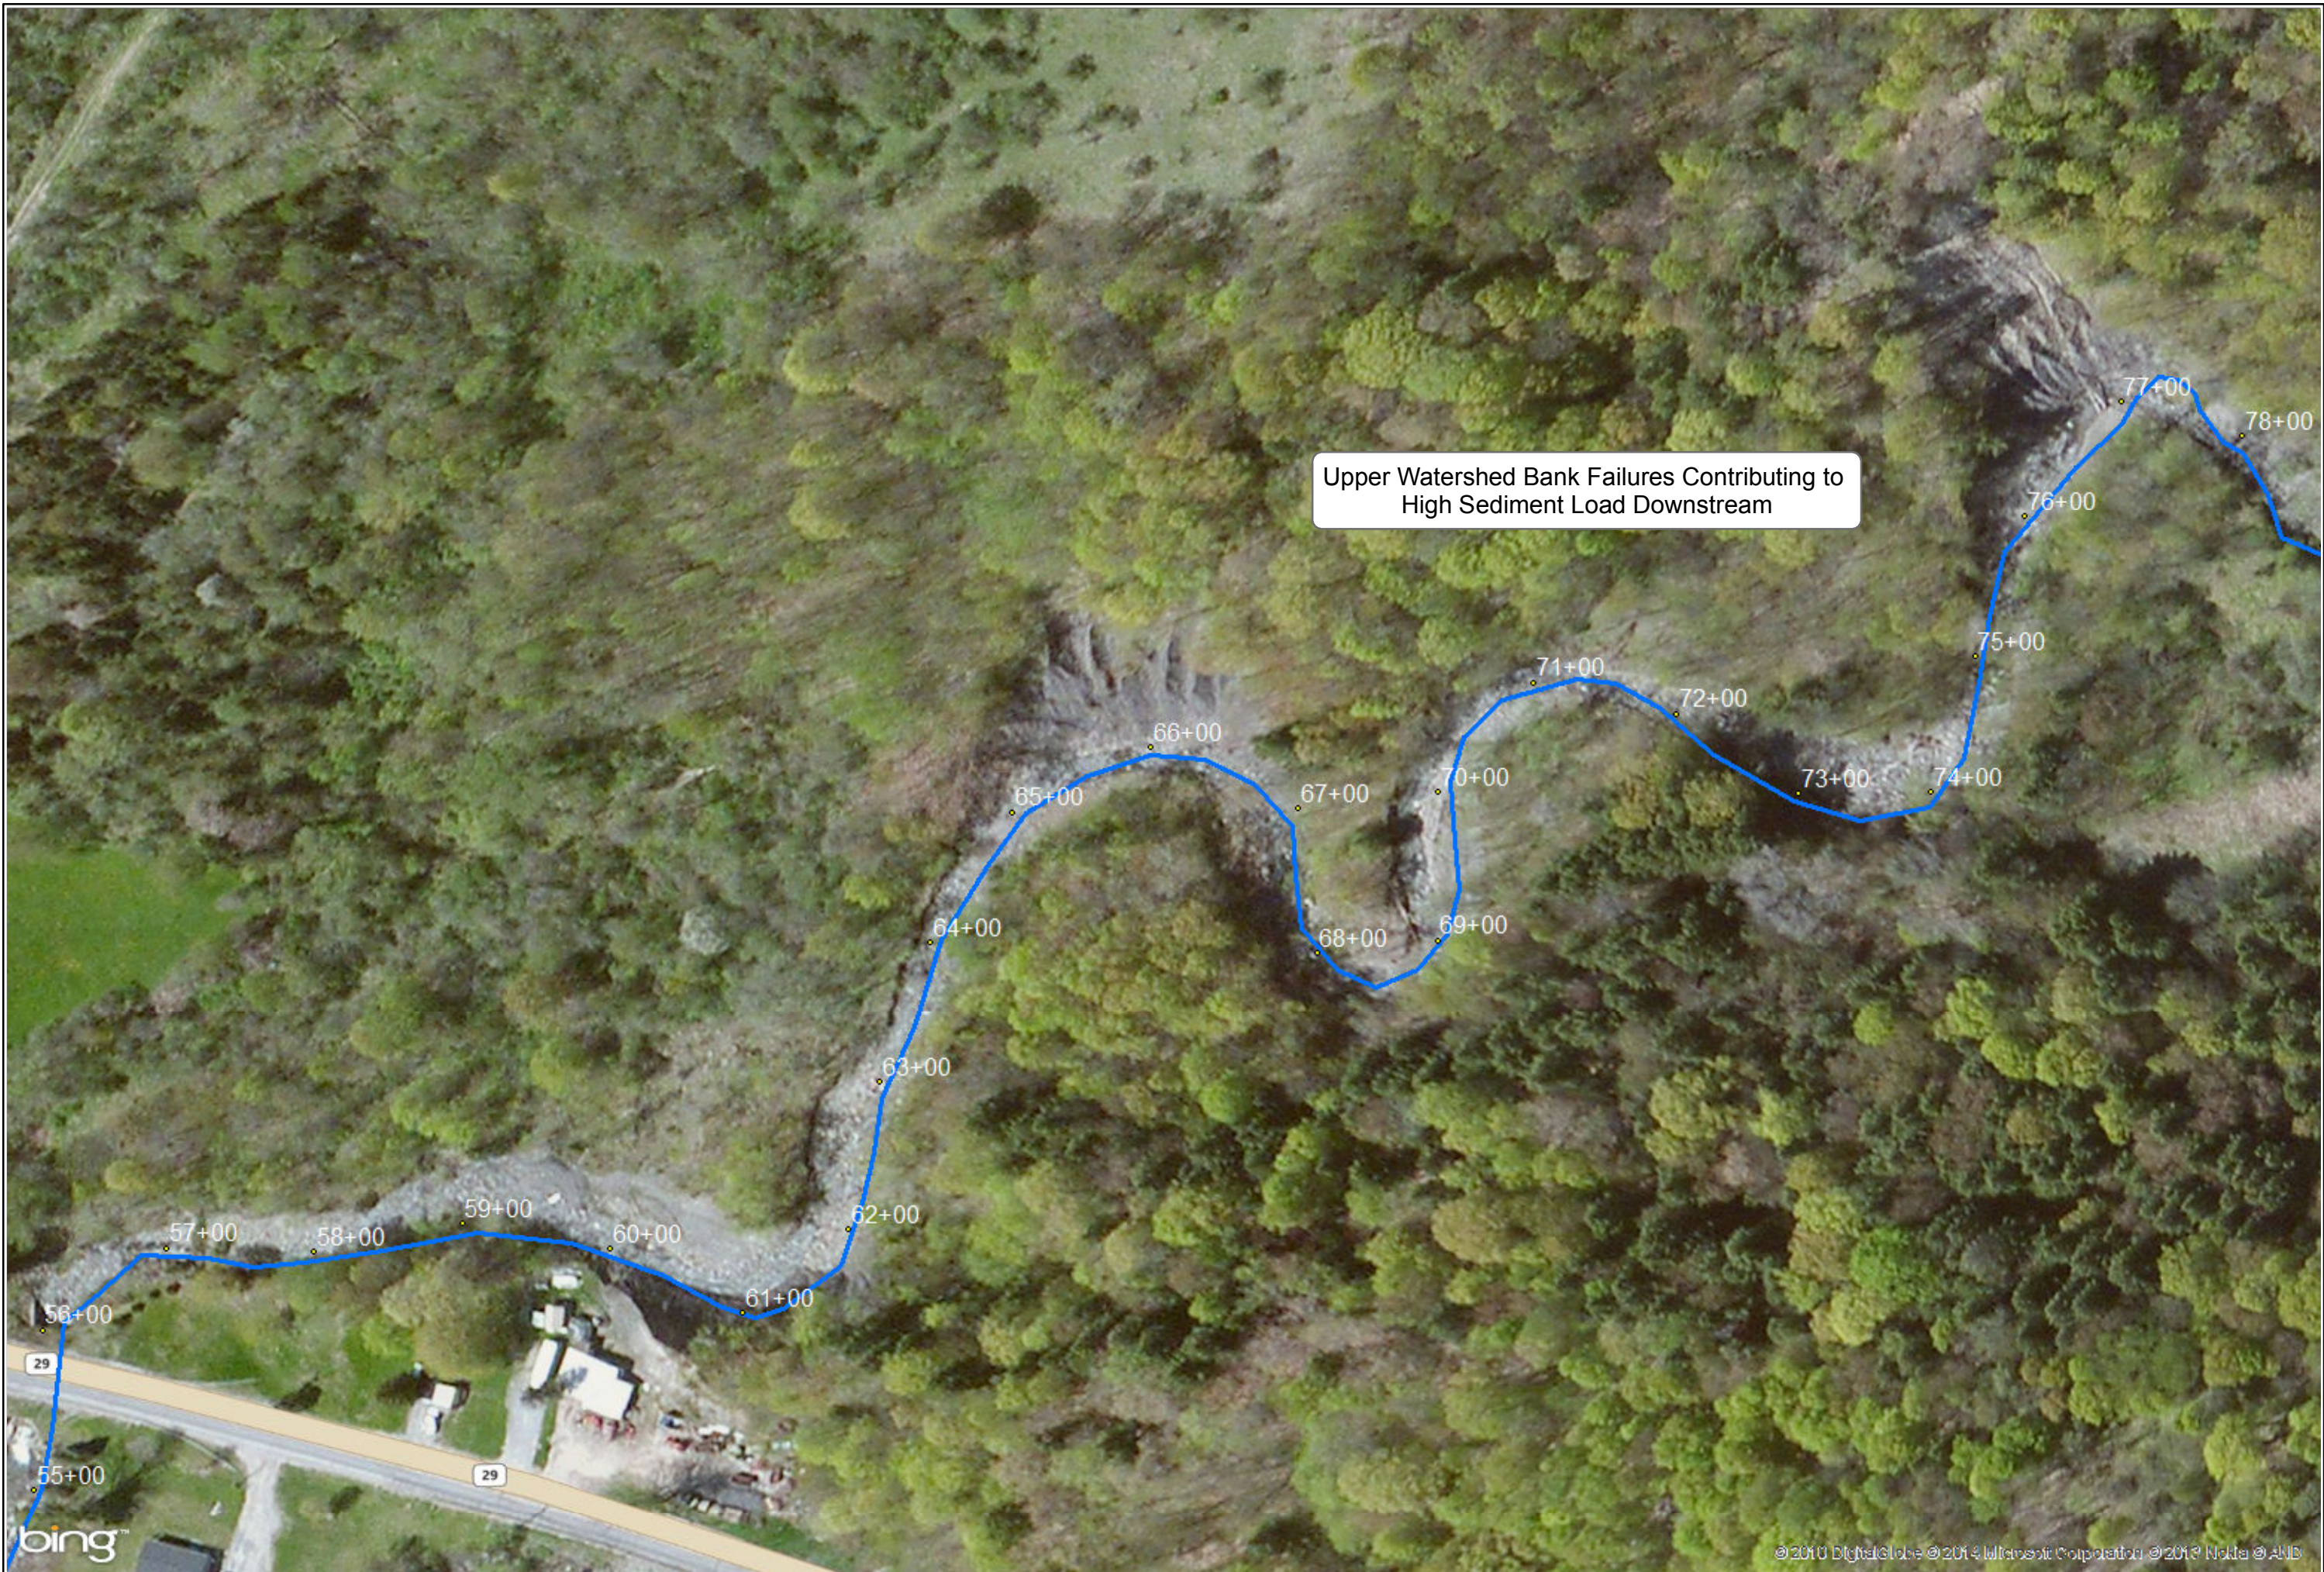
Upper Watershed Bank Failures Contributing to High Sediment Load Downstream

Figure 5 is a location plan of High Risk Area #1. At least three high bank failures were observed upstream of the Route 29 crossing at STA 61+00, STA 67+00, and STA 76+50. These failures are actively contributing fine and coarse-grained sediments to Maltanner Creek. A number of smaller bank slides, bank erosion, and general channel instability were also observed along this reach.

A review of older aerial photography shows that the bank failures upstream of STA 56+00 are not new. Given the geology of this region and the stream power associated with Maltanner Creek, it is likely that the erosion is due to naturally occurring processes. The sandy/silty soils and clay observed in the valley are highly susceptible to erosion. Assessment of the surrounding topography indicates that the steep gorge through which Maltanner Creek flows was formed almost entirely through erosion from the higher plateau that surrounds the gorge. For thousands of years, flood flows have been eroding the banks and transporting sediment down to the West Canada River.

Hydraulic modeling indicates high velocities through this reach during severe flow events, fostered by the steep slope and narrow valley. Velocities at the three major bank failure locations range between 12 and 17 feet per second, which would mobilize all but the largest of boulders. Stabilization of the severe bank failures at STA 61+00, STA 67+00, and STA 76+50 would likely be cost prohibitive, as they are over 110 feet high and would likely require substantial structural elements to repair. A fourth bank failure appears to be forming near STA 99+00. Survey indicates that the channel in this region has an extremely steep slope, as high as 7 percent. Channels this steep would naturally set up a step pool system but only with large enough boulders in the system to form grade control structures at periodic intervals. The sandy/silty gravel/cobble and clay do not provide large enough material to create these structures. As such, downcutting is predicted to continue until large boulders begin to accumulate and self-armour the channel.

Further evaluation of constructing a sediment-controlling dam (Alternative 1-2) is recommended for the upper portions of Maltanner Creek.

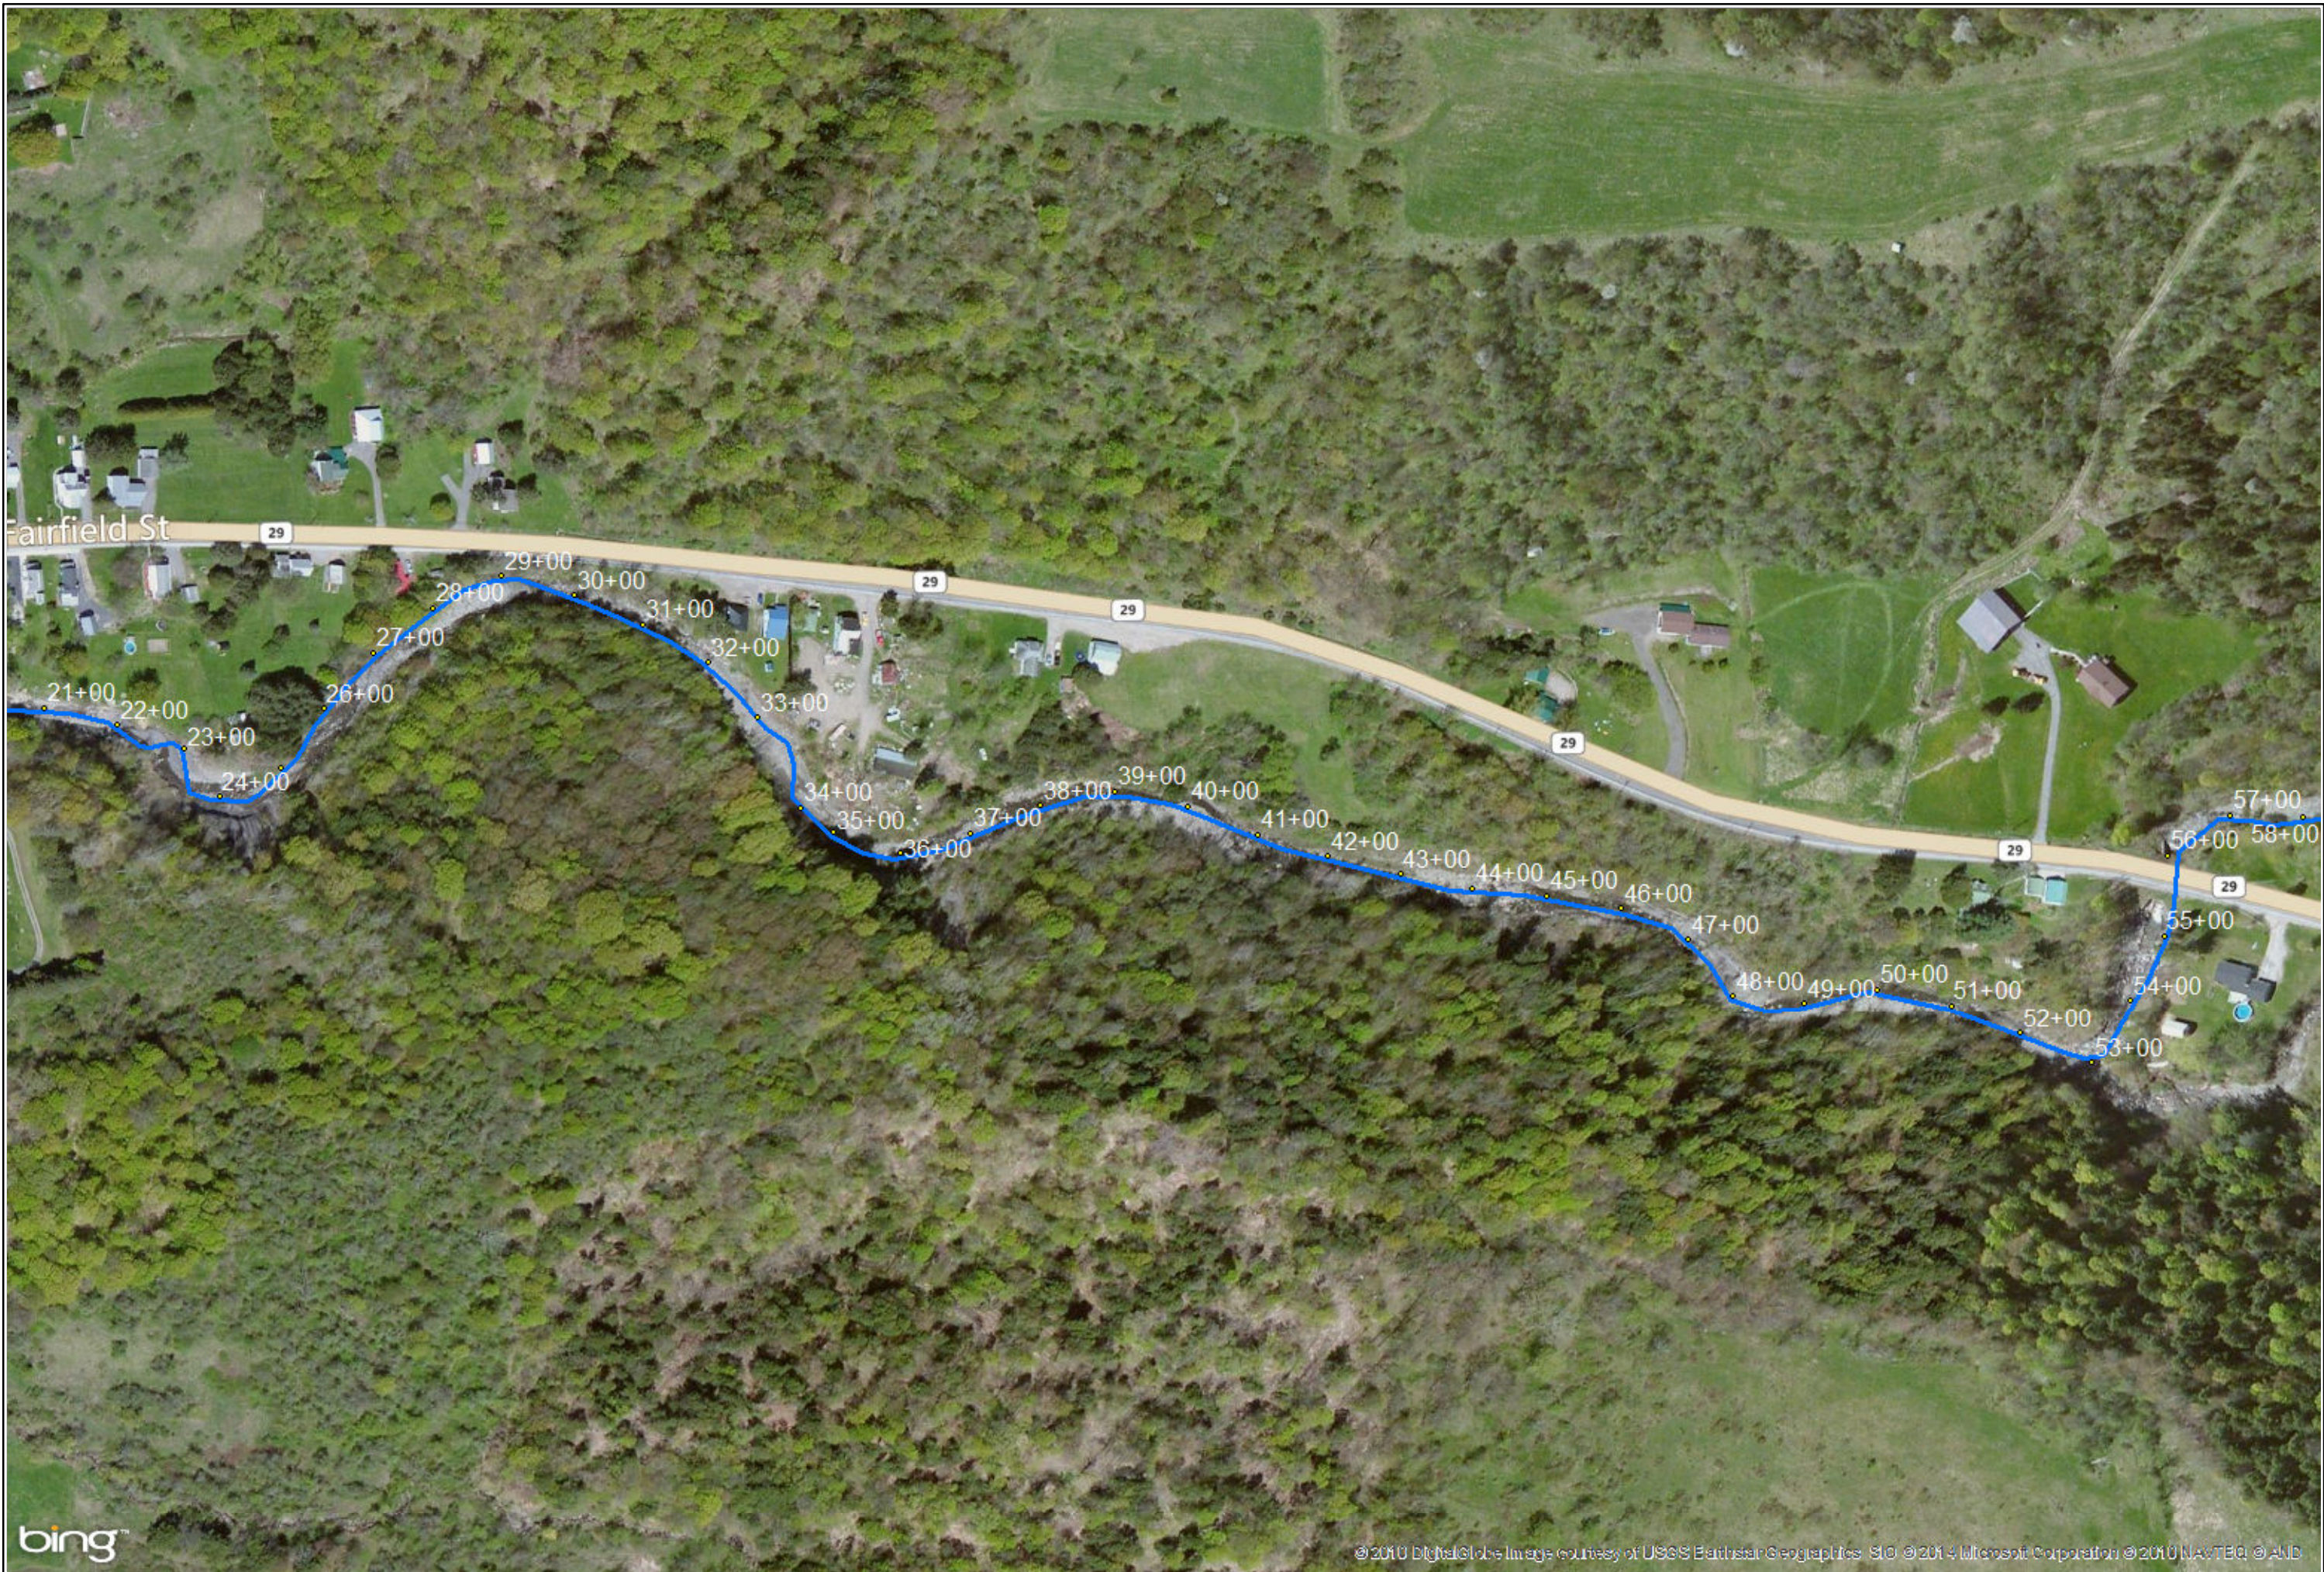
Figure 8: Maltanner Creek High Risk Area #3
NYDOT: Emergency Transportation Infrastructure Recovery
Herkimer County, New York

Figure 8 is a location plan of High Risk Area #3. Multiple bank failures occur in this reach, including bank slides between STA 52+50 and STA 50+00, between STA 45+00 and STA 40+50; a failure in the vicinity of STA 35+50; as well as bank slides between STA 35+00 and STA 32+50, and between STA 25+00 and STA 23+00. In addition, there are a number of bank slides along a tributary that joins Maltanner Creek at STA 53+00, just downstream of the Route 29 crossing.

Alternatives 3-1 and 3-2 are recommended. Stabilization should be considered on a case-by-case basis, but the benefits of undertaking a bank stabilization project need to be weighed against potential further degradation of the channel that may result due to the difficulty involved in accessing many of the sites with heavy equipment.

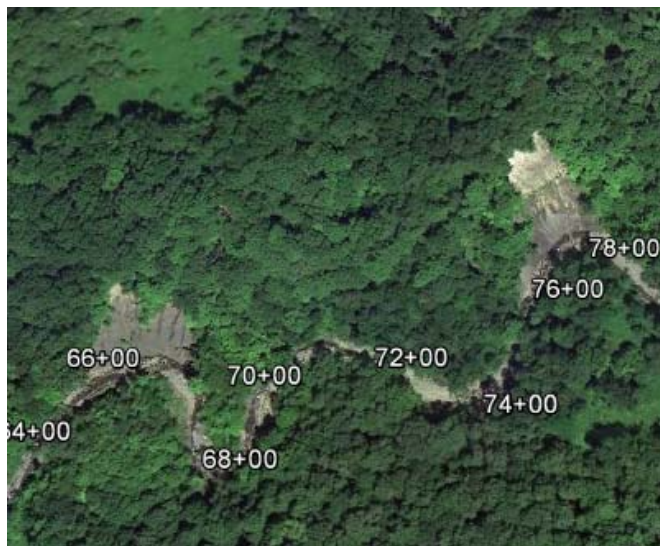
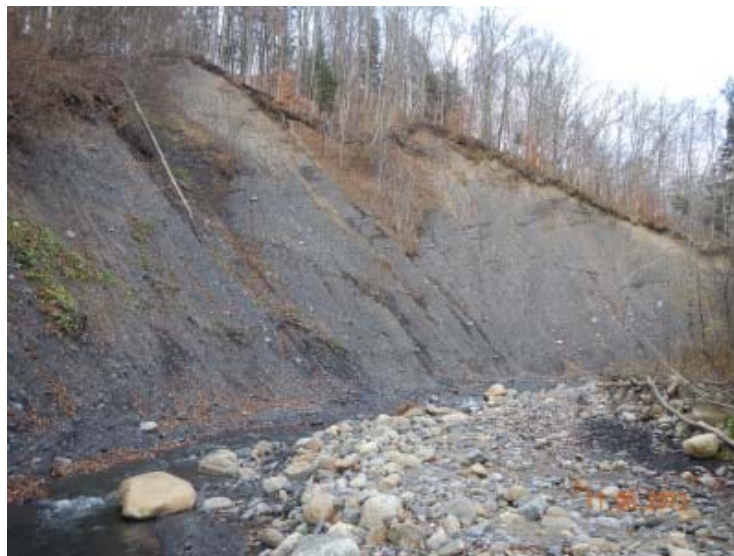
High-Risk Area #1 – Upper Watershed Bank Failures and Erosion

Site Description: This reach includes multiple high bank failures between STA 78+00 and 56+00, that actively contribute sediment to the creek and exacerbate flooding conditions downstream.

- Further evaluation of constructing a sediment control dam.

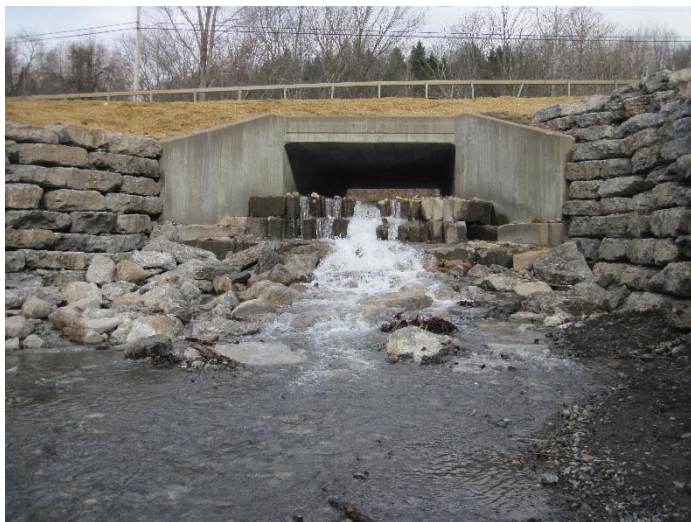
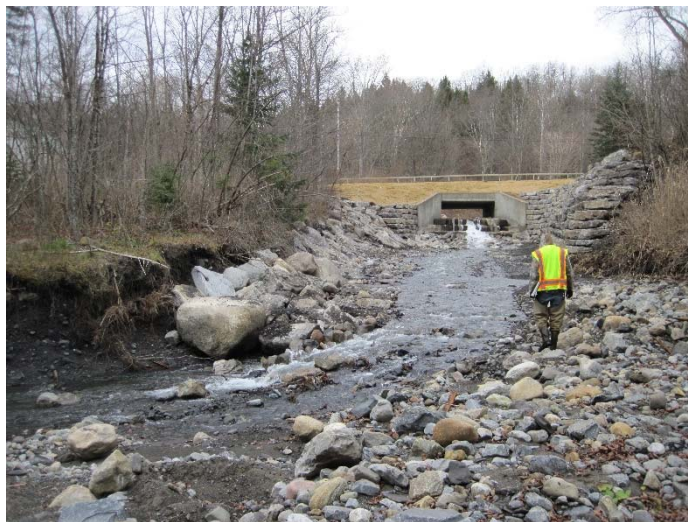
High-Risk Area #2 – Fairfield Street (Route 29) Bridge

Site Description: Located at STA 56+00 is the Route 29 Bridge crossing over Maltanner Creek. The existing bridge consists of a narrow but tall crossing with a steep channel gradient directly downstream of the crossing.

- Replace the Route 29 bridge with a wider span, flatter channel, and appropriately armored/roughened channel to mitigate velocities and protect adjacent banks.

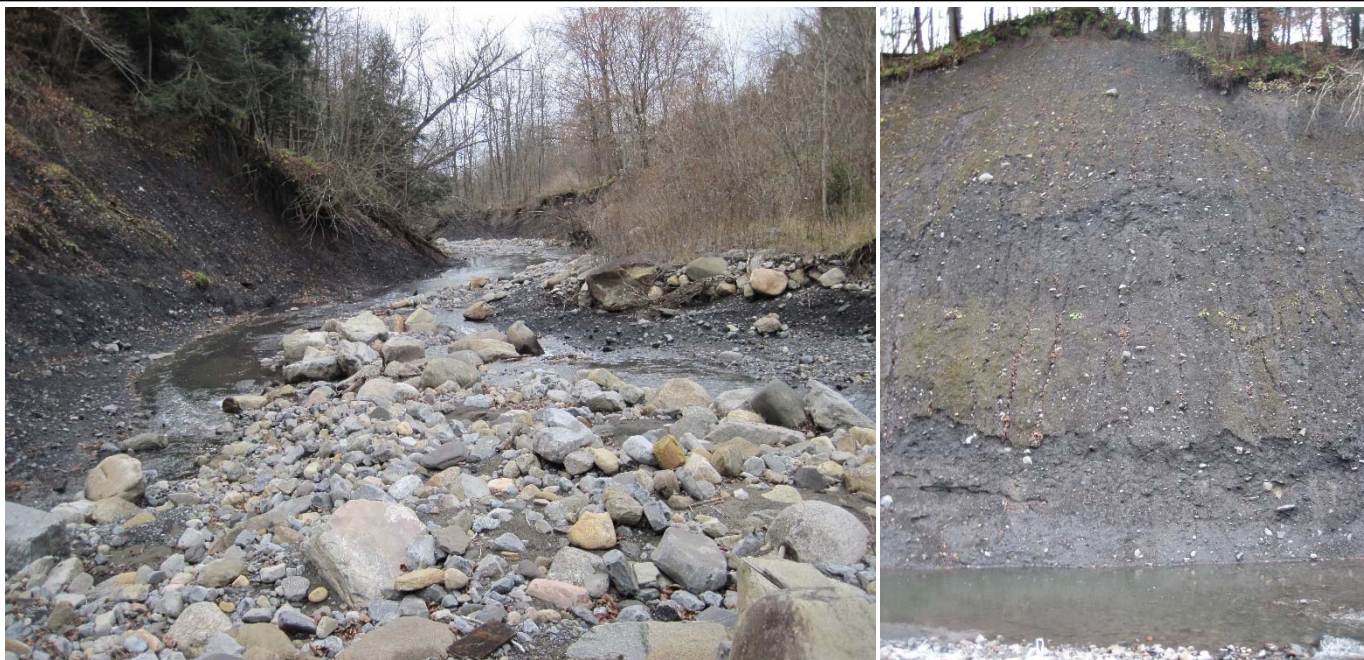
High-Risk Area #3: Mid Watershed Bank Failures and Erosion (STA 23+00 to 56+00)

Site Description: From the Route 29 bridge downstream to STA 23+00 are multiple bank failures and bank slides. Included in this area is the tributary just downstream of the Route 29 bridge which has a number of bank failures as it joins Maltanner Creek. The left photo views from the convergence of Maltanner Creek and the unnamed tributary, downstream. The right photo is a large bank failure located at STA 35+00.

- A stream repair and maintenance program for this reach of Maltanner Creek is recommended to be developed and implemented including conventional and bioengineering bank stabilization techniques.

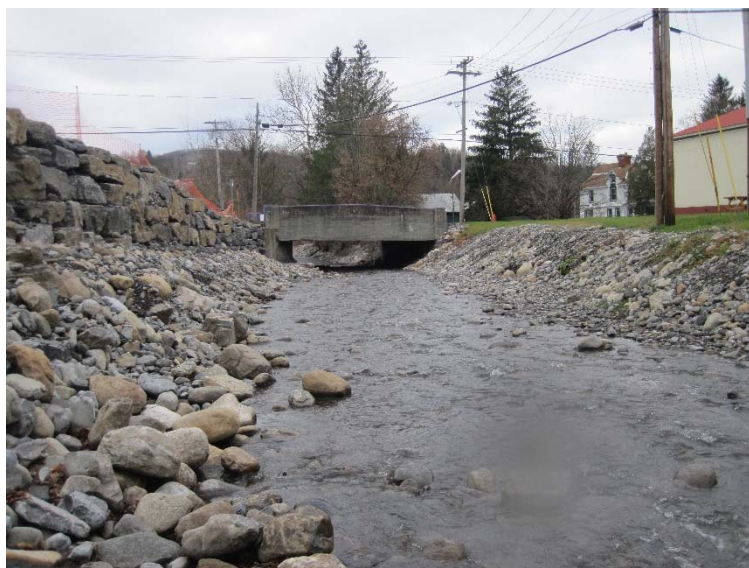
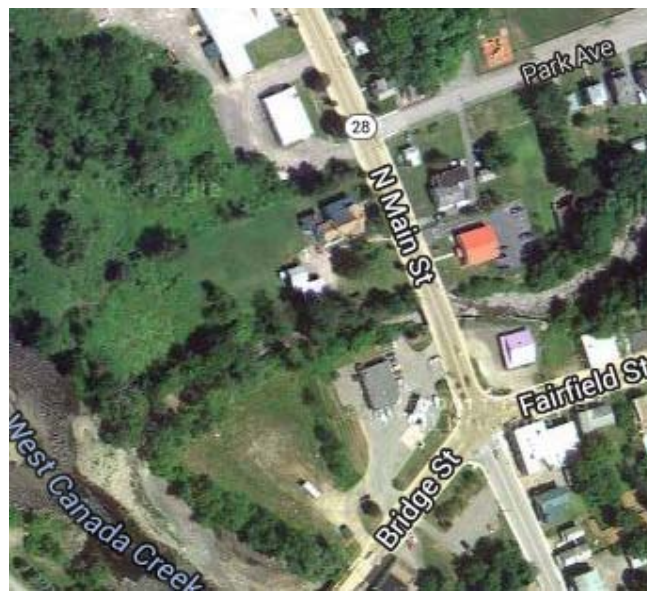
High-Risk Area #4: Middleville Center at North Main Street (Route 28)

Site Description: This high risk area includes the stretch of creek from North Main Street downstream to mouth, STA 5+50 to STA 0+00. The North Main Street Bridge is not large enough to span the full bankfull width of Maltanner Creek and causes severe flooding in the Village of Middleville during flood events.

- Reconstruct the North Main Street Bridge with a wider structure, a lower bed, and appropriate bed roughening to help stabilize the channel in this section.

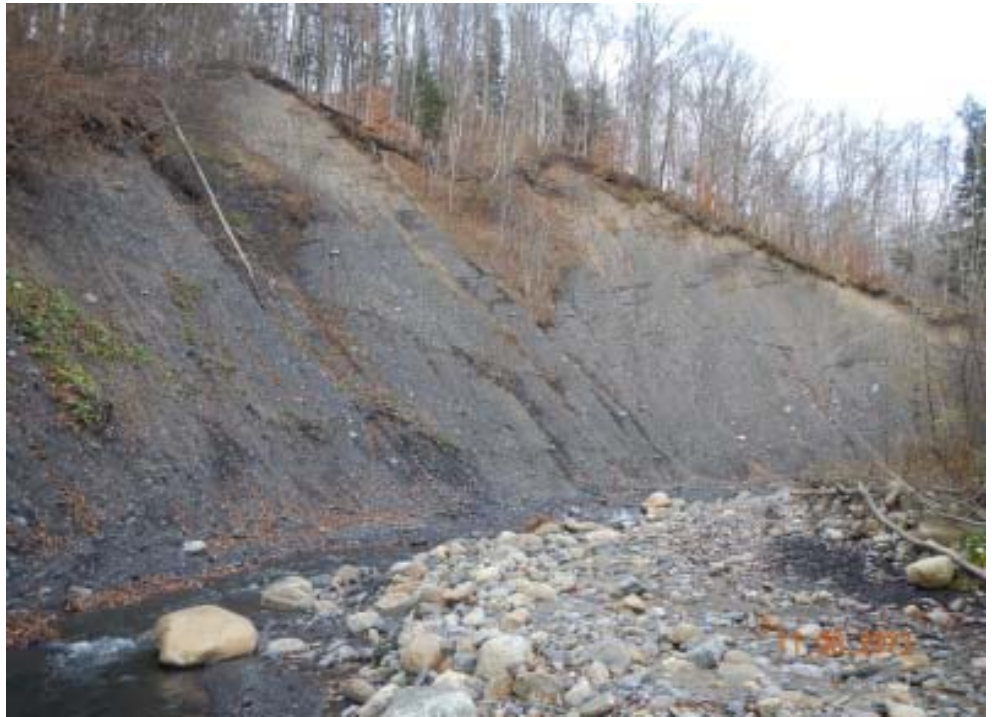
In the upstream reaches of Maltanner Creek are several large bankfailures that contribute to sediment load downstream.

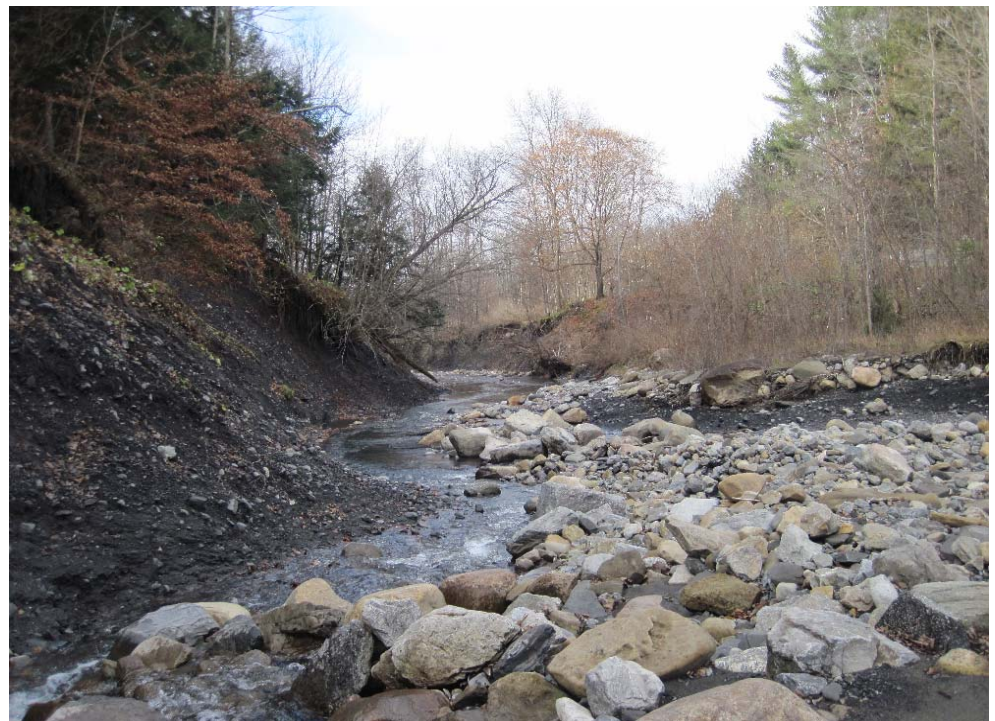
2

After the convergence of Maltanner Creek and an unnamed tributary, looking downstream are continuous bankfailures that line the channel.

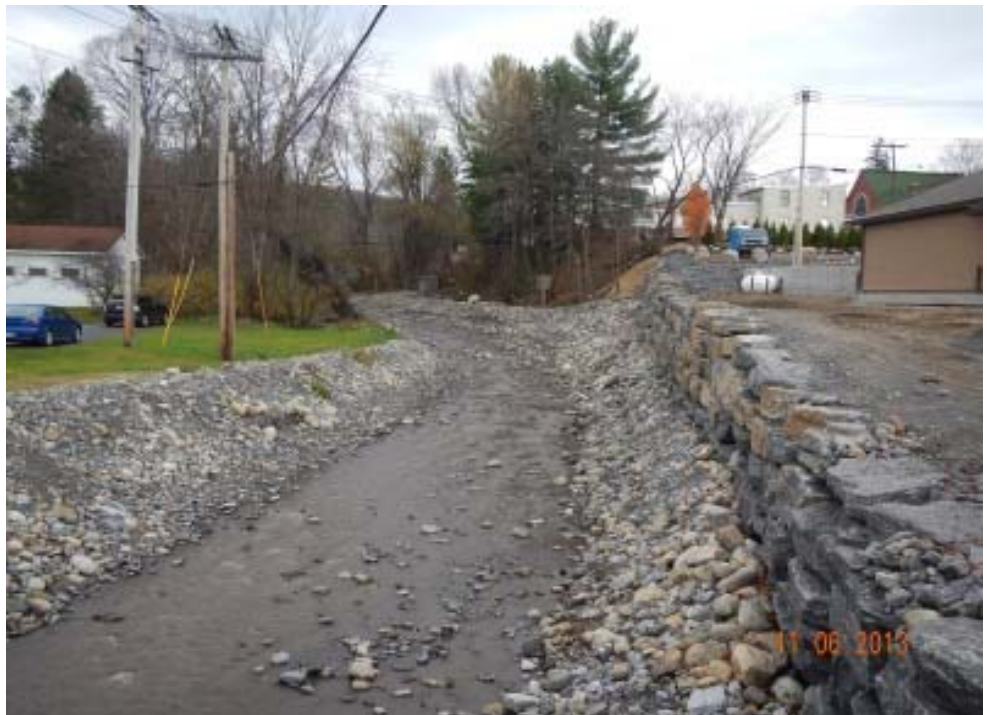
3

Looking upstream from the N Main Street Bridge crossing, the channel has been heavily dredged and widened with a stacked revetment wall constructed to protect commercial property.

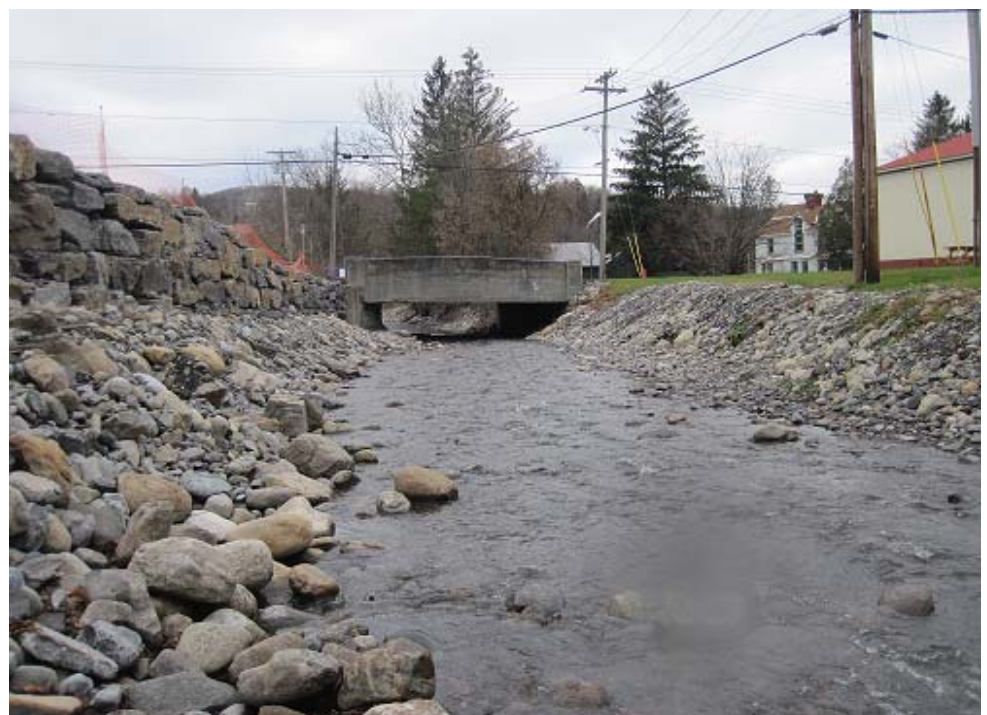
4

A downstream view of the N Main Street Bridge shows its undersized crossing width which creates hydraulic constriction and overtopping during flood conditions.

4. Replace the North Main Street (Route 28) Bridge at STA 5+50 – The bridge at North Main Street (Route 28) is undersized and in poor condition. This bridge has been identified for replacement through the Governor's Scour Critical Bridge Replacement Program. Replacement of this bridge with an approximate 45-foot span structure is recommended as a top priority. Design criteria should be
