EMERGENCY TRANSPORTATION INFRASTRUCTURE RECOVERY WATER BASIN ASSESSMENT AND FLOOD HAZARD MITIGATION ALTERNATIVES

ORISKANY CREEK ONEIDA COUNTY, NEW YORK

April 2014

MMI #5231-01

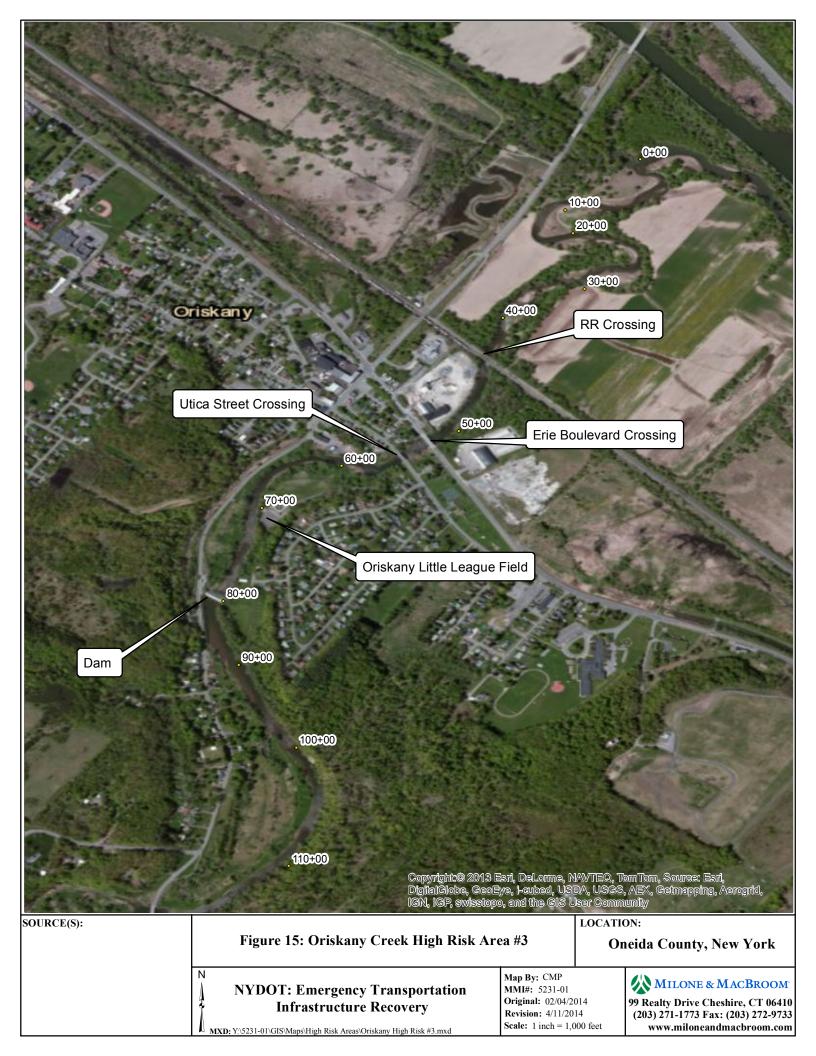
FEMA PROFILE IN HIGH RISK AREA #3 (1 OF 2)

In flood events larger than the 10-year frequency, the FEMA profile indicates that the backwater effect caused by hydraulic constrictions at the Utica Street bridge (at STA 56+50, approximately 2,500 feet downstream of the dam) reaches upstream of the dam and combines with the backwater effect of the dam to raise water surface elevations through this reach. The Erie Boulevard and railroad bridges (STA 53+50 and STA 43+50, respectively) also create a backwater effect that extends upstream from these bridges, contributing to increased water surface elevations from STA 43+50 to upstream beyond the dam at STA 81+50, including the Little League fields on the right bank. A recently constructed earthen levee between the Little League fields and the creek was observed during field investigations in October and November 2013. The FEMA profiles showing these bridges and the dam are included as Figures 16 and 17.

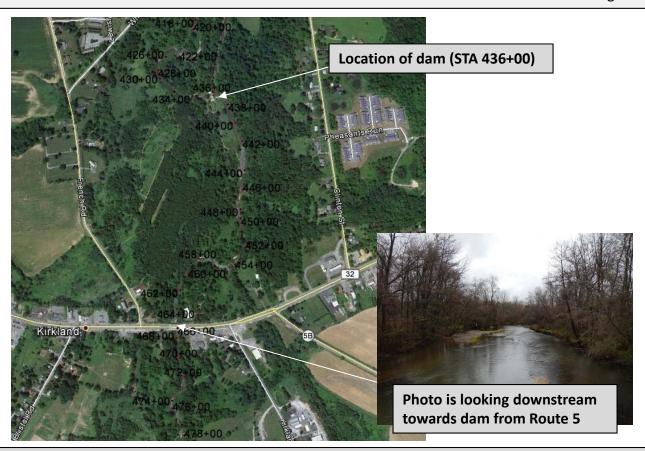
High-Risk Area #2: Low Head Dam at STA 436+00

Site Description: This dam is located approximately 3,000 feet downstream of Route 5 in Kirkland. The dam is acting to significantly increase water surface elevations through Kirkland extending upstream of the Route 5 Bridge. A sediment bar has formed upstream of the dam. The hydraulics in this reach are complex and include the backwater from the dam as well as numerous under-sized downstream bridges.

- Remove the dam, thus reducing water surface elevations in the vicinity of Route 5 during flood events. Removal of the dam would have additional benefit of improving aquatic connectivity.
 Accumulated sediments behind the dam would need to be either stabilized or removed.
- If dam removal is considered, analysis of the hydraulics of the downstream bridges must be taken into consideration when evaluating flood mitigation improvements.

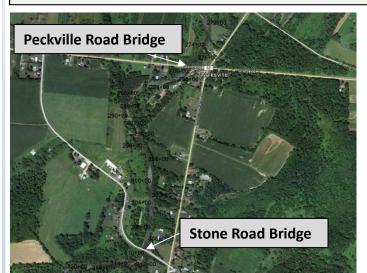
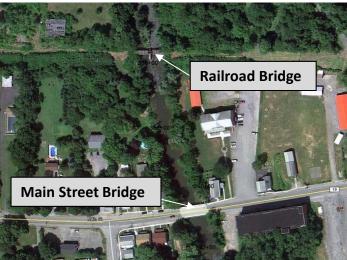
High-Risk Area #2: Undersized Bridges Downstream of Kirkland

Site Description: Undersized bridges downstream of Kirkland contribute to flooding conditions in the area. These include the Main Street Bridge (STA 390+00), an abandoned railroad bridge (STA 385+00), the Peckville Road Bridge (STA 310+00), and the Stone Road Bridge (STA 278+00). The backwater from these bridges reaches the dam at STA 436+00.

- Replace undersized bridges at Main Street (STA 390+00), the abandoned railroad (STA 385+00), Peckville Road (STA 310+00), and Stone Road (STA 278+00).
- When evaluating the hydraulics for any one of these structures, the hydraulics of the others should be
 considered as well as the effects of the upstream dam. This reach of Oriskany Creek is complex and
 changes from one structure affect the hydraulics of the others and vice versa.

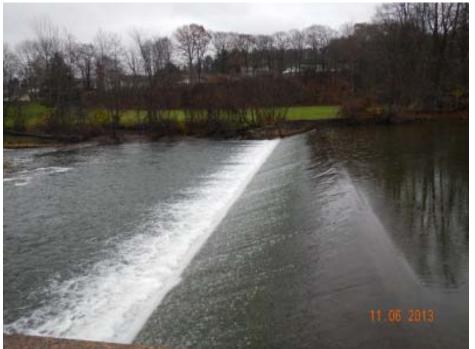
High-Risk Area #3: Dam at STA 81+50

Site Description: According to the FEMA profile, the dam at STA 81+50 creates an increase in water surface elevation upstream of the dam by more than 5 feet during the 10-year flood event, which is contributing to flooding and flood-related damages along Valley Road. In flood events larger than the 10-year frequency flood, the backwater effect caused by hydraulic constrictions at the Utica Street Bridge (at STA 56+50, approximately 2,500 feet downstream of the dam) reaches upstream of the dam and combines with the backwater effect of the dam to raise water surface elevations through this reach.

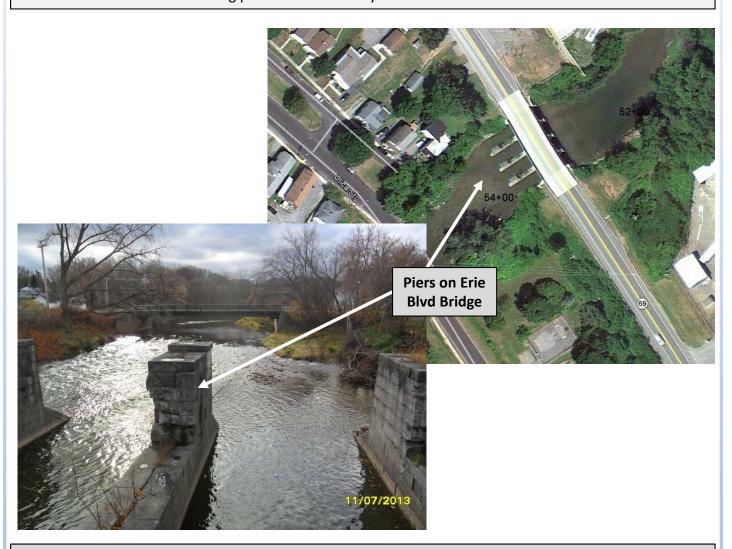
High-Risk Area #3: Modification/Removal of Piers at Erie Boulevard Bridge

Site Description: The Erie Boulevard (Route 69) Bridge at STA 53+50 is the site of frequent jams of woody debris that contribute to flooding problems in Oriskany.

Modify the Erie Boulevard Bridge to reduce the geometry and number of piers to reduce the frequency of debris jams and improve hydraulic capacity at the bridge.

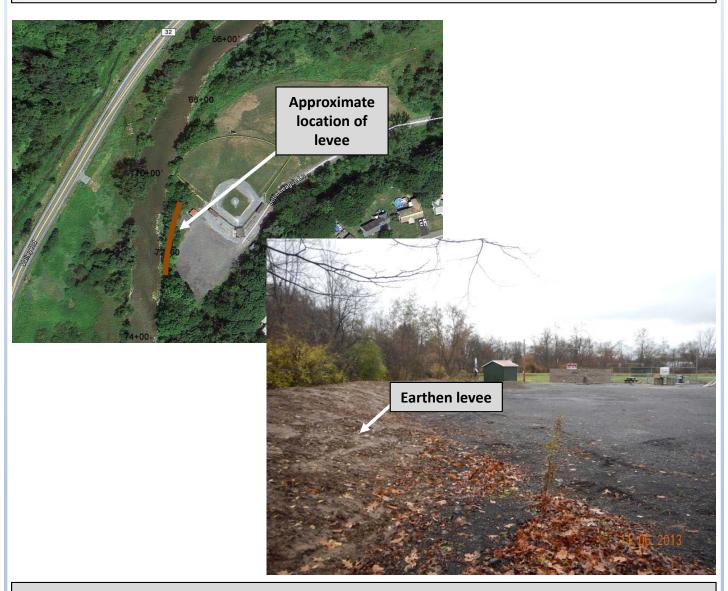
High-Risk Area #3: Removal of Levee at Little League Field

Site Description: During field inspections, a recently constructed earthen levee was observed between the Little League fields and Oriskany Creek, approximately between STA 72+00 and STA 69+00. The levee separates Oriskany Creek from its natural floodplain, thus reducing flood storage and potentially exacerbating flooding at points further downstream.

• Completely remove the levee.

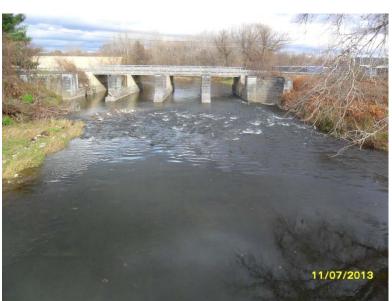
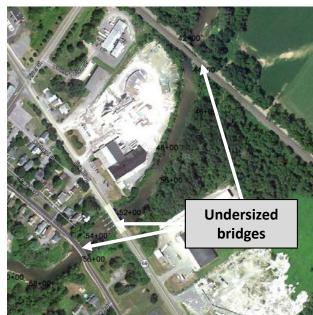
High-Risk Area #3: Undersized Bridges in Oriskany

Site Description: Bridges at Utica Street (STA 56+50), Erie Boulevard (STA 53+50), and the railroad (STA 43+50) serve as hydraulic constrictions during flood flows.

- Remove or replace one or a combination of these three bridges to provide the largest flood mitigation.
 Due to the close proximity of Utica Street and Erie Boulevard, it may be feasible and cost effective to replace one of these bridges with a larger structure and remove the other, routing traffic over the one remaining bridge.
- The hydraulic analysis and design will need to take into account the backwater effect of the Mohawk River.

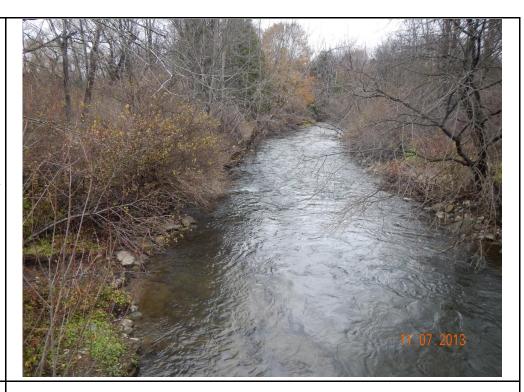
Looking downstream from bridge at Van Hyning Road at STA 1096+00. Oriskany Creek has overtopped its banks as a result of this undersized bridge.

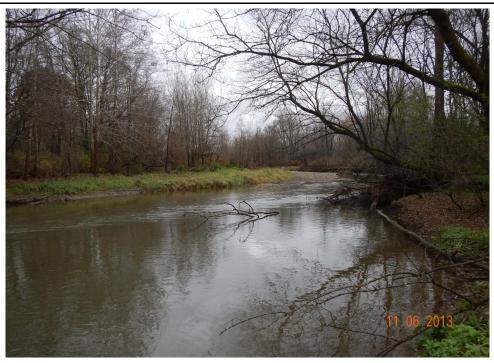
2

Oriskany Creek at STA 575+00, approximately 2,000 feet upstream of the Norton Avenue Bridge, looking in a downstream direction. The creek has overtopped its banks in this area due to a backwater condition created by the bridge.

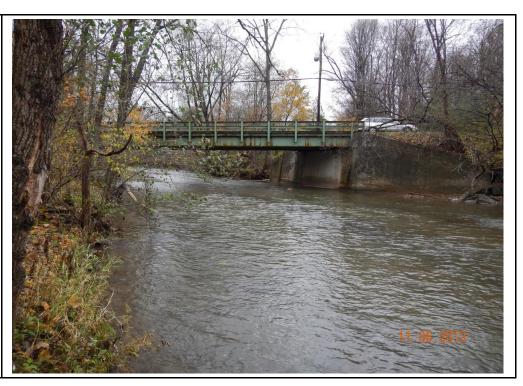
3

Norton Avenue Bridge (STA 554+00) viewed from downstream. This bridge is undersized and creates a hydraulic constriction.

Tier 1: Replace undersized bridges at Route 315 (STA 936+50) and Norton Avenue (STA 554+00) with structures that are large enough to span the creek's bankfull width and convey flood flows without causing a hydraulic constriction. The Route 315 bridge is one of the bridges identified for replacement in Governor Cuomo's Scour Critical Bridge Replacement Program. According to the Governor's website, "This bridge carries NY Route 315 over Oriskany Creek in the Town of Marshall, Oneida County. The highway at this location carries an average of 1,980 vehicles a day. This 51 ft. span steel jack arch bridge on high concrete abutments founded on rock was constructed in 1930, connects Waterville with Deansboro. The bridge connects residential and business districts."

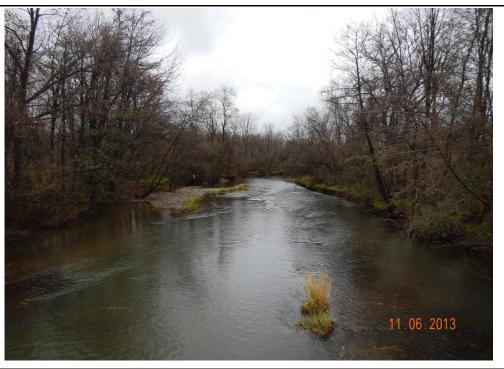
4

At Route 5 Bridge in Kirkland (STA 466+00) looking downstream towards low head dam. The dam causes an increase in water surface elevations through this area.

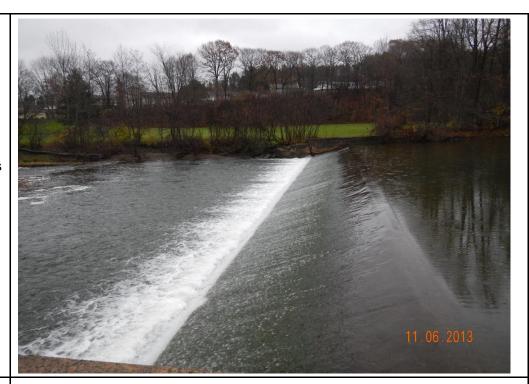
5

Low head dam on Oriskany Creek at STA 81+00. The dam causes an increase in water surface elevations along Valley Road.

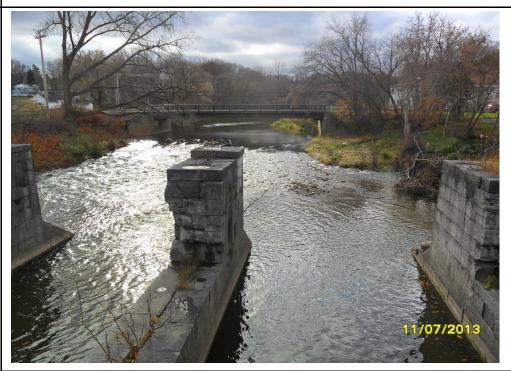
6

View from Erie Blvd (STA 53+50) looking upstream towards Utica Street Bridge (STA 56+50). Piers on the Erie Blvd bridge are visible in the foreground. The piers and the undersized bridges contribute to ice jams and flooding in this area.

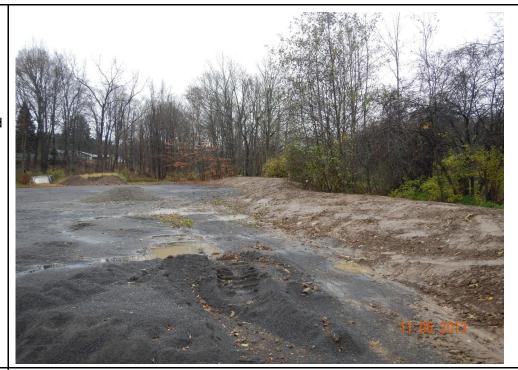
7

Earthen levee at ball field in Oriskany. The levee separates Oriskany Creek from its floodplain and could potentially exacerbate flooding problems. It should be removed.

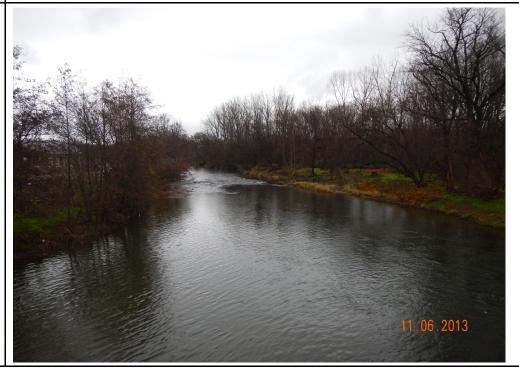
8

View looking downstream towards the Mohawk River from the Erie Blvd Bridge (STA 53+50). Oriskany Creek downstream of this area is influenced by water levels on the Mohawk River during flood events.
