# **SAUQUOIT CREEK DRAINAGE STUDY FINDINGS OF 2019 HALLOWEEN STORM – HYDRAULIC MODELING**

Project name **Sauquoit Creek Drainage Study**  
Project no. **74959**  
Recipient **Sauquoit Creek Basin Intermunicipal Commission**  
Document type **Report**  
Version **1**  
Date **May 11, 2020**  
Prepared by **Ahintha H Kandamby, Ph.D., PE, CFM**  
Checked by **Shaun B. Gannon, PE, D.WRE, PH, CFM, PMP**

# 1. FINDINGS OF 2019 HALLOWEEN STORM EVENT – HYDRAULIC MODELING

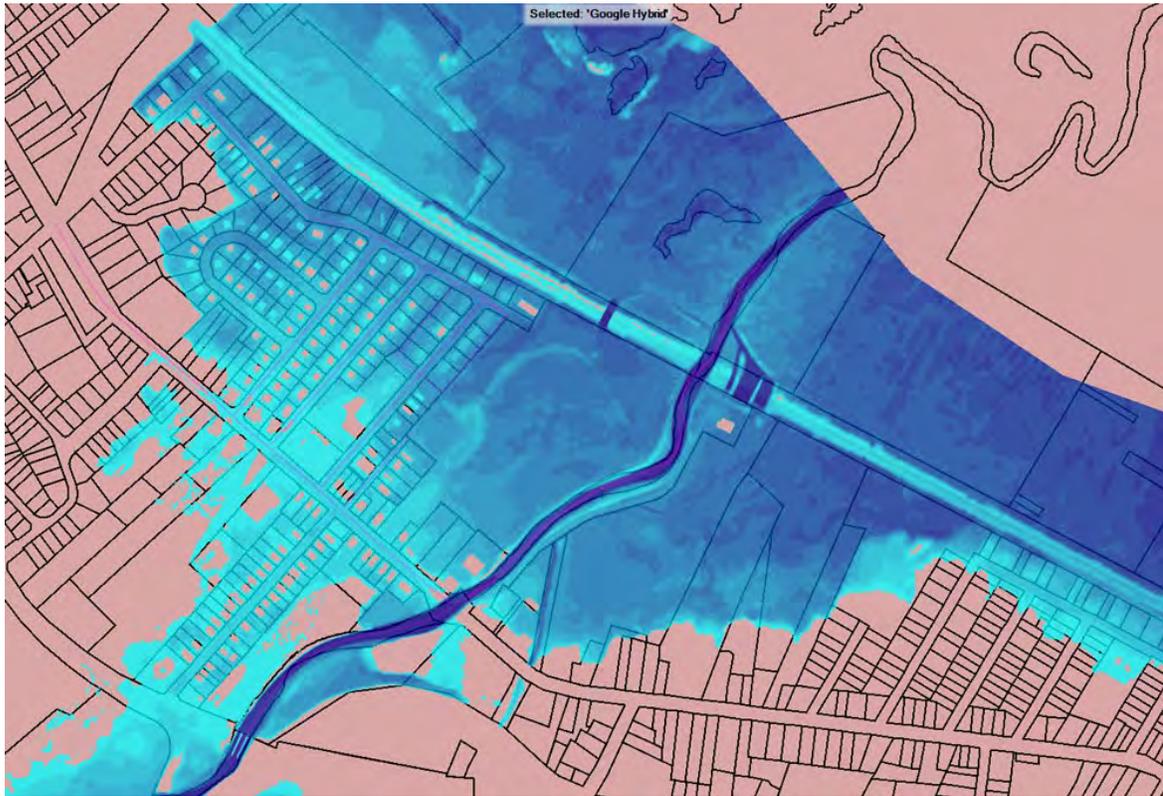
Figure 6 shows the number of residential buildings whose first-floor elevations were completely under water during the event. Approximately 67 residential buildings were potentially critically impacted by inundation of their FFE, and / or basement. Approximately, 114 buildings were not flooded to the FFE, however their parcels were inundated to various depths, which could have weakened their foundations.

**Figure 6. Inundated Buildings at the peak of the Halloween Storm**

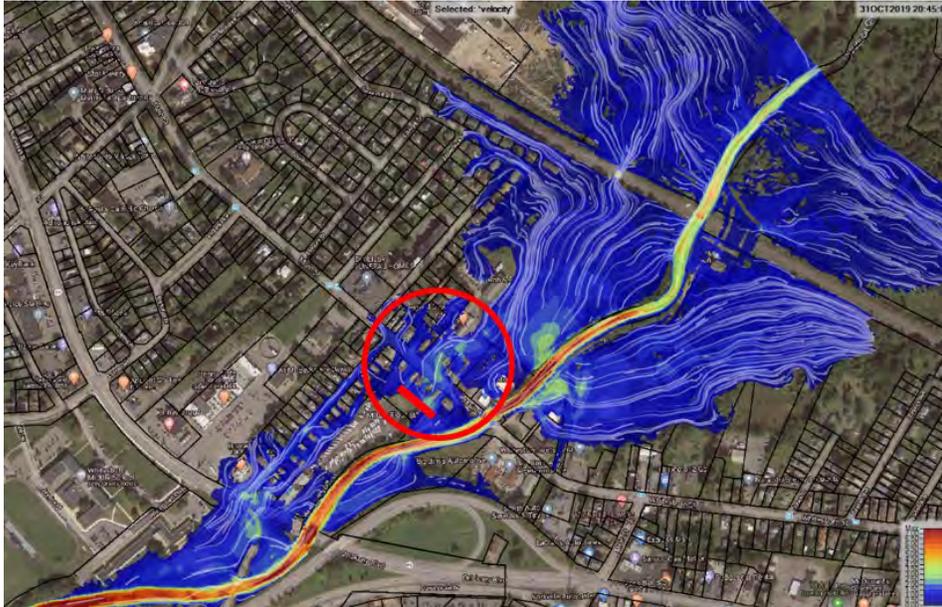
**Figure 9. Flood development (Whitesboro Middle School / Main Street area)**

In Figure 9 the model shows flooding beginning to concentrate at the Whitesboro Middle Schools parking lot and flow down Gardner Street towards Main Street. The figure also depicts how flow begins to concentrate at the northern end of the Boulevard Trailer property about 880-feet downstream from the Oriskany Boulevard bridge. Floodwater then passes over Main Street inundating the residential neighborhoods on both sides of the Main Street roadway (Circled in Figure 9). The maximum velocity and the maximum depths located at the thick red line drawn on Figure 9 is above 3 fps and above 2.5 feet. The flood water then continues to flow into the lower areas adjacent to the railroad embankment.

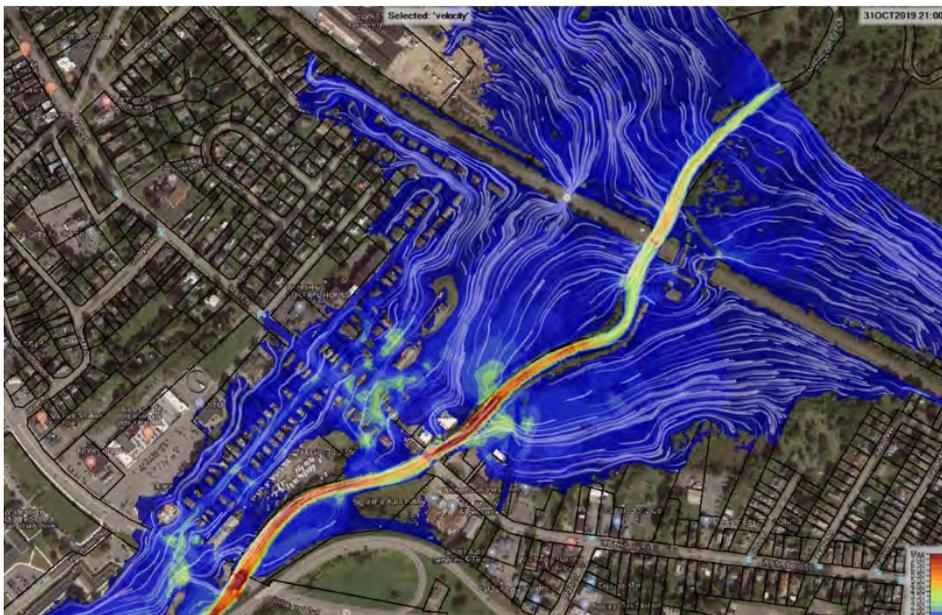
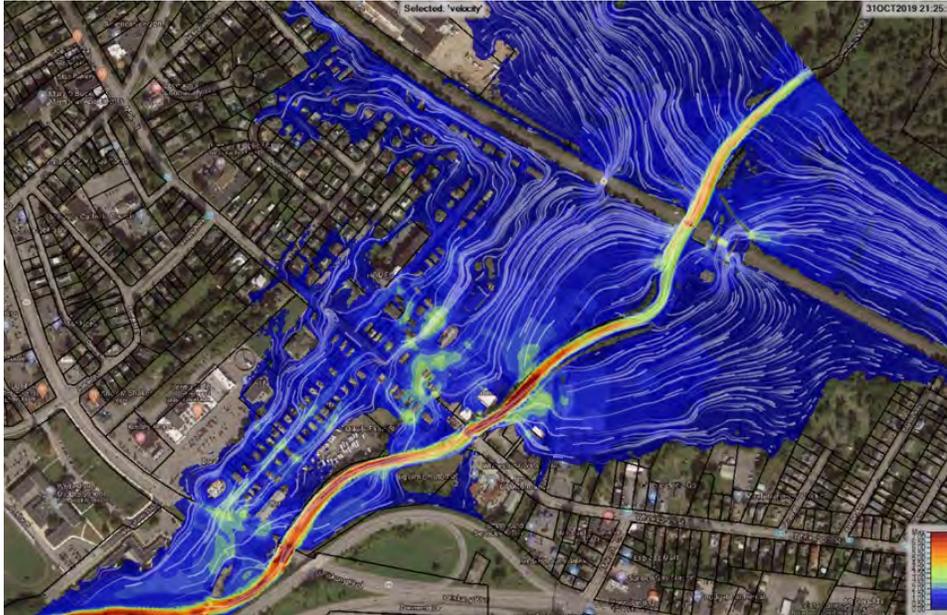
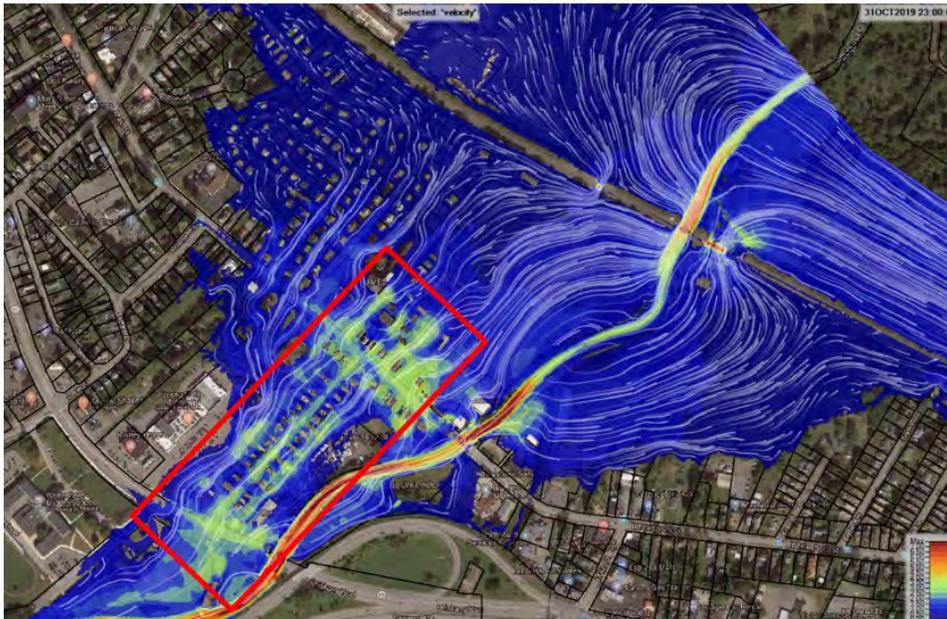
Figures 10 through 12 show the flooding evolution in the left floodplain between the Main Street Bridge crossing and the railroad crossing of the Sauquoit Creek. Figure 11 and Figure 12 show the peak velocity and the peak depth contours during the storm. In Figure 12, the neighborhoods that are under high velocity during the storm are marked with a rectangle. The streamlines indicate the direction of flow. The color shading shows the relative intensity of the velocity field.

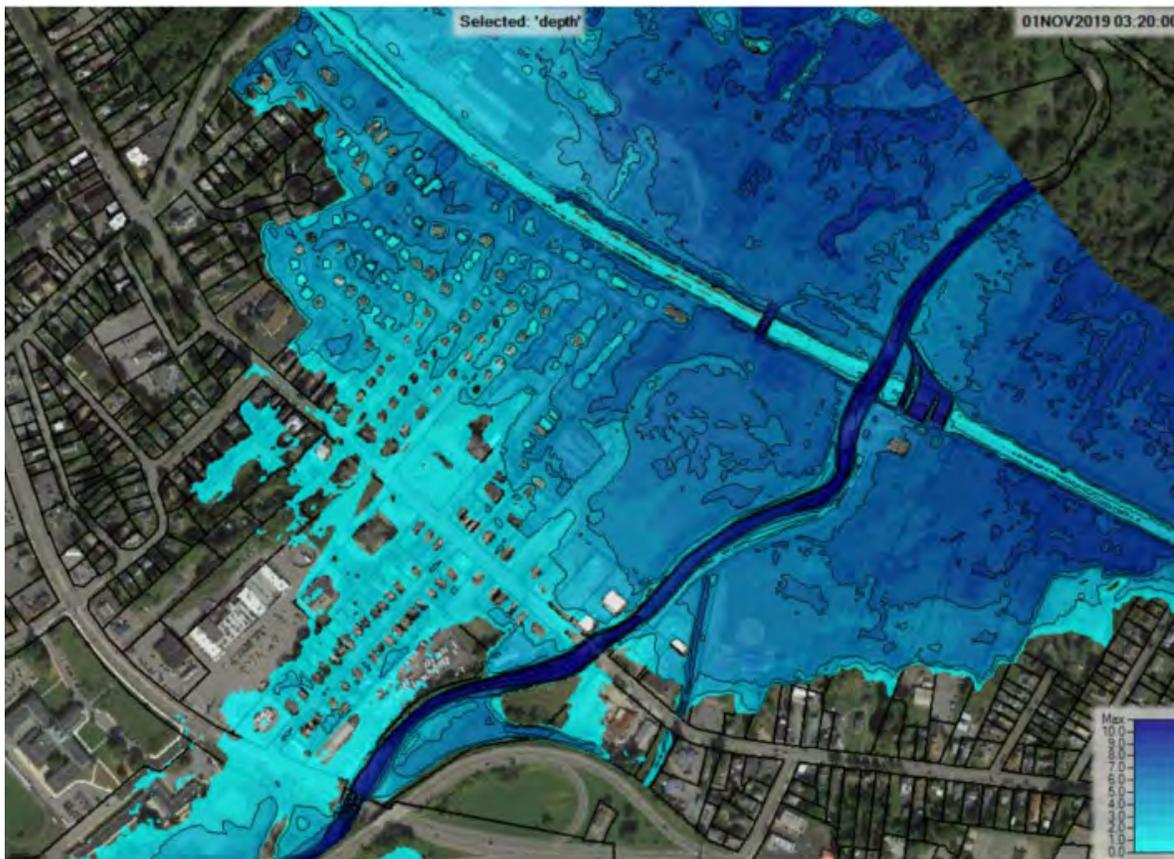
A majority of residential buildings are concentrated towards the Northwestern side of the left floodplain of Sauquoit Creek near or within Dunham Place, Wind Place and Ellmore Place. Figures 10 through 12 shows the leading edge of the flood wave travel along Sauquoit Street and enter Dunham Place, Wind Place and Ellmore Place, and shows low velocities during the peak event. Figure 13 shows that the peak depth occurs 40 minutes after the peak velocity occurred.

**Figure 13. Sauquoit Creek Maximum Flood Depth during the 2019 Halloween Storm**

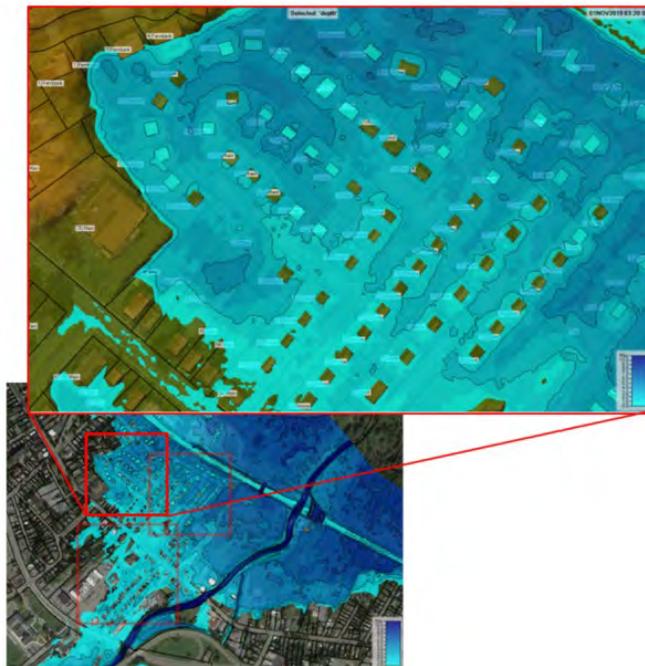
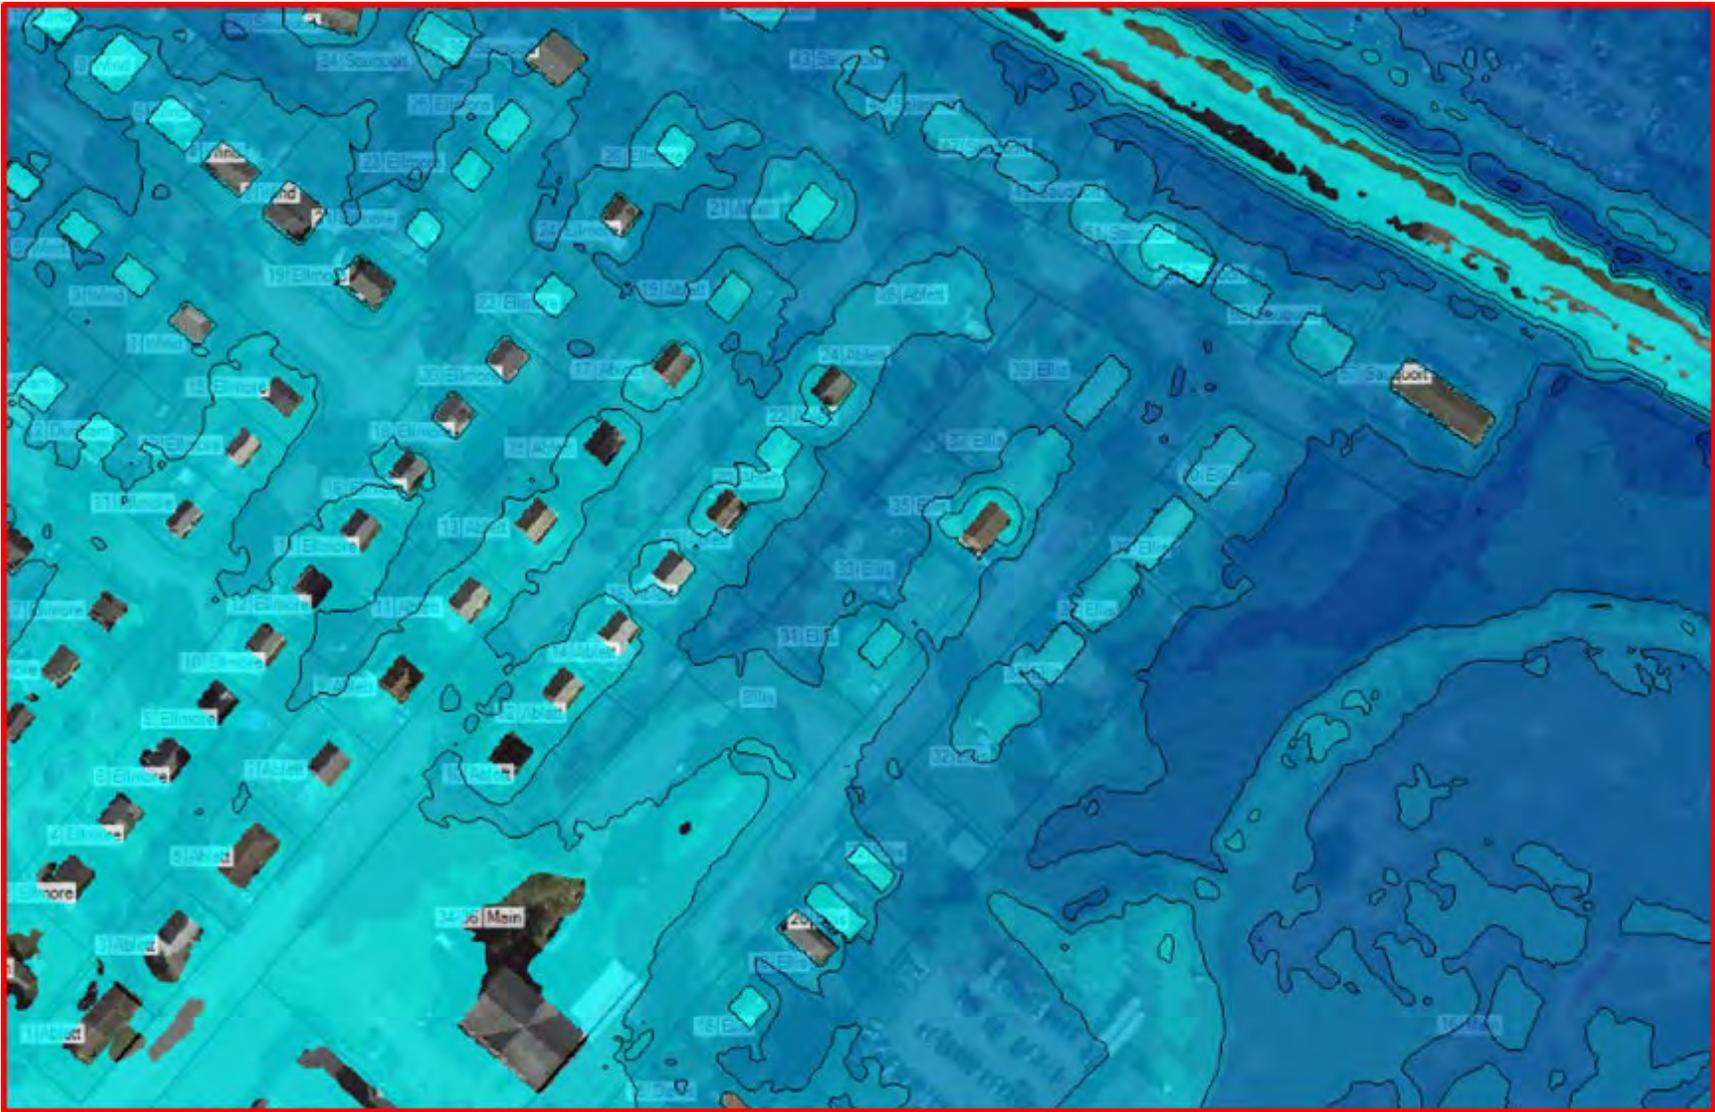
Enlarged view Figure 14 2

From Figure 14, one can determine that for the neighborhoods of Dunham and Wind Place, most houses are flooded by more than two feet of water. Modeling also shows approximately 16 properties in this neighborhood that have their FFE fully submerged. The remaining may not have been subject to first floor flooding; however, each is subject to potential hydrostatic pressure from the depth of floodwater, potentially weakening the foundations structural integrity.

Specifically, house numbers 7, 9, 10, 12, and 14 Wind Place, 19 Dunham Place, 24, 26, 28 and 36 Sauquoit Street yards are flooded by more than four feet of water. Additionally, 1, 2 and 4 Dunham and 1, 3, 5, 6 and 8 Wind Place, and 21, 22, 23, 24, 25 and 26 Ellmore Drive yards are flooded by up to three feet of water. The majority of the Ellmore Drive and Albert Drive towards Sauquoit Street are also submerged by similar amounts.

**Figure 14. Inundated buildings at the peak of the 2019 Halloween Storm**

Continuing along each street, house numbers 10 through 16, and 18, 19, and 20 Ellmore Drive house yards are submerged by approximately two feet of water. The effects of buoyancy and hydrostatic pressure from the flood water surrounding each of these structures, may have adversely affected the foundation of each.

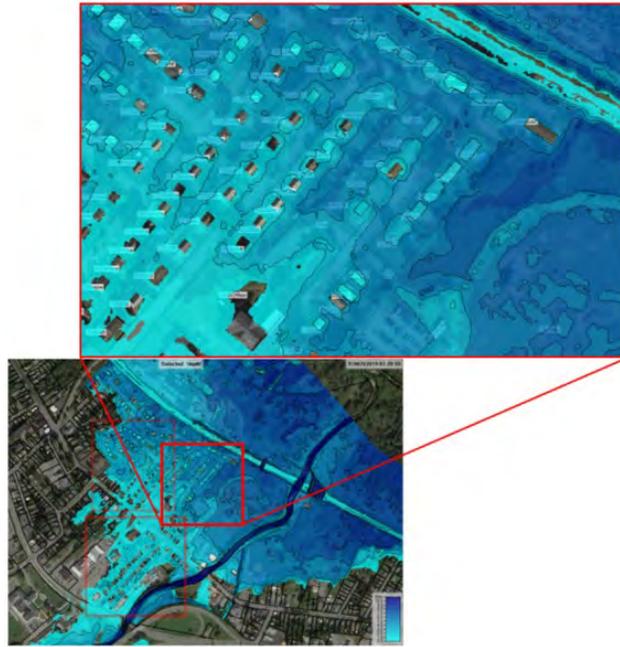
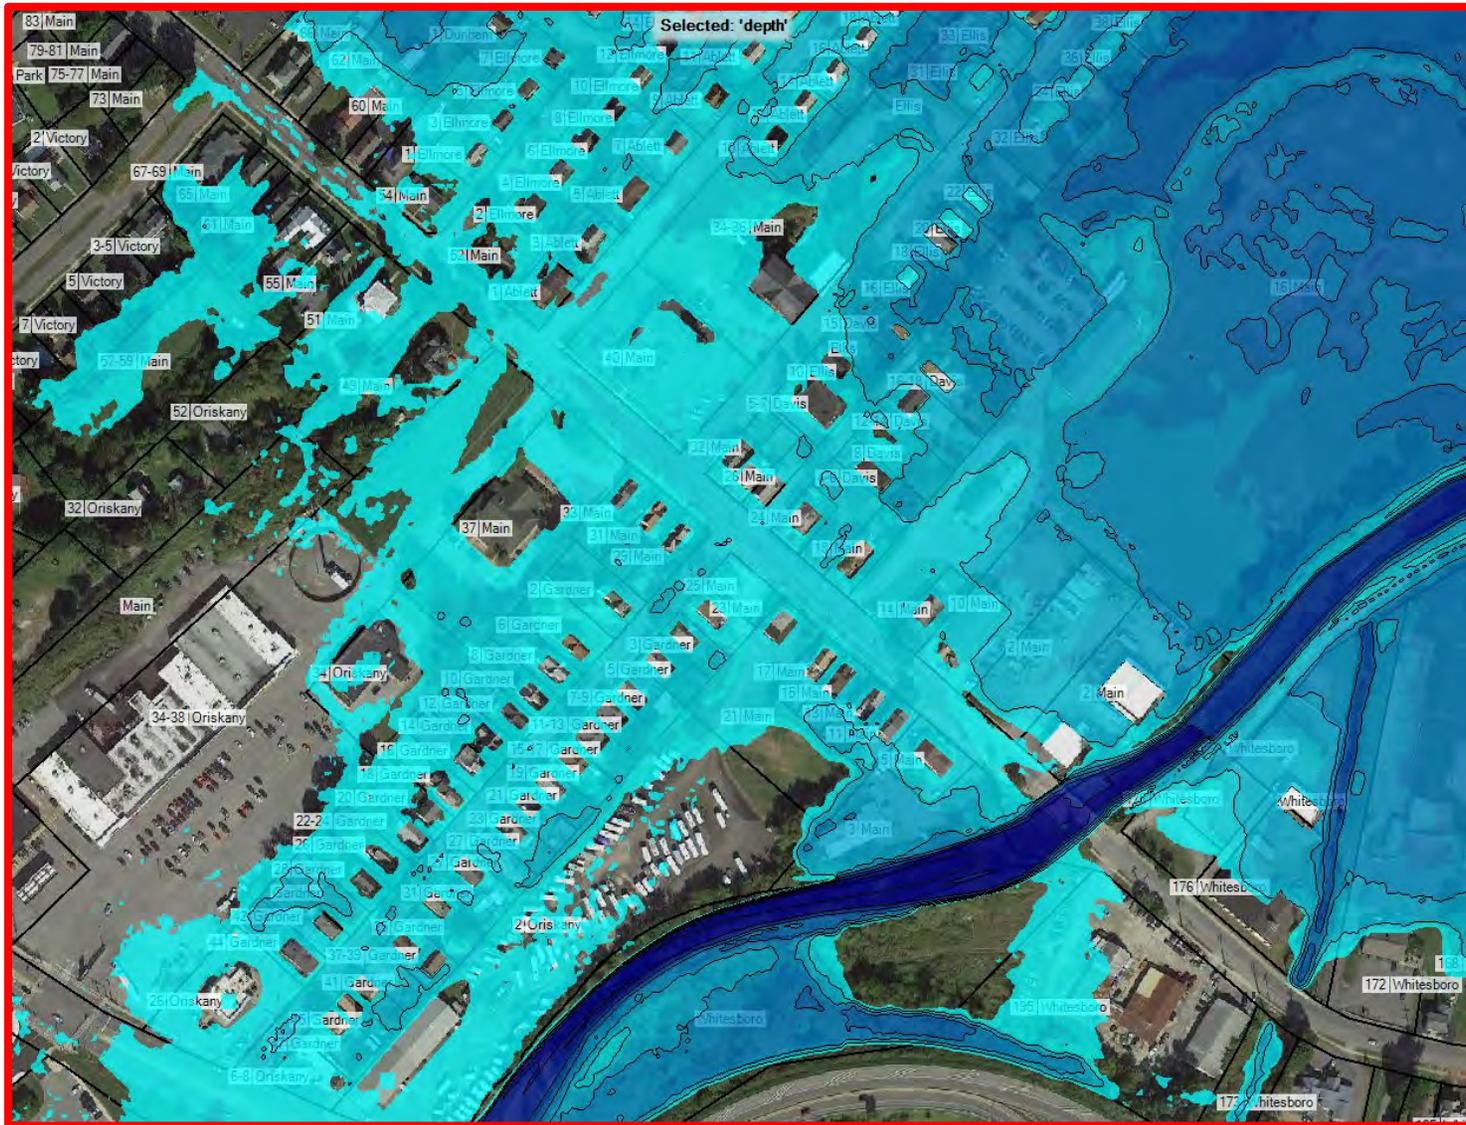
Enlarged view Figure 15 3

Figure 15 shows that all the FFE on Sauquoit Street along the railroad embankment are under greater than three feet of water. Ellis and Albert Avenues are fully inundated by more than four feet, with the deepest inundation at the intersection with Sauquoit Street. House numbers 31 through 40 Ellis Avenue, with the exception of 35 Ellis Avenue yards are submerged by more than four feet of water, with more than two feet of water above their FFE. Rob's Auto Service's yard is under more than four feet of water, which poses an eminent threat of buoyancy if vehicles were stored in the yard prior to the flood. However, the maximum velocity in this area during the peak of the flood remains under one foot per second, which reduces the danger of dragging potential floating vehicles into adjacent buildings. Finally, 15, 16, 20 and 22 Ellis Avenue yards are under more than 2.5 feet of water, including approximately a half of a foot above the FFE.

Figure 15. Inundated buildings at the peak of the 2019 Halloween Storm

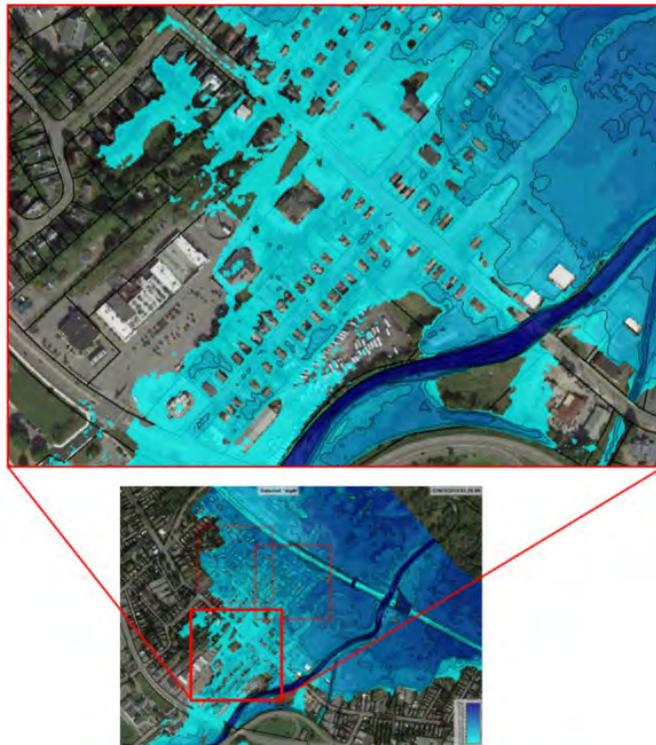
In Figure 16 the flooding mainly within the Gardner and Main Street neighborhoods are shown. The yards in these neighborhoods experienced a flood depth of less than 1.5 foot.

Figure 16. Inundated buildings at the peak of the 2019 Halloween Storm

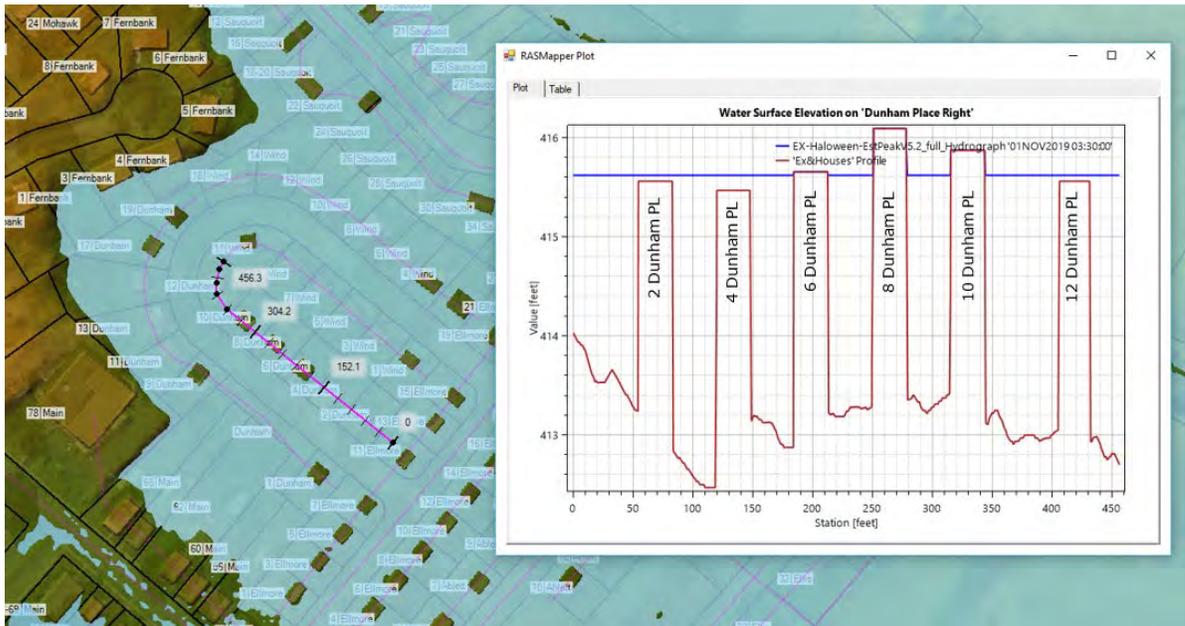
Figure 17. Dunham Place (Right Side)

Next, 6 Dunham Place, Figure 17, (3rd house), experienced smaller potential hydrostatic forces, but shows a large potential hydrostatic force when examining Figure 20, the lateral profile. A similar observation is seen for 10 and 17 Dunham Place houses (Refer to Figures 21 and 22).

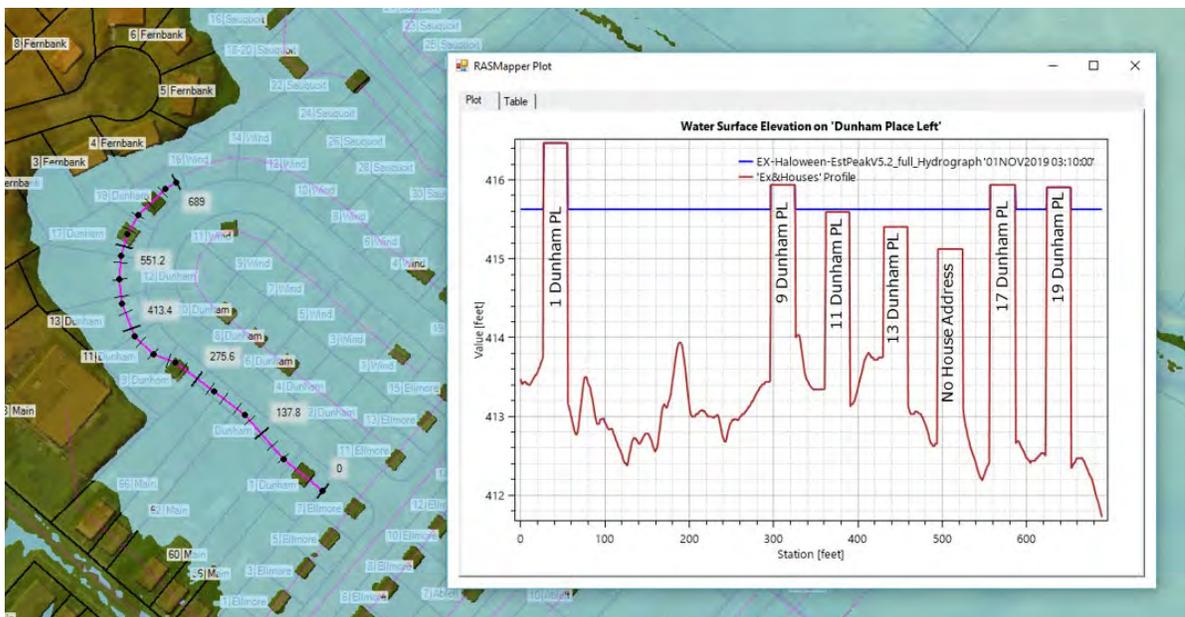
Figure 18. Dunham Place (Left Side)

For Reference, Figure 18 begins with 1 Dunham Place on the far left. Figure 19 is the profile for this address in the lateral direction. The potential hydrostatic force differential on all four sides are significant even though the FFE of the house was not fully inundated.

Moving next to 9 Dunham Place (2nd house on Figure 18), again the potential hydrostatic force in longitudinal direction is significant even though the FFE of the house was not fully inundated. A lateral direction is not considered for this house since the pressure differential in the longitudinal direction alone is significant on the house.

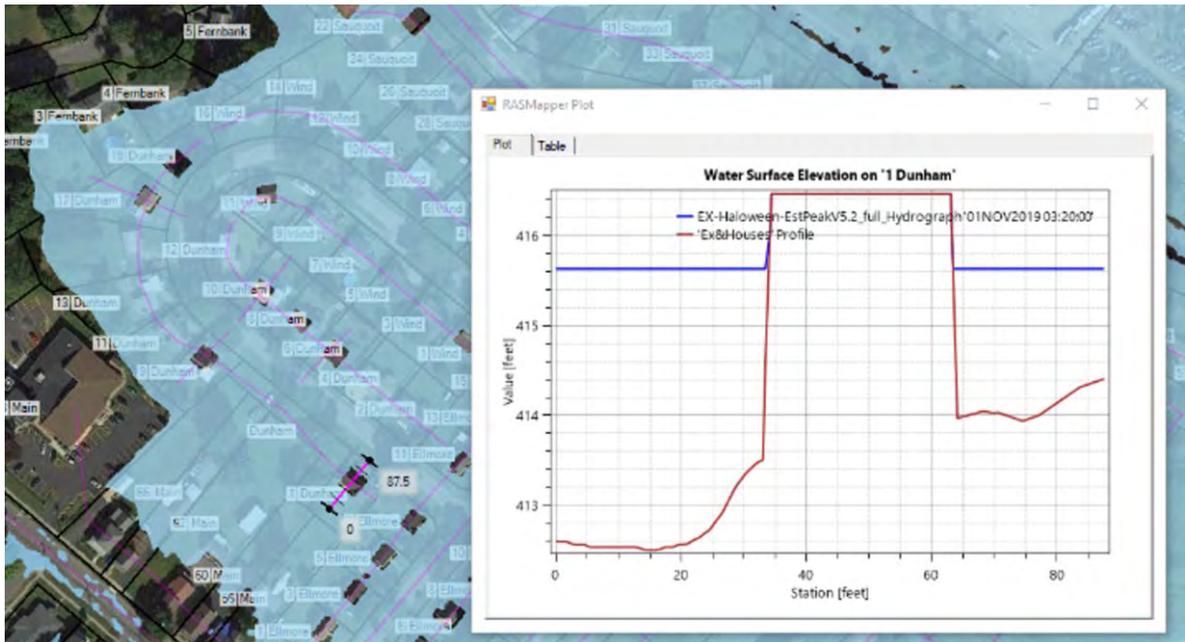
Figure 19. House Address: 1 Dunham Place

For example, the houses at number 1 and 9 Dunham Place did not flood the FFE. However, they experienced a varying hydrostatic pressure differential on walls for 14 hours, which can lead to foundational or structural damages. Therefore, if only with inundation maps of the surrounding water depths were used to assess structural damage of these buildings, condemnation based on structural failure may not have been justified. In conclusion, the finding in Table 1 should be applied along with the latest inundation maps to perform a full assessment of vulnerabilities that could lead to a condemnation of a building due to flooding.

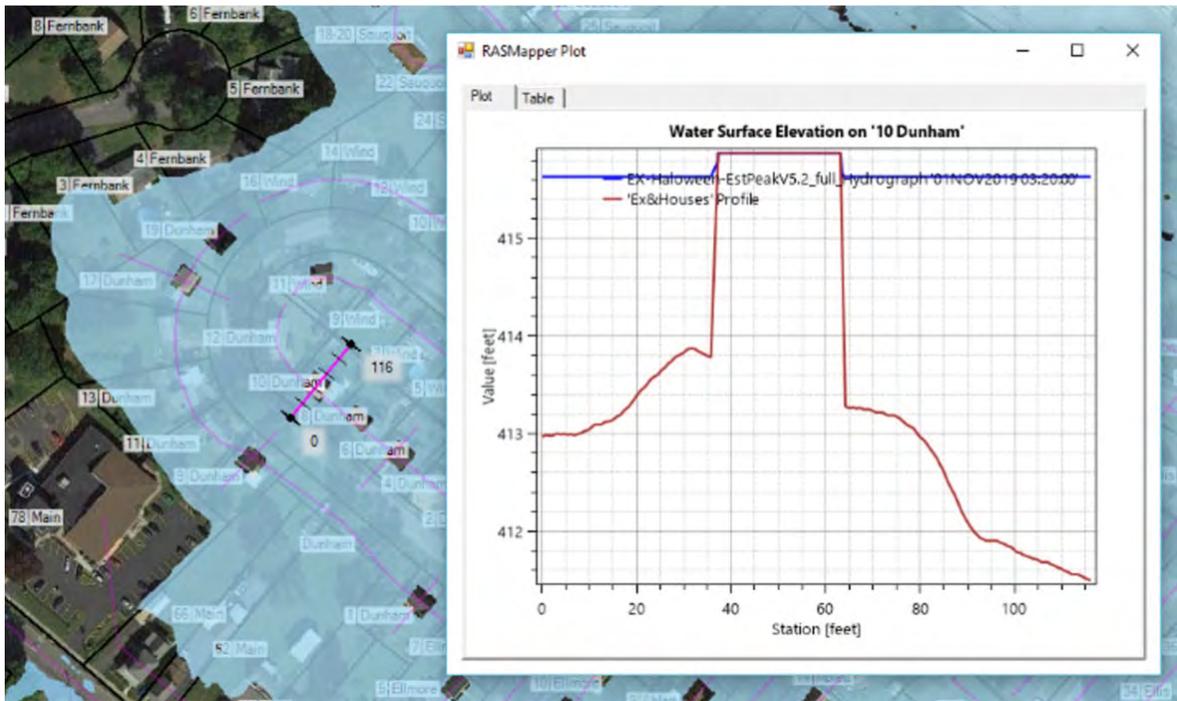
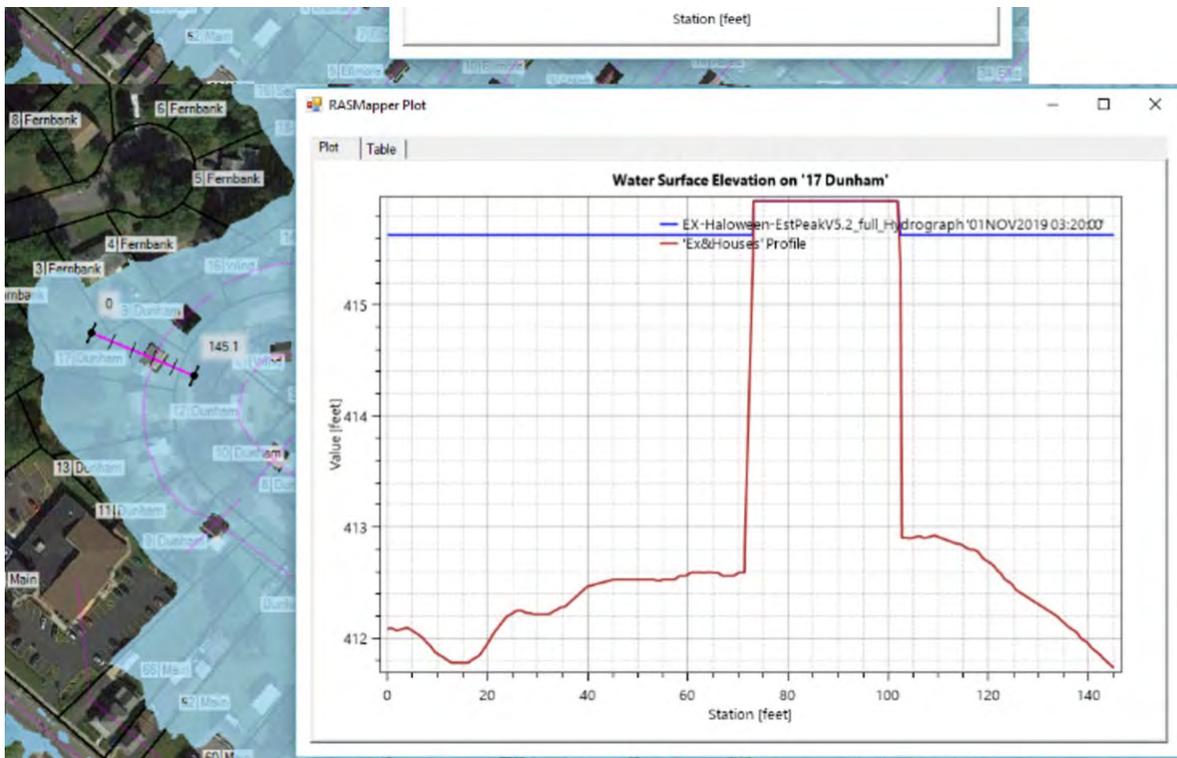
Figure 21. House Address: 10 Dunham Place

Figure 22. House Address: 17 Dunham Place

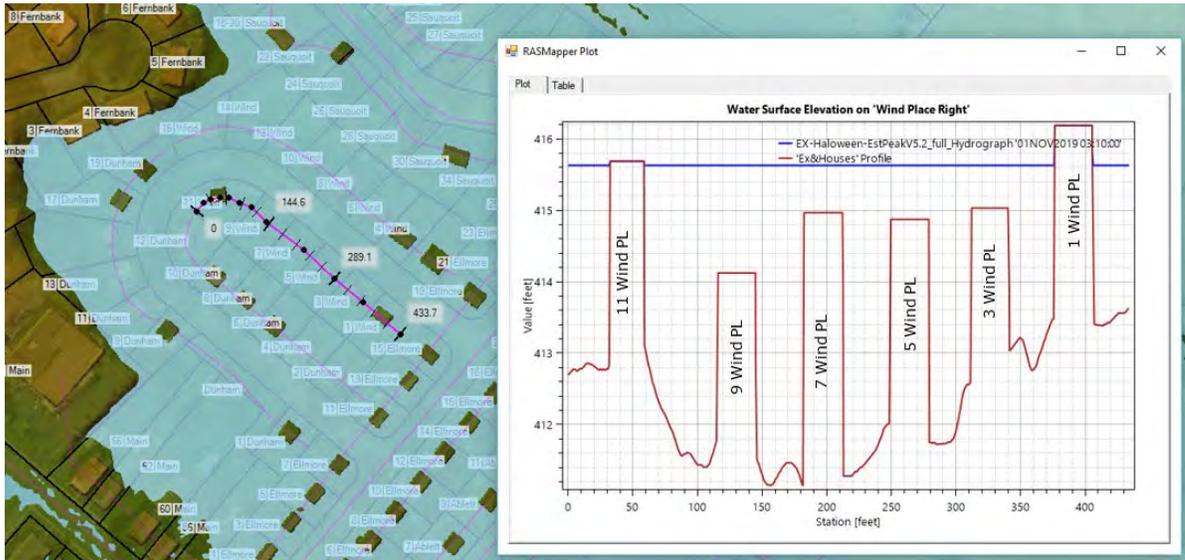
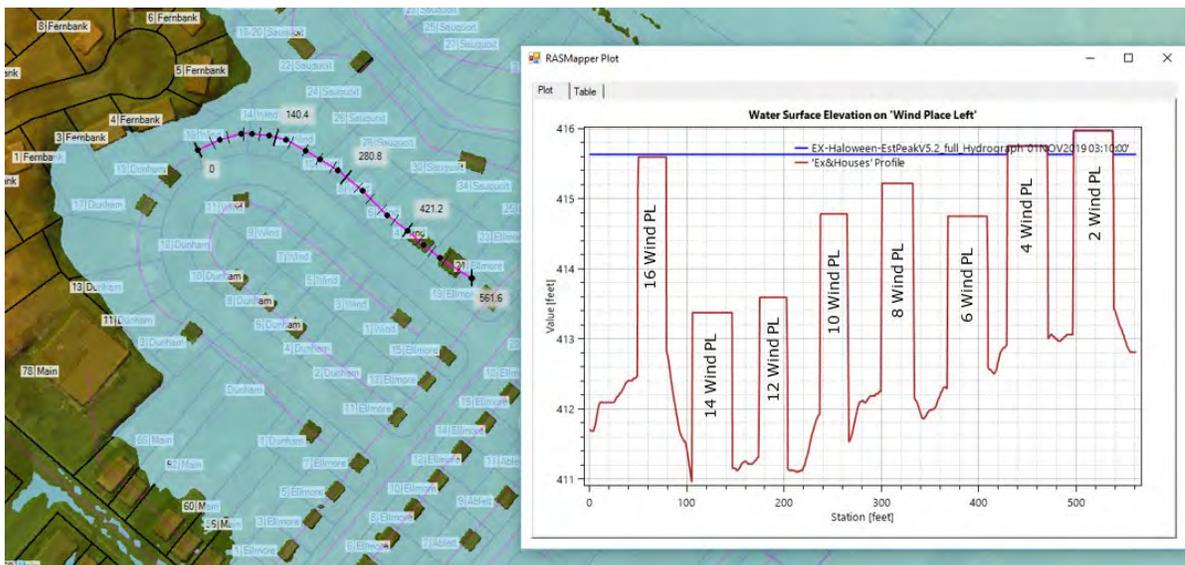
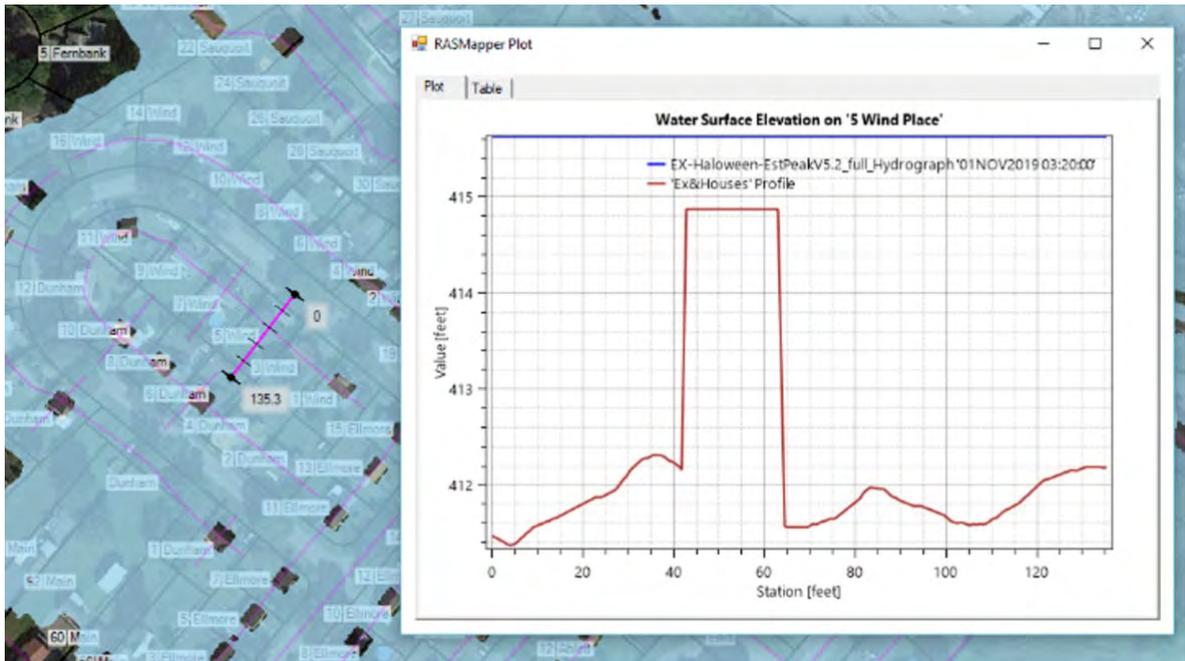
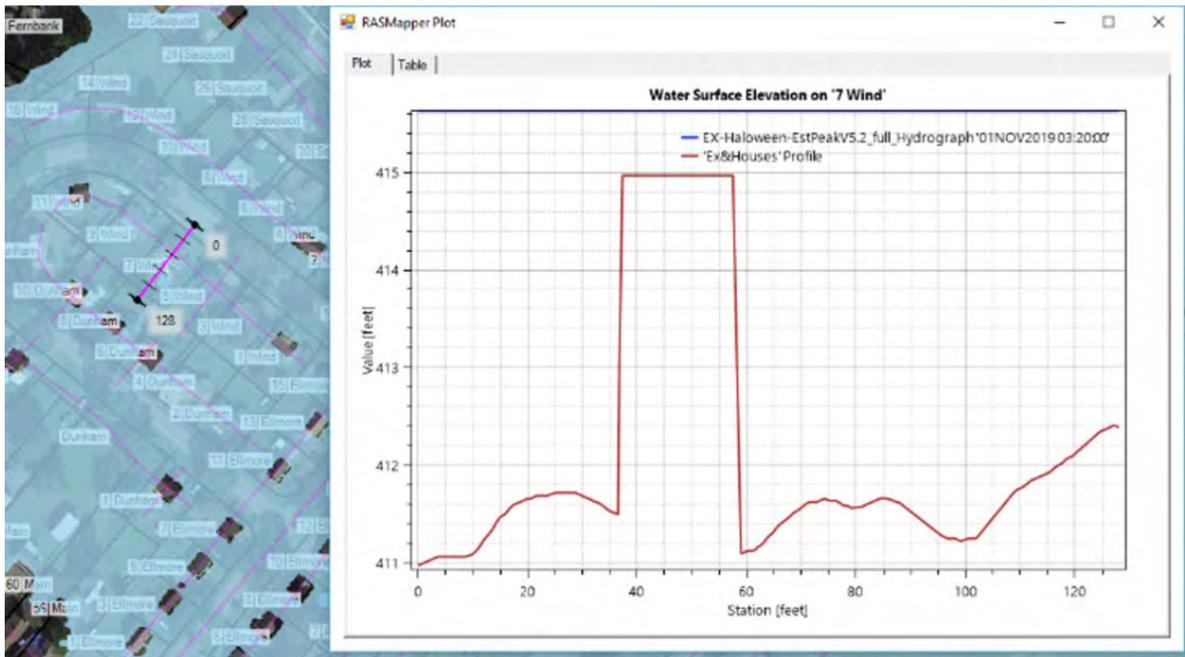
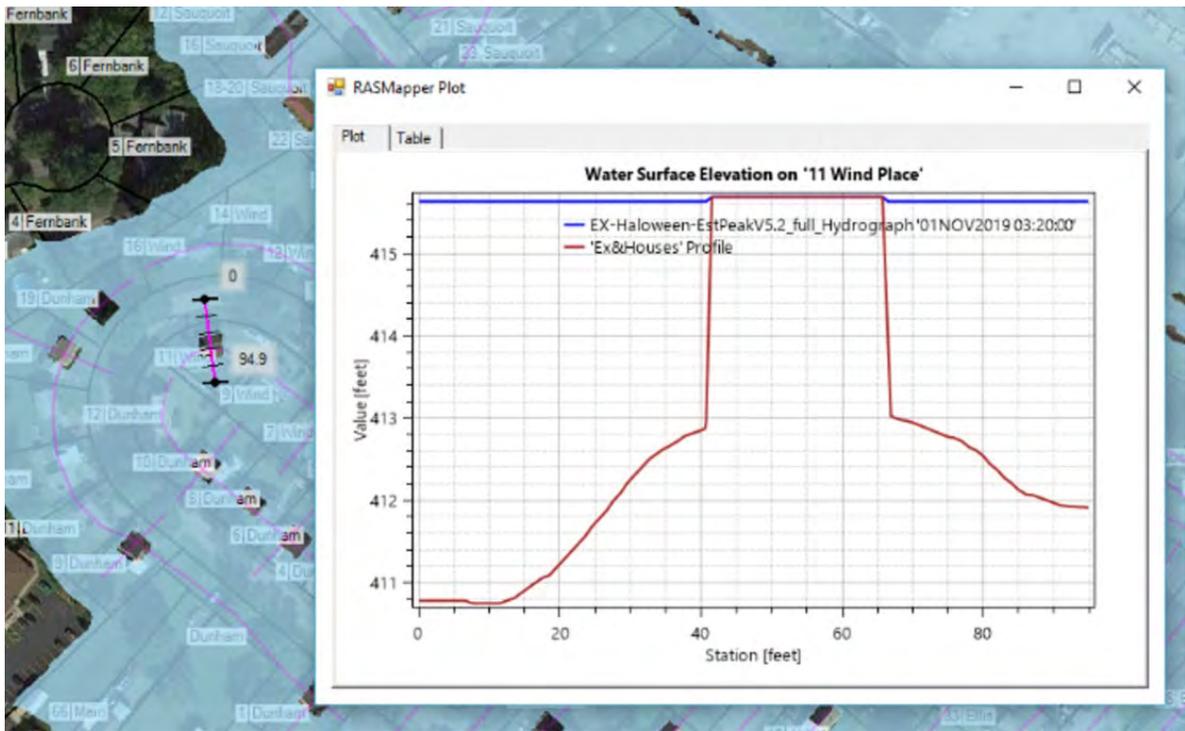
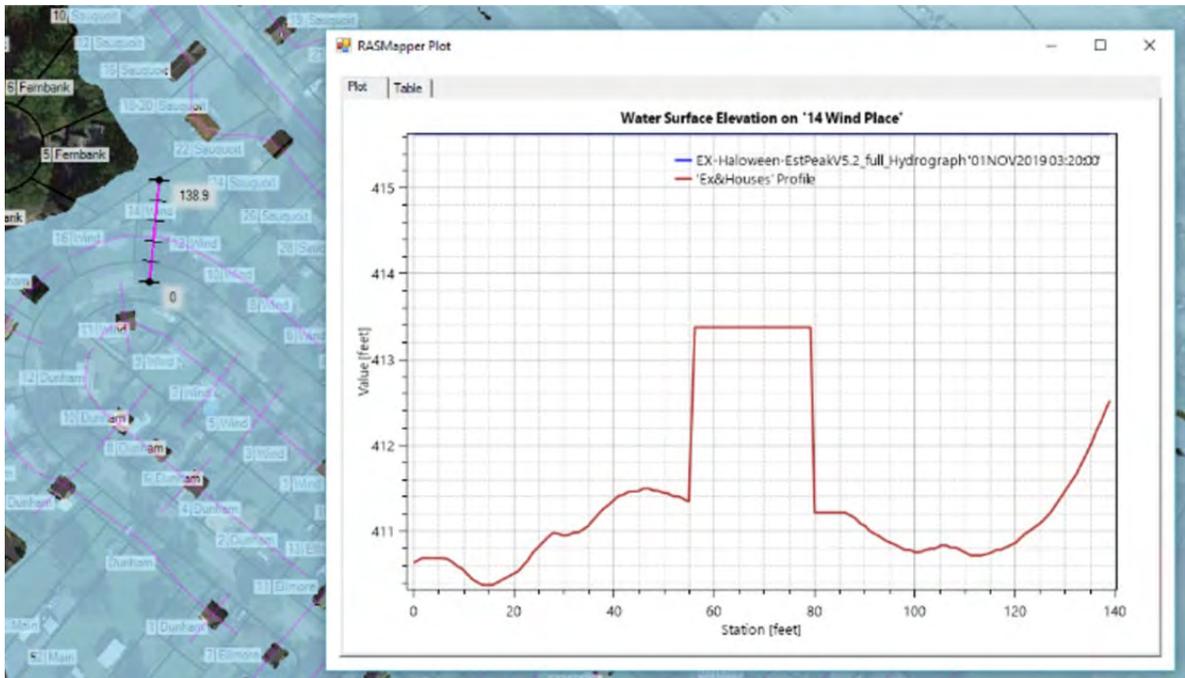
Wind Place house numbers 5, 7, 8, 11 and 14 were also condemned as a result of the flood damage caused by this storm event. As per the simulation; the profile views on Figures 23 and 24 indicate that the first floors of these houses were significantly inundated with several feet of water and experienced a prolonged flood resident time. This could have contributed to potential hydrostatic pressure differential which could also have weakened their structural integrity.
