# City of Rome, NY

Existing Conditions Scan

Black River Blvd/Rt 26

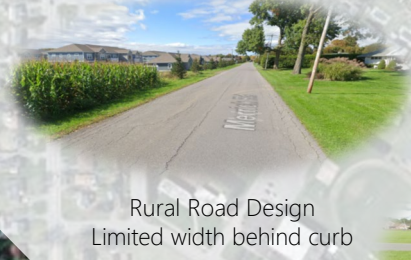
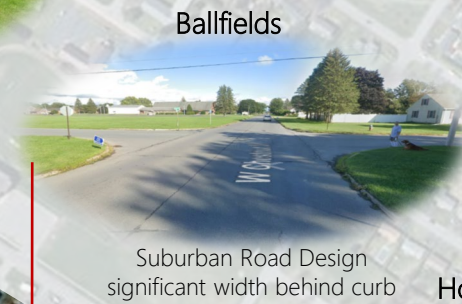
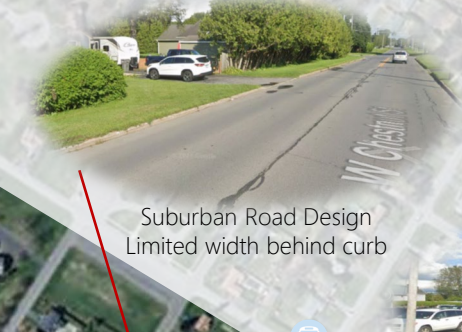
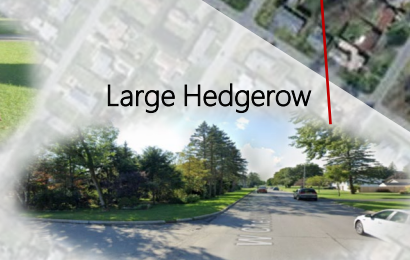
Very wide intersection

Large Hedgerow

Bus Stop

Higher Capacity Road Design  
moderate width behind curb

Commercial High-Volume  
Roadway Design
