Final Report

August 2021

STREAM SEDIMENT AND DEBRIS MANAGEMENT PLAN

SAUQUOIT CREEK, ONEIDA COUNTY, NEW YORK

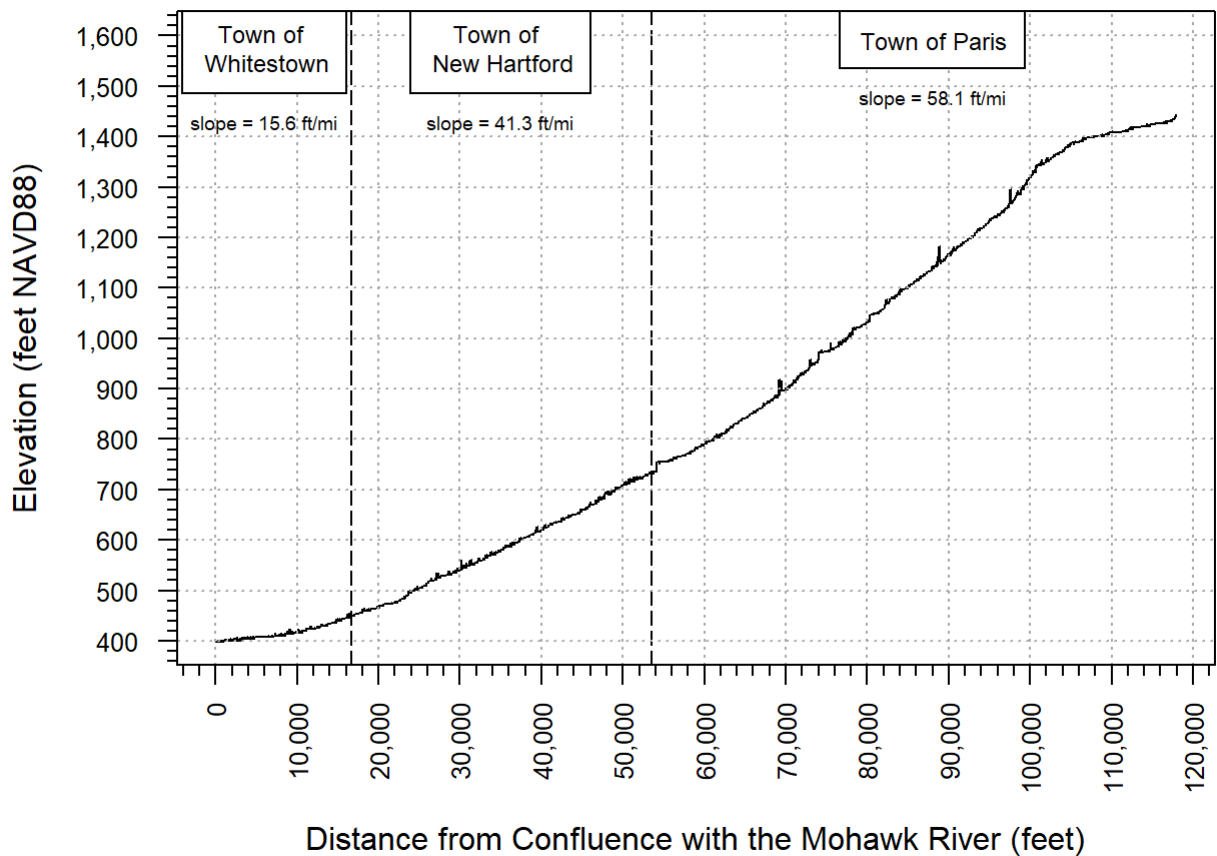
Figure 2. Sauquoit Creek profile of stream bed elevation and channel distance from the confluence with the Mohawk River.

Figure 2 is a stream bed elevation and channel distance from the confluence with the Mohawk River profile using 2-meter light detection and ranging (LiDAR) data from 2008. Sauquoit Creek has an average slope of 0.9% over the profile stream length. The creek's streambed lowers approximately 1,047 vertical feet over this reach from an elevation of 1,444-feet above sea level (NAVD 88) at the headwaters in the Town of Paris, to 397-feet above sea level at the confluence of the Mohawk River in the Town of Whitestown (NYSITS 2013).

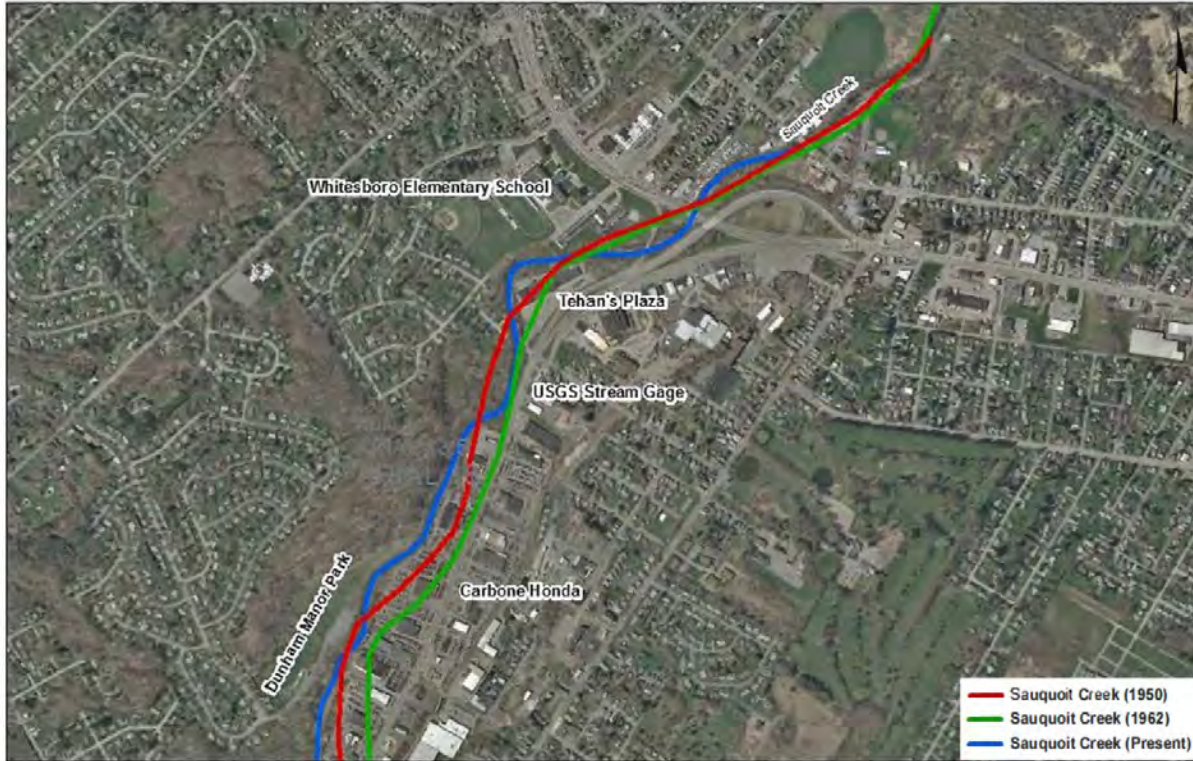
Figure 5. Historic 1950 and 1962 and present day channel alignment of Sauquoit Creek (OBG 2018).

have been armored using concrete or stacked rock walls that confine the channel, resulting in a channel that lacks the capacity to convey flows during storm events (MMI 2014). Bank armoring often has the unintended consequence of disconnecting the main channel of a waterway from its floodplain and resulting in head cutting or downcutting of the channel. Head cutting or downcutting increases sediment availability in the water column and can lead to potential aggradation and sediment issues downstream.

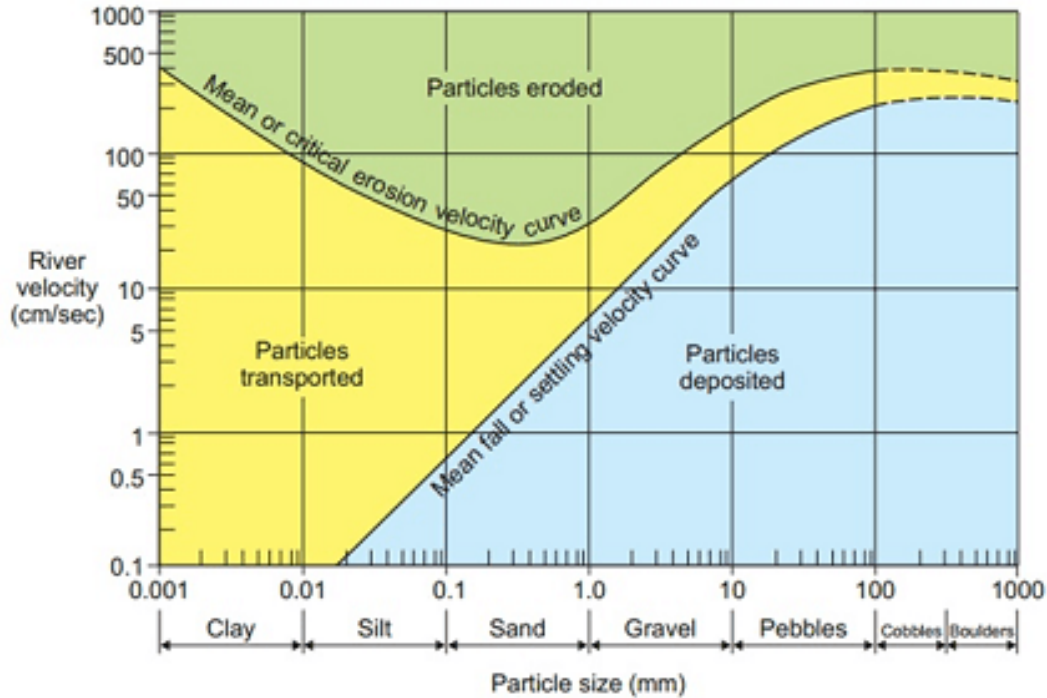
Figure 12. The Hjulström-Sundborg diagram, which illustrates the relationship between particle size (mm) and river velocity (cm/sec) to evaluate whether sediment will be eroded, transported, or deposited in a given waterway (Earle 2019).

Other factors that affect stream-water velocity are the size of sediments on the stream bed and the discharge, or volume, of water passing a point in a unit of time. Smaller particles may rest on the stream bed where they can be moved by saltation and traction or they can also be held in suspension in the flowing water, especially at higher velocities. Streams that flow fast tend to be turbulent (e.g. flow paths are chaotic and the water surface appears rough) and the water may be muddy, while those that flow more slowly tend to have laminar flow (e.g. straight-line flow and a smooth water surface) and clear water. Turbulent flow is more effective than laminar flow at keeping sediments in suspension and transporting suspended sediments downstream. Figure 12 displays the Hjulström-Sundborg diagram, which shows the relationships between particle size and the tendency to be eroded, transported, or deposited at different current velocities (Earle 2019).

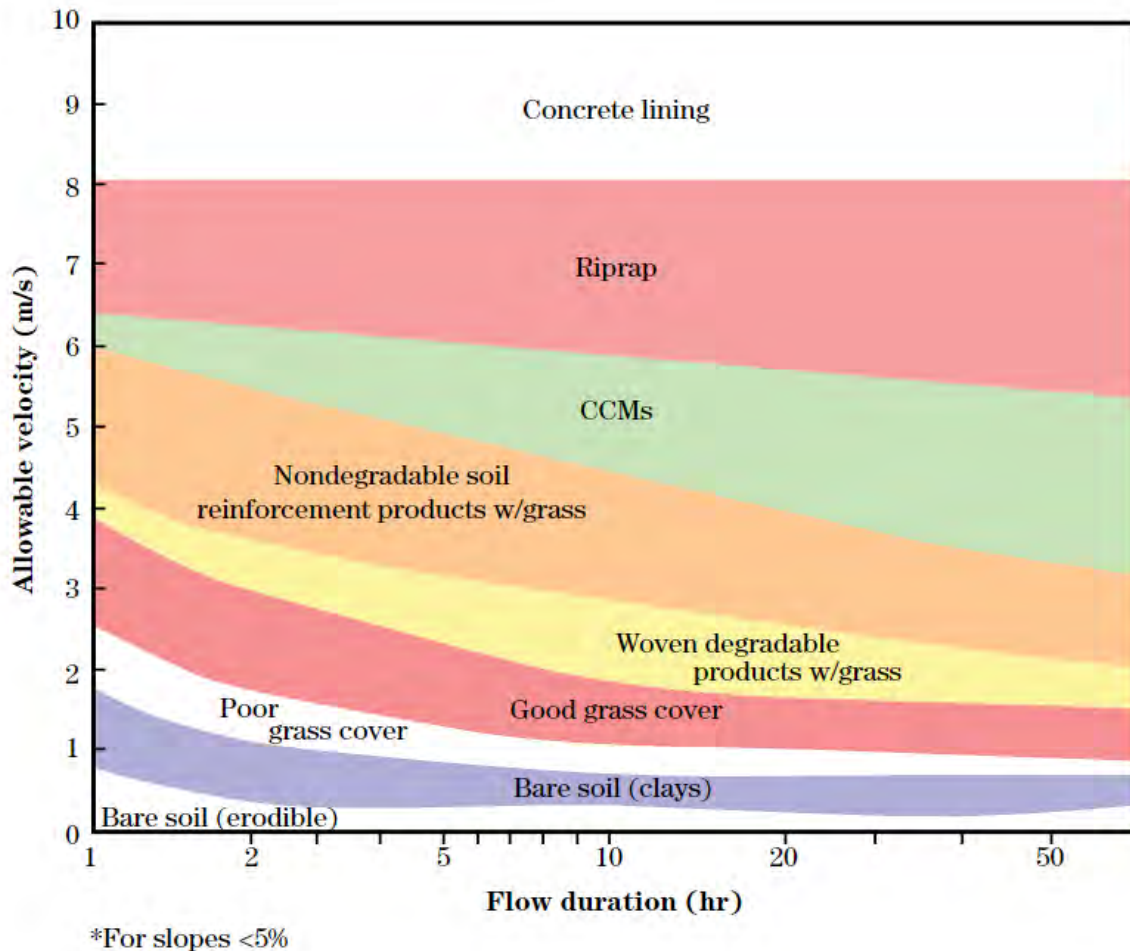
Figure 13. Effect of flow duration on allowable velocities for various channel linings (NRCS 2007).

The composition of the channel should be considered in any flood mitigation strategy that proposes to modify the channel lining of any waterway. Channelization, which is a method of river engineering that widens or deepens rivers to increase the capacity for flow volume, often includes altering the composition of the channel gradation. When determining the channel lining material, numerous channel design factors should be analyzed, including the terrain, bathymetry, channel slope, bed gradation, allowable velocity, and maximum shear stress of the lining materials. Figure 13 depicts the erosion resistance of various channel lining materials by showing the effects of flow duration and allowable velocity (NRCS 2007).

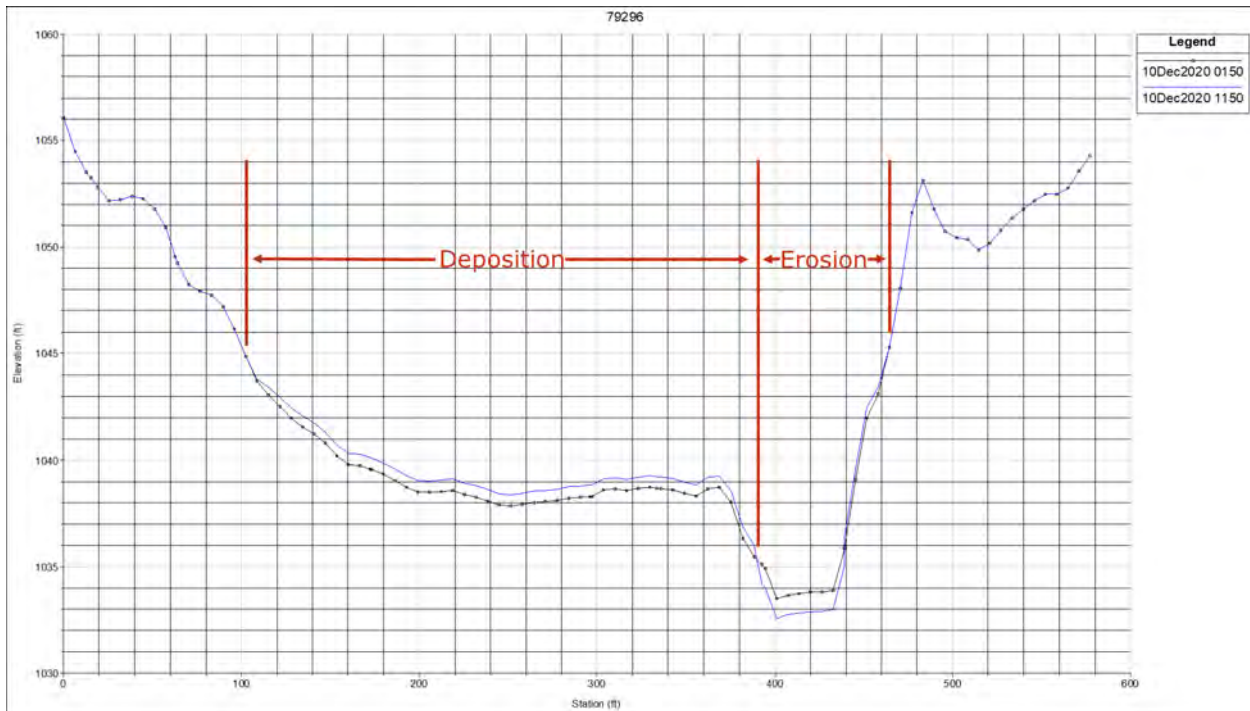
Figure 14. Representative HEC-RAS 1-D sediment transport output for invert change in cross section view.

Invert changes are used to identify areas of deposition and erosion along a cross-section. When the invert change is positive, deposition has occurred since the elevation has increased over the model simulation run. In contrast, if the invert change is negative, then erosion has occurred since the elevation has decreased over the model simulation run. Figure 14 is a representative diagram from a 1-D H&H model simulation displaying a cross section view with deposition occurring in the overbank and erosion occurring in the stream channel over a 10-hour time period.

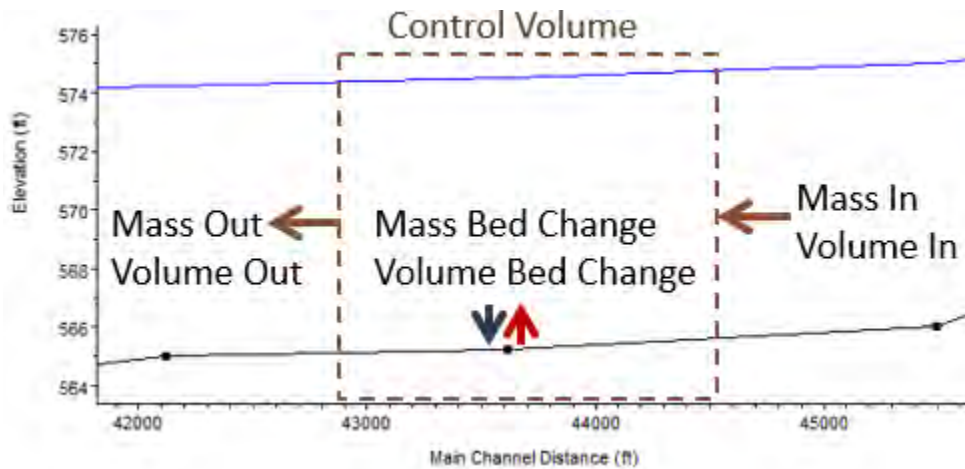
Figure 15. Representative diagram for mass and volume bed change in profile view.

In H&H models, mass bed load can be determined as an incremental or cumulative change for a given cross section over time. Mass bed load is determined by calculating the difference in the mass in the bed between two consecutive time steps for a given cross section. Mass bed load can be used as an indicator of sediment deposition or erosion. When the mass bed load value is positive, there is a greater influx of mass (i.e. mass in is larger than mass out) and deposition is most likely to occur. In contrast, when the mass bed load value is negative, there is a greater outflux of mass (i.e. mass out is larger than mass in) and erosion is most likely to occur. Figure 15 is a representative diagram of how mass bed changes in profile view (USACE [date unknown]).

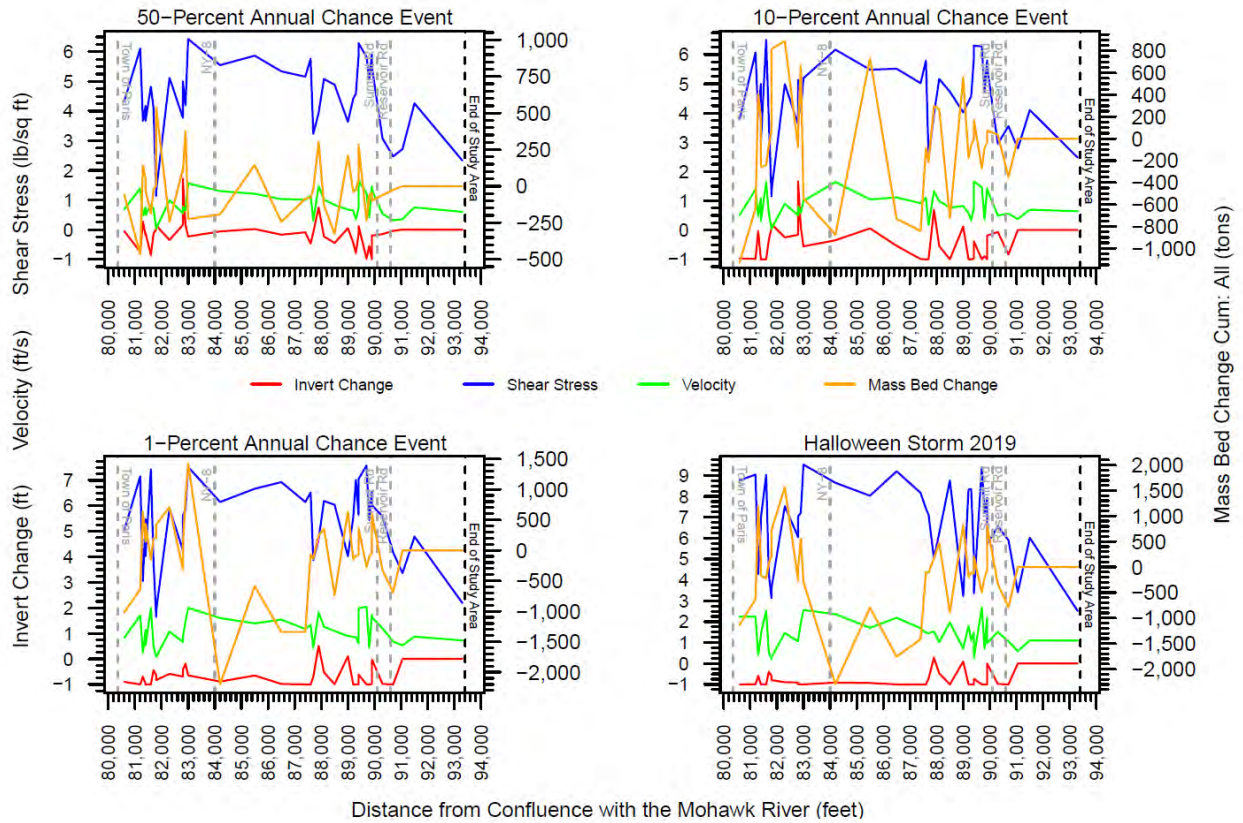
Figure 19. Analysis of invert change (ft), velocity (ft/s), shear stress (lbs./sq. ft) and cumulative mass bed change (tons) using the 1-D HEC-RAS sediment transport model for Zone A.

Figure 19 displays the results of the sediment transport model simulations for Zone A for the four different annual chance flood events and the four erosional / depositional variables. Based on the sediment transport analysis, willow stakes and hardwood trees and brush mattresses with riprap toe and hardwood trees were determined to be the most appropriate streambank stabilization strategies for this reach.

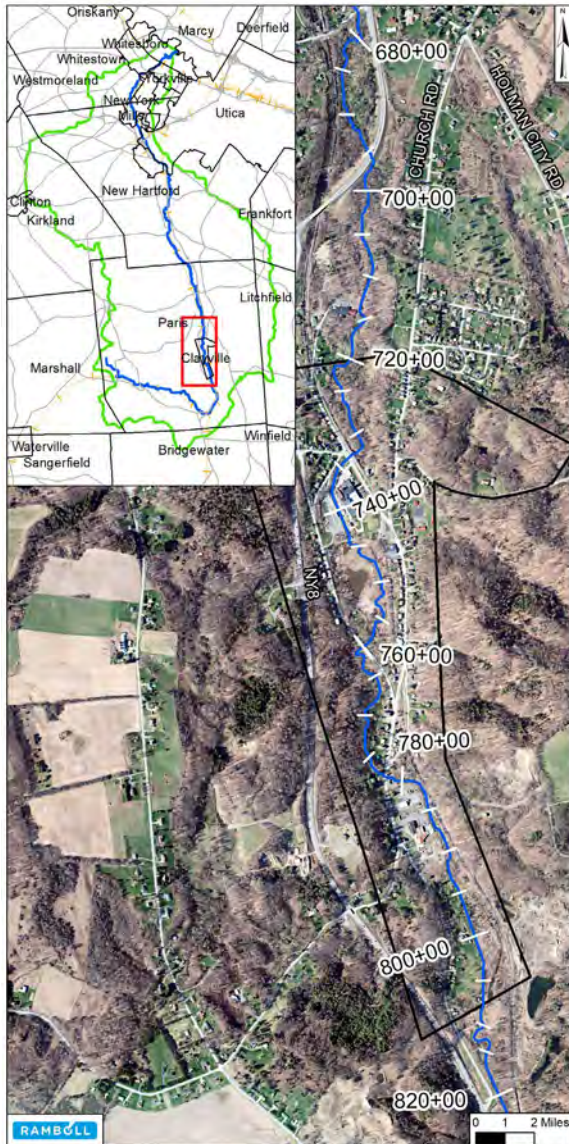
Figure 21. Location map for Zone B: Paris – Clayville.

Zone B covers the Village of Clayville starting at RS 805+00 to RS 700+00. This reach includes three roadway crossings, including Main Street and two separate crossings of Oneida Street, one railroad bridge crossing, and three separate dams (Figure 21).

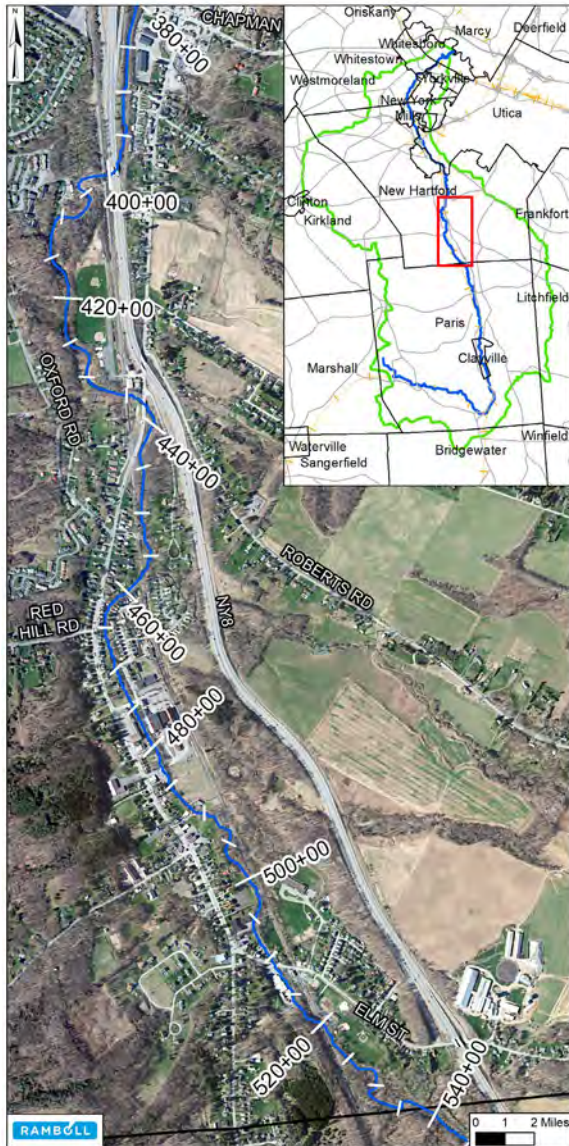
Figure 27. Location map for Zone D: New Hartford/Washington Mills.

Zone D is the upstream portion of Sauquoit Creek in the Town of New Hartford and encompasses the Washington Mills hamlet. This zone begins at RS 540+00 and ends near RS 410+00. The zone includes four roadway crossings, including, Oneida Street, Elm Street, and Bleachery Avenue, and three separate railroad bridge crossings (Figure 27).

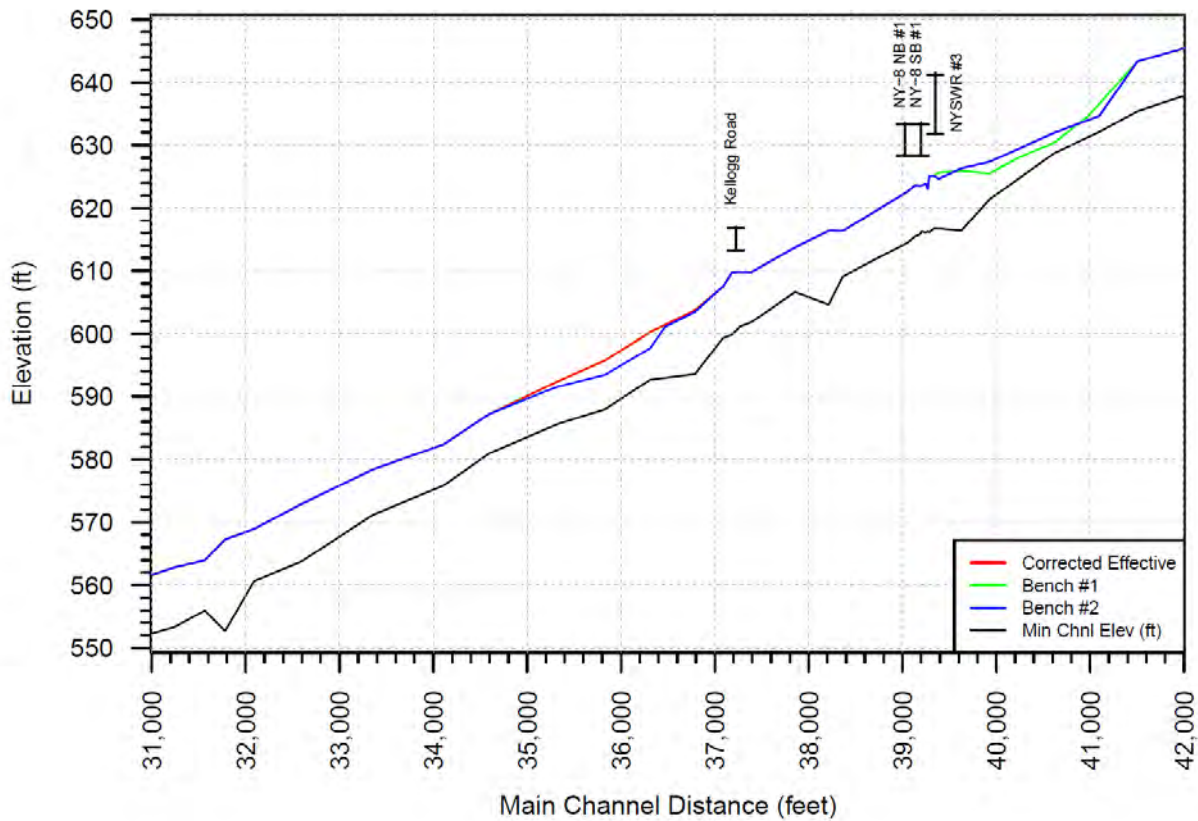
Figure 33. HEC-RAS model simulation results for each structural engineering strategy in Zone E.

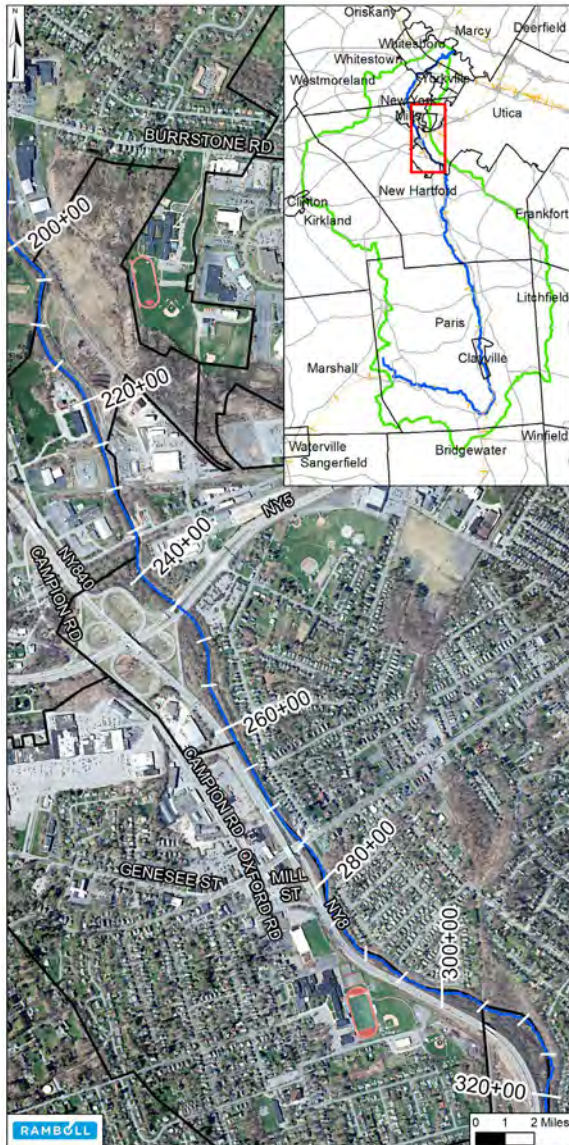
Figure 35. Location map for Zone F: New Hartford/Utica – Downstream.

Zone F contains the reach of Sauquoit Creek that borders the Town of New Hartford and City of Utica starting at the upstream end of Brookline Drive and extending downstream to NY-5. This zone starts at RS 315+00 and ends at RS 240+00. This zone includes three roadway crossings, including Genesee Street and two crossings of NY-5 (east and west bound), and one NYSWR railroad crossing (Figure 35).

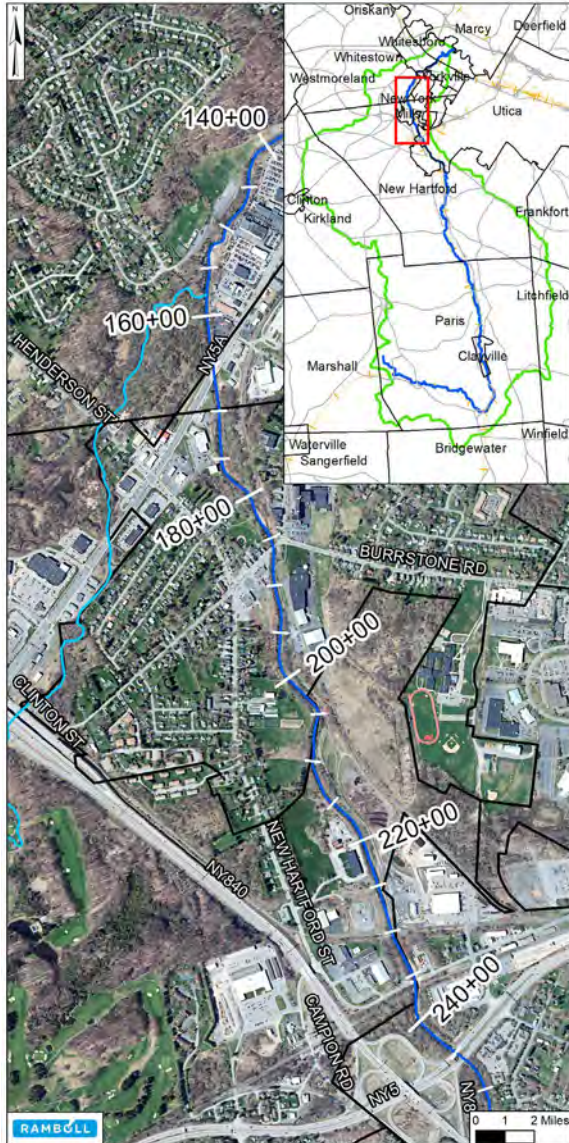
Figure 39. Location map for Zone G: New York Mills/New Hartford.

Zone G contains the reach of Sauquoit Creek that travels through Village of New York Mills. This zone begins at RS 240+00 and ends at RS 180+00. This zone includes two roadway crossings, including Clinton Street and Chenango Road, one recreational trail crossing, and one NYSWR railroad crossing (Figure 39).
