**EMERGENCY TRANSPORTATION INFRASTRUCTURE RECOVERY**  
**WATER BASIN ASSESSMENT**  
**AND FLOOD HAZARD MITIGATION ALTERNATIVES**

**EAST CANADA CREEK**  
**HERKIMER COUNTY, NEW YORK**

April 2014

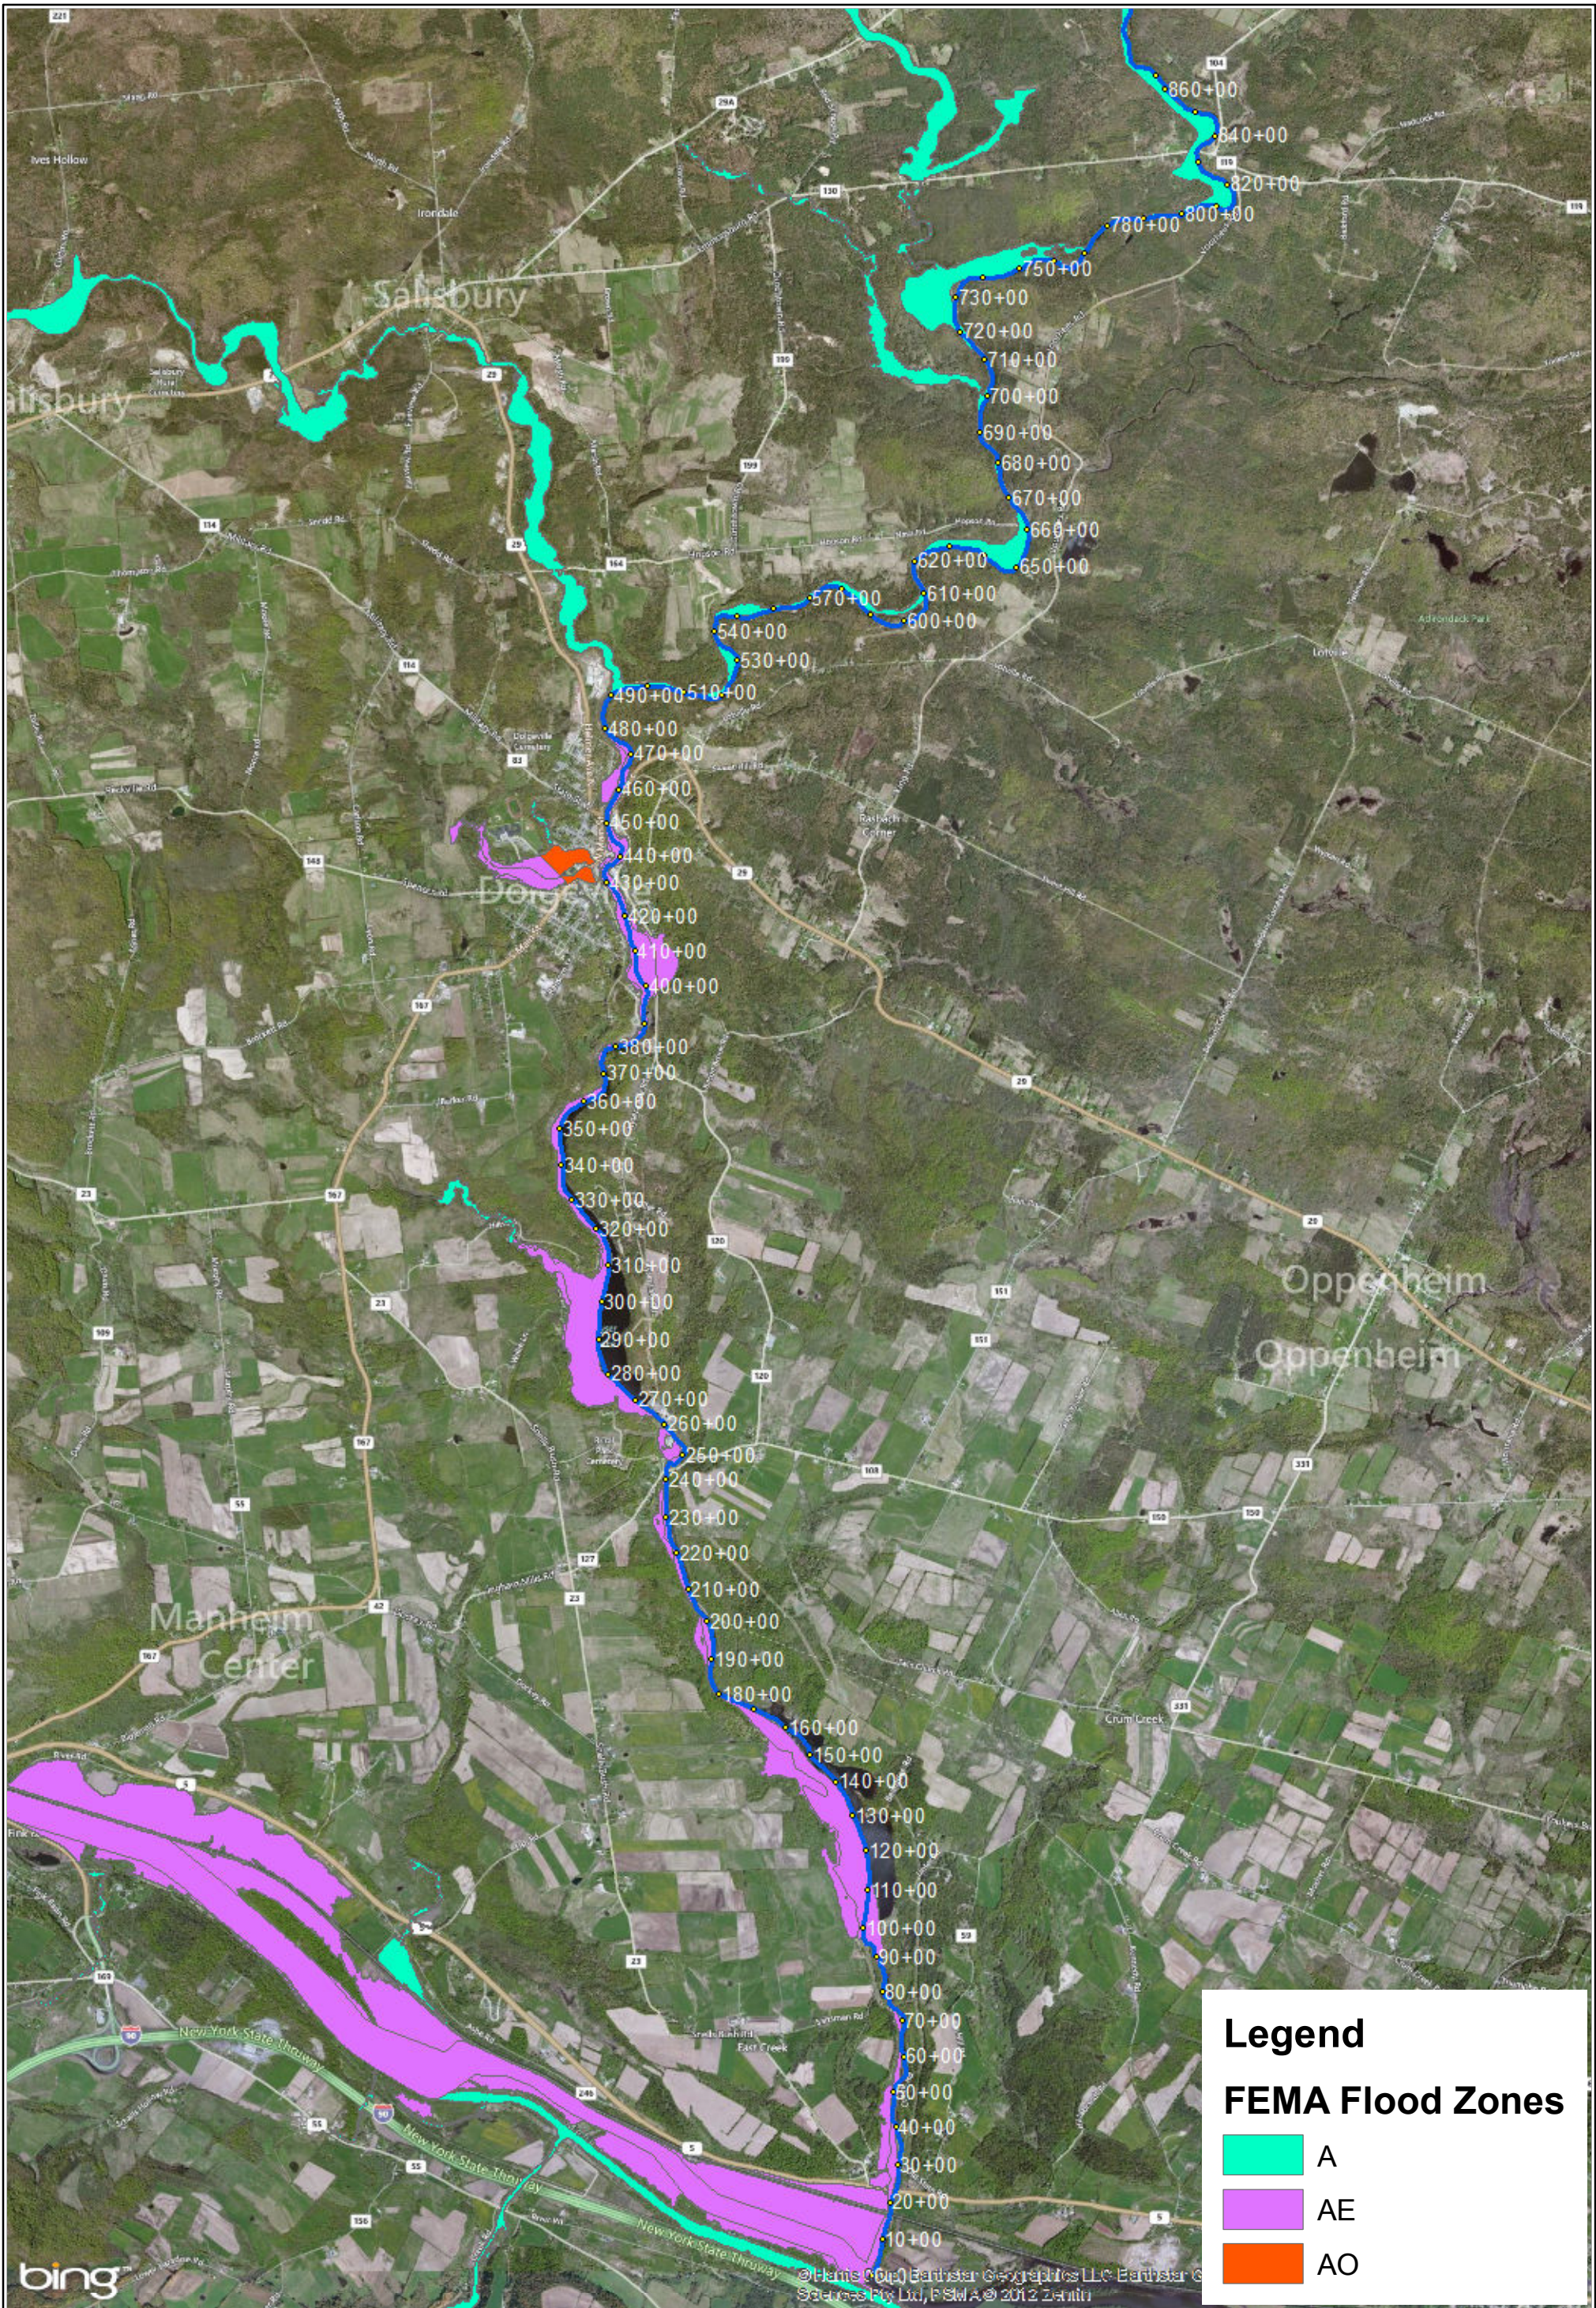
**Figure 5: East Canada Creek FEMA Flood Zones**

FEMA Flood Insurance Rate Maps (FIRMs) are available for the Village of Dolgeville. FEMA inundation mapping (Figure 5) indicates that during a 100-year frequency event East Canada Creek overtops its banks upstream of the Route 29 bridge, resulting in flooding that extends across North Main Street on the west bank and up to Route 29 on the east bank. Downstream of Dolgeville, the creek floods an area along Van Buren Street on the west bank and, further downstream, floods across Dolge Avenue on the east bank.

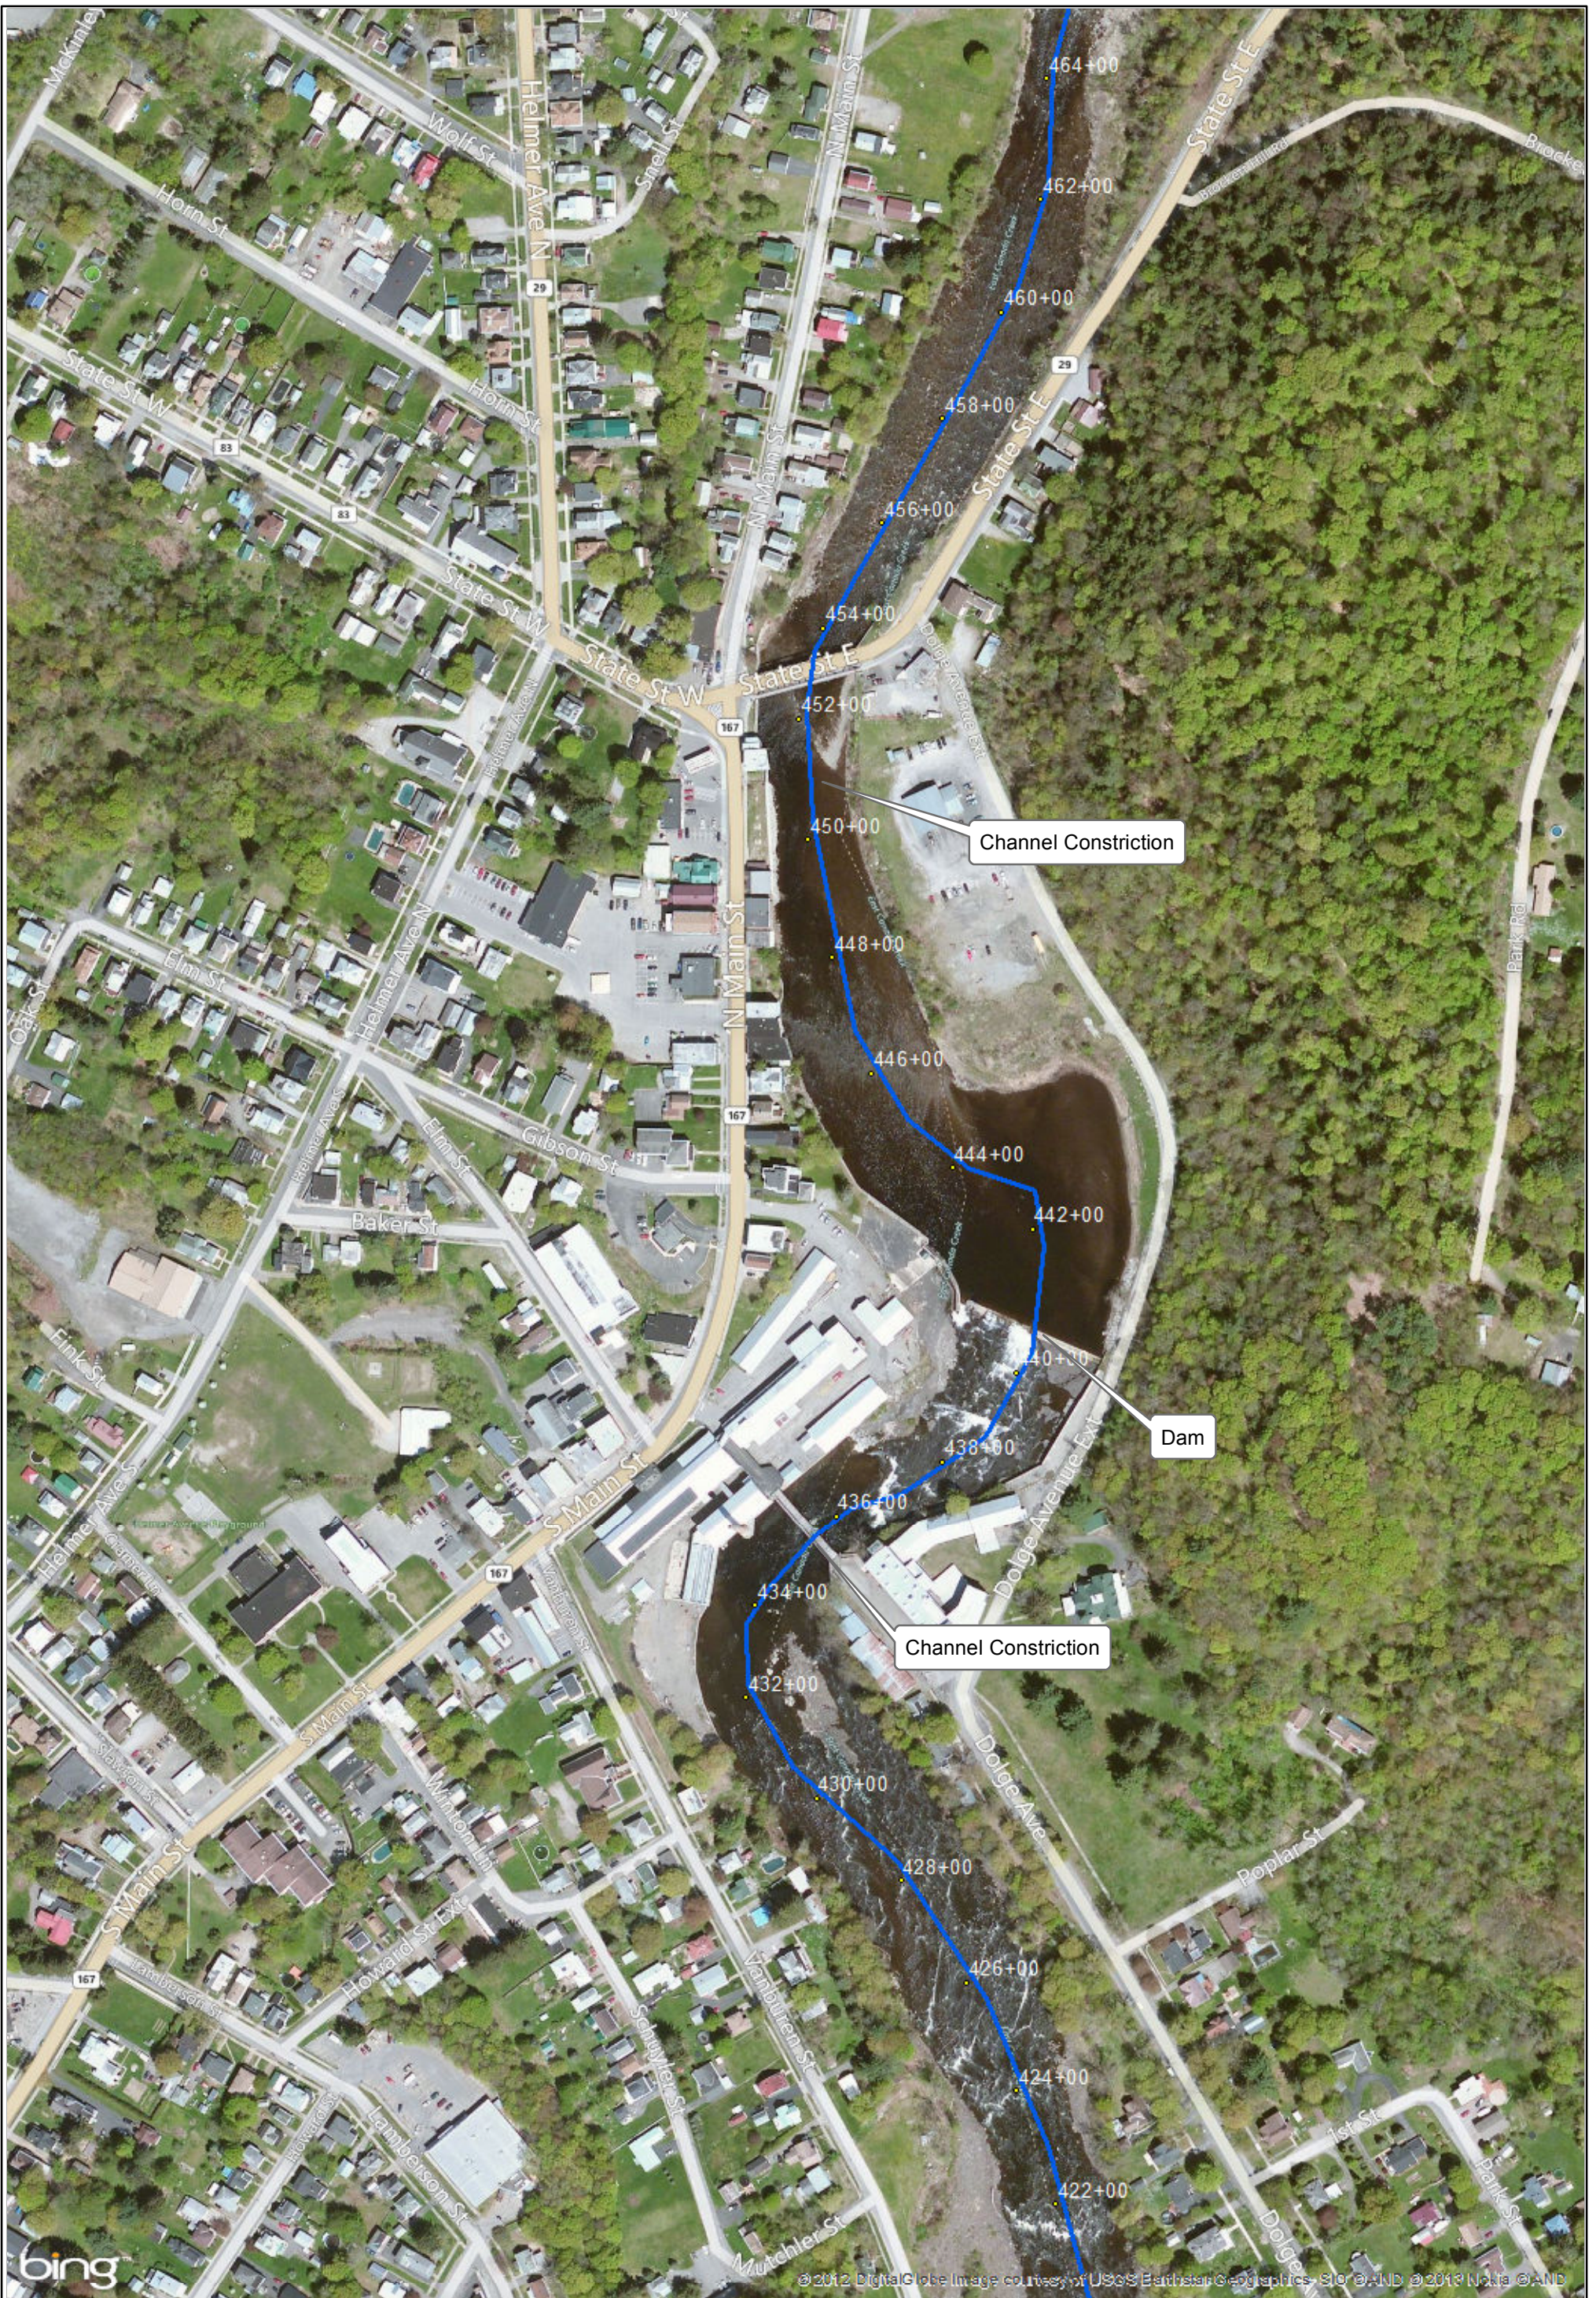
**Figure 6: East Canada Creek High Risk Area #1**

Figure 6 is a location plan of High Risk Area #1. This area encompasses East Canada Creek as it flows through the village of Dolgeville and includes two bridges and the narrow channel associated with each bridge: the Route 29 bridge (STA 453+00) and the pedestrian walkway located approximately 1,800 feet downstream of the Route 29 bridge (STA 435+25). Also included is the Dolgeville Dam located between the two bridges, located approximately 1,200 feet downstream of Route 29 (STA 440+50).

#### *Alternative 1-1: Modification of Operation of the Daniel Green Company Dam (STA 440+50)*

It may be possible to reduce or "draw down" water levels behind the dam by opening a low-flow outlet or removing weirs or flashboards. Drawing down of the impoundment would ideally occur when high flow events are forecast. Similarly, there may be a way to reduce occurrences of ice jams by altering the operations of the dam during periods of time when ice jams are prone to occur. Strategies such as these would require entering into a dialogue with the owners of the dam. A comprehensive understanding of the operation of the dam will be required in order to determine whether a modified operational plan would reduce ice jams and flooding.

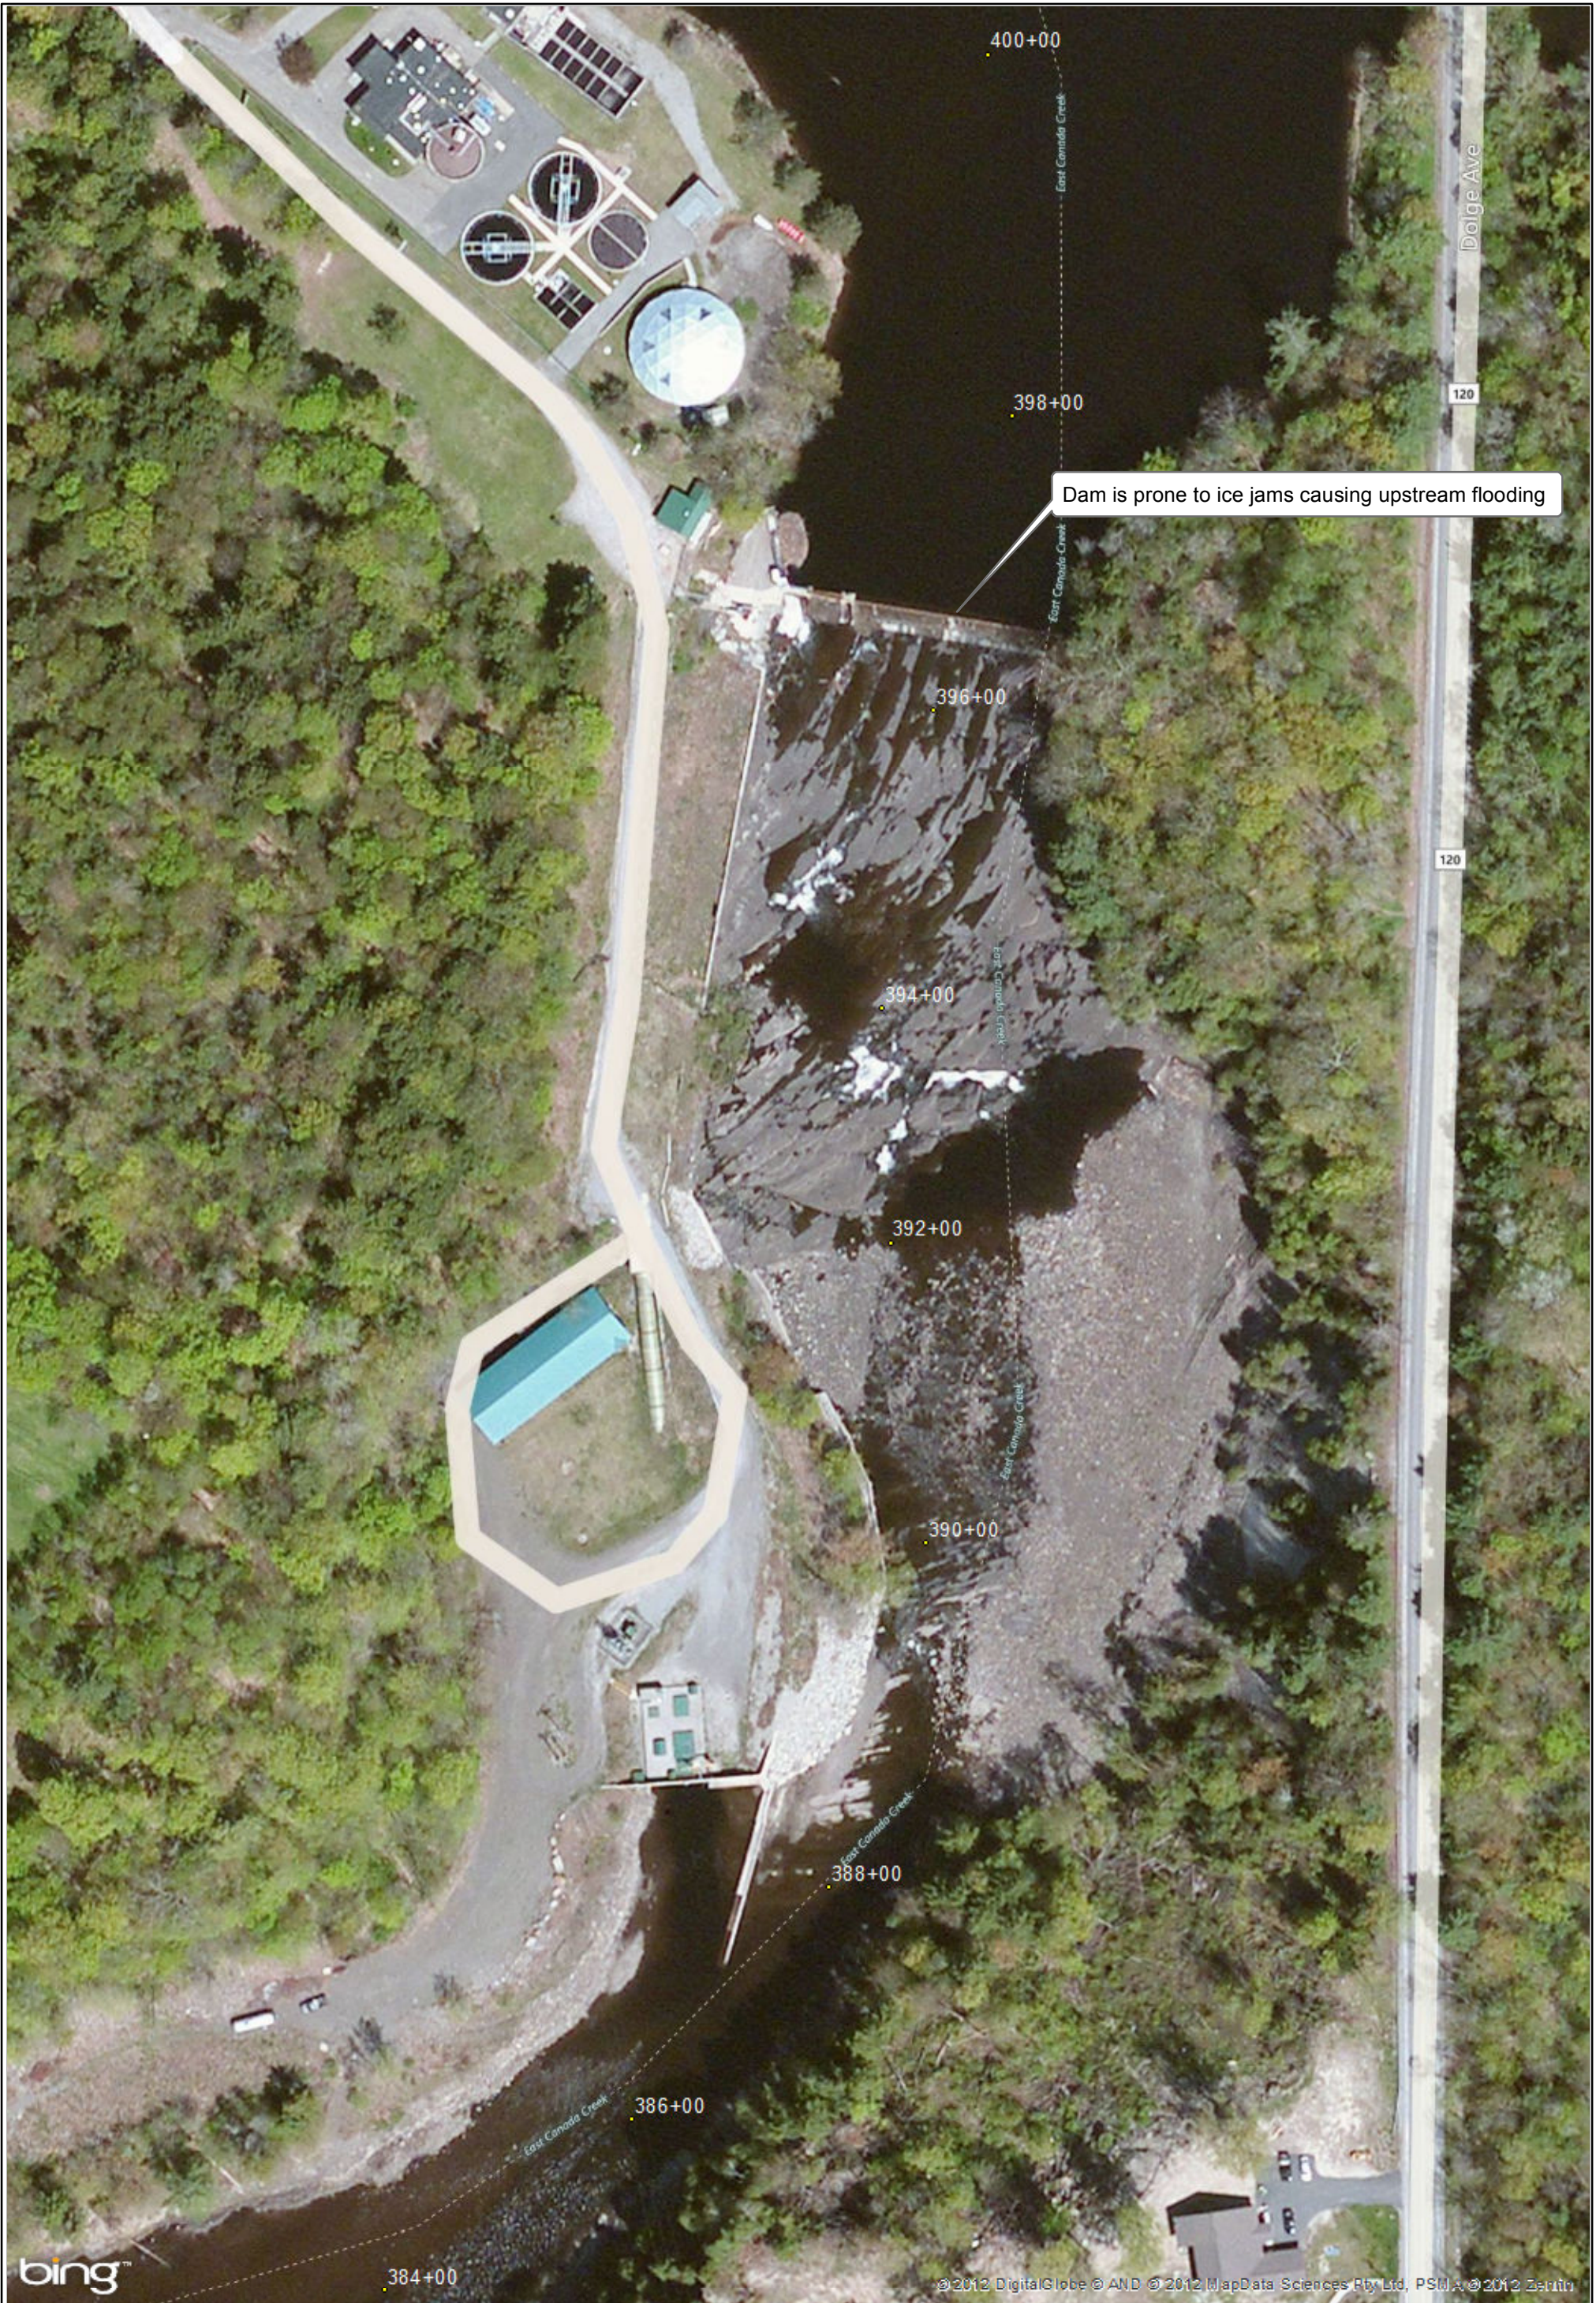
**Figure 8: East Canada Creek High Risk Area #2**

Figure 8 is a location plan of High Risk Area #2. This area is in the vicinity of the wastewater treatment plant and hydroelectric station downstream of Dolgeville and includes the dam and spillway at STA 396+25.

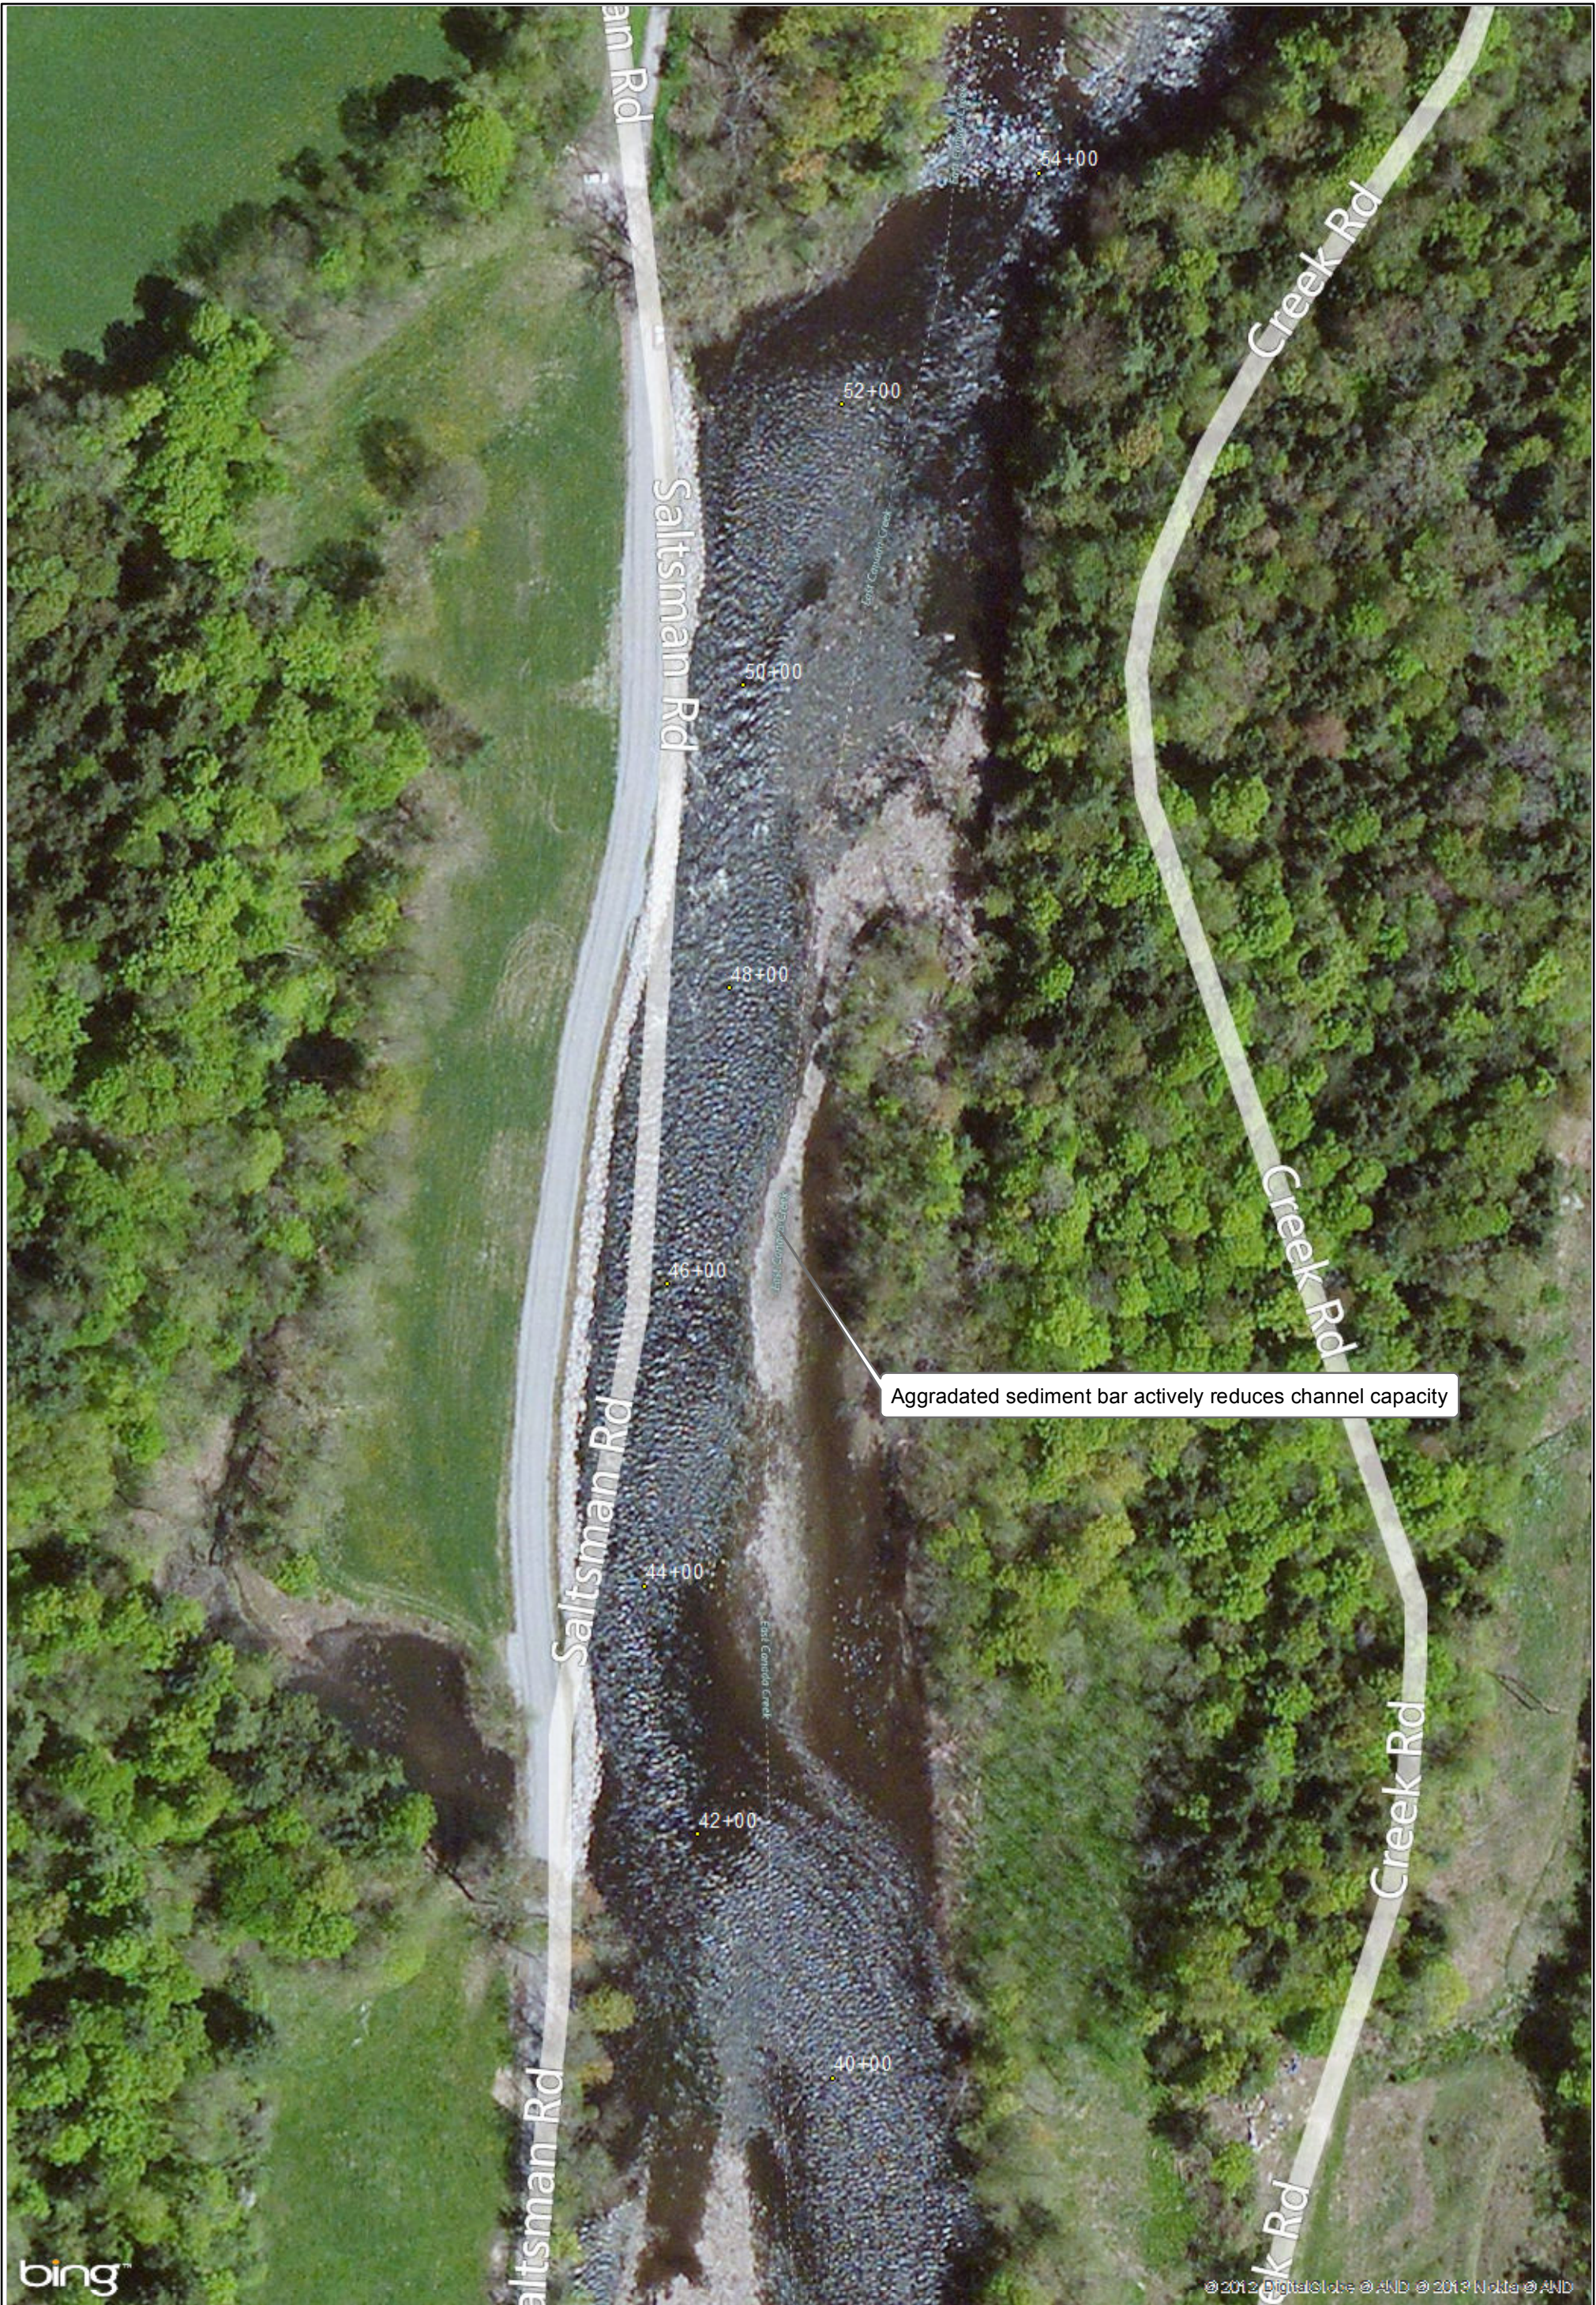
**Figure 9: East Canada Creek High Risk Area #3**

Figure 9 is a location plan of High Risk Area #3. After the June 2013 flood, a large sediment bar formed in the channel on East Canada Creek downstream of the dams and power plant at East Canada Lake adjacent to Saltsman Road (STA 52+00 to 42+00). A large deposit of sediment also formed at this location following a flood event in 2006.
