EMERGENCY TRANSPORTATION INFRASTRUCTURE RECOVERY
WATER BASIN ASSESSMENT
AND FLOOD HAZARD MITIGATION ALTERNATIVES

MALTANNER CREEK
HERKIMER COUNTY, NEW YORK

April 2014

MMI #5231-01

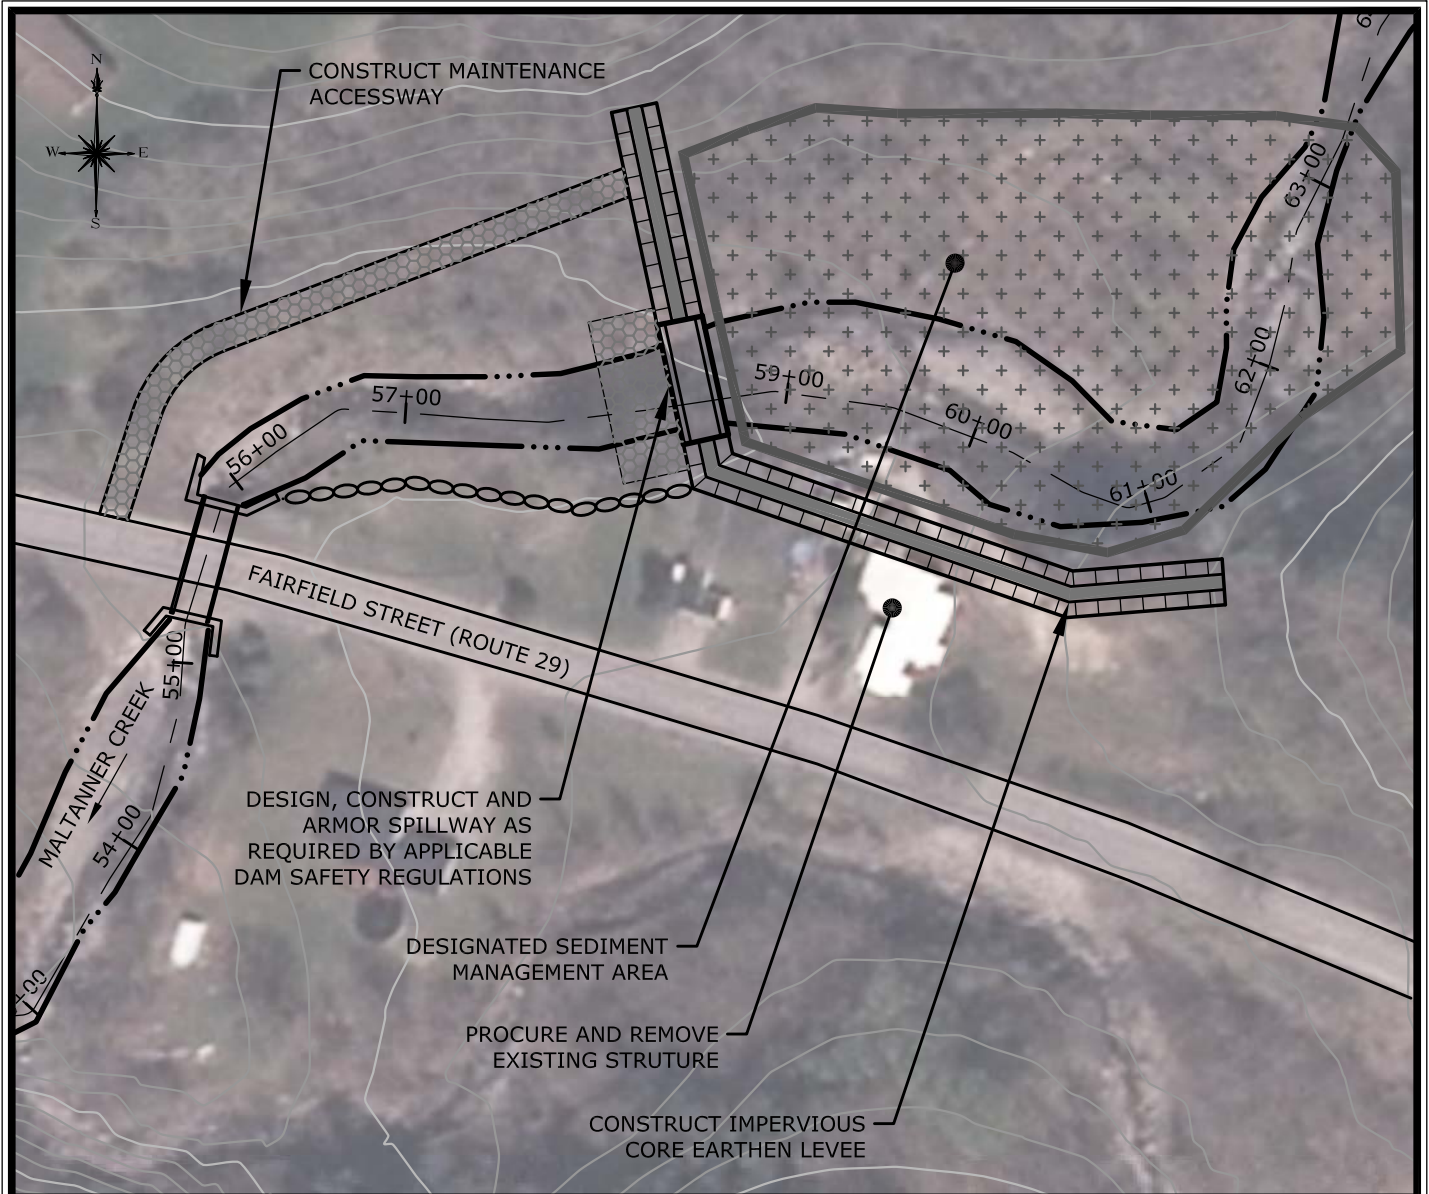
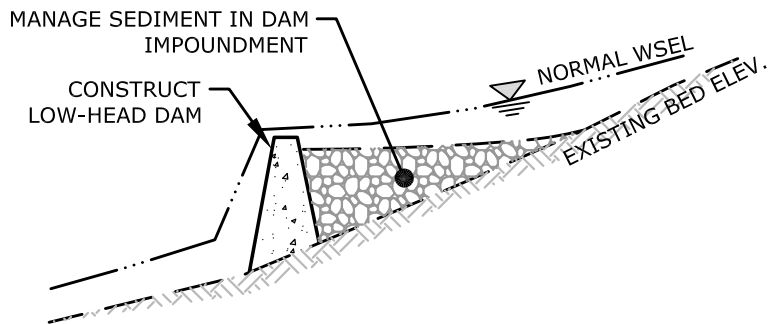
FIG. 6

**MALTANNER CREEK HIGH RISK AREA #1
 SEDIMENT RETENTION BASIN**

This alternative would require acquisition of the house on the left bank near STA 60+00. That parcel or one nearby could serve as the access during construction and the future access for periodic operation and maintenance needs. A trucking route would have to be constructed and maintained to facilitate the removal of sediment whenever needed. Figure 6 is a conceptual design of this alternative.

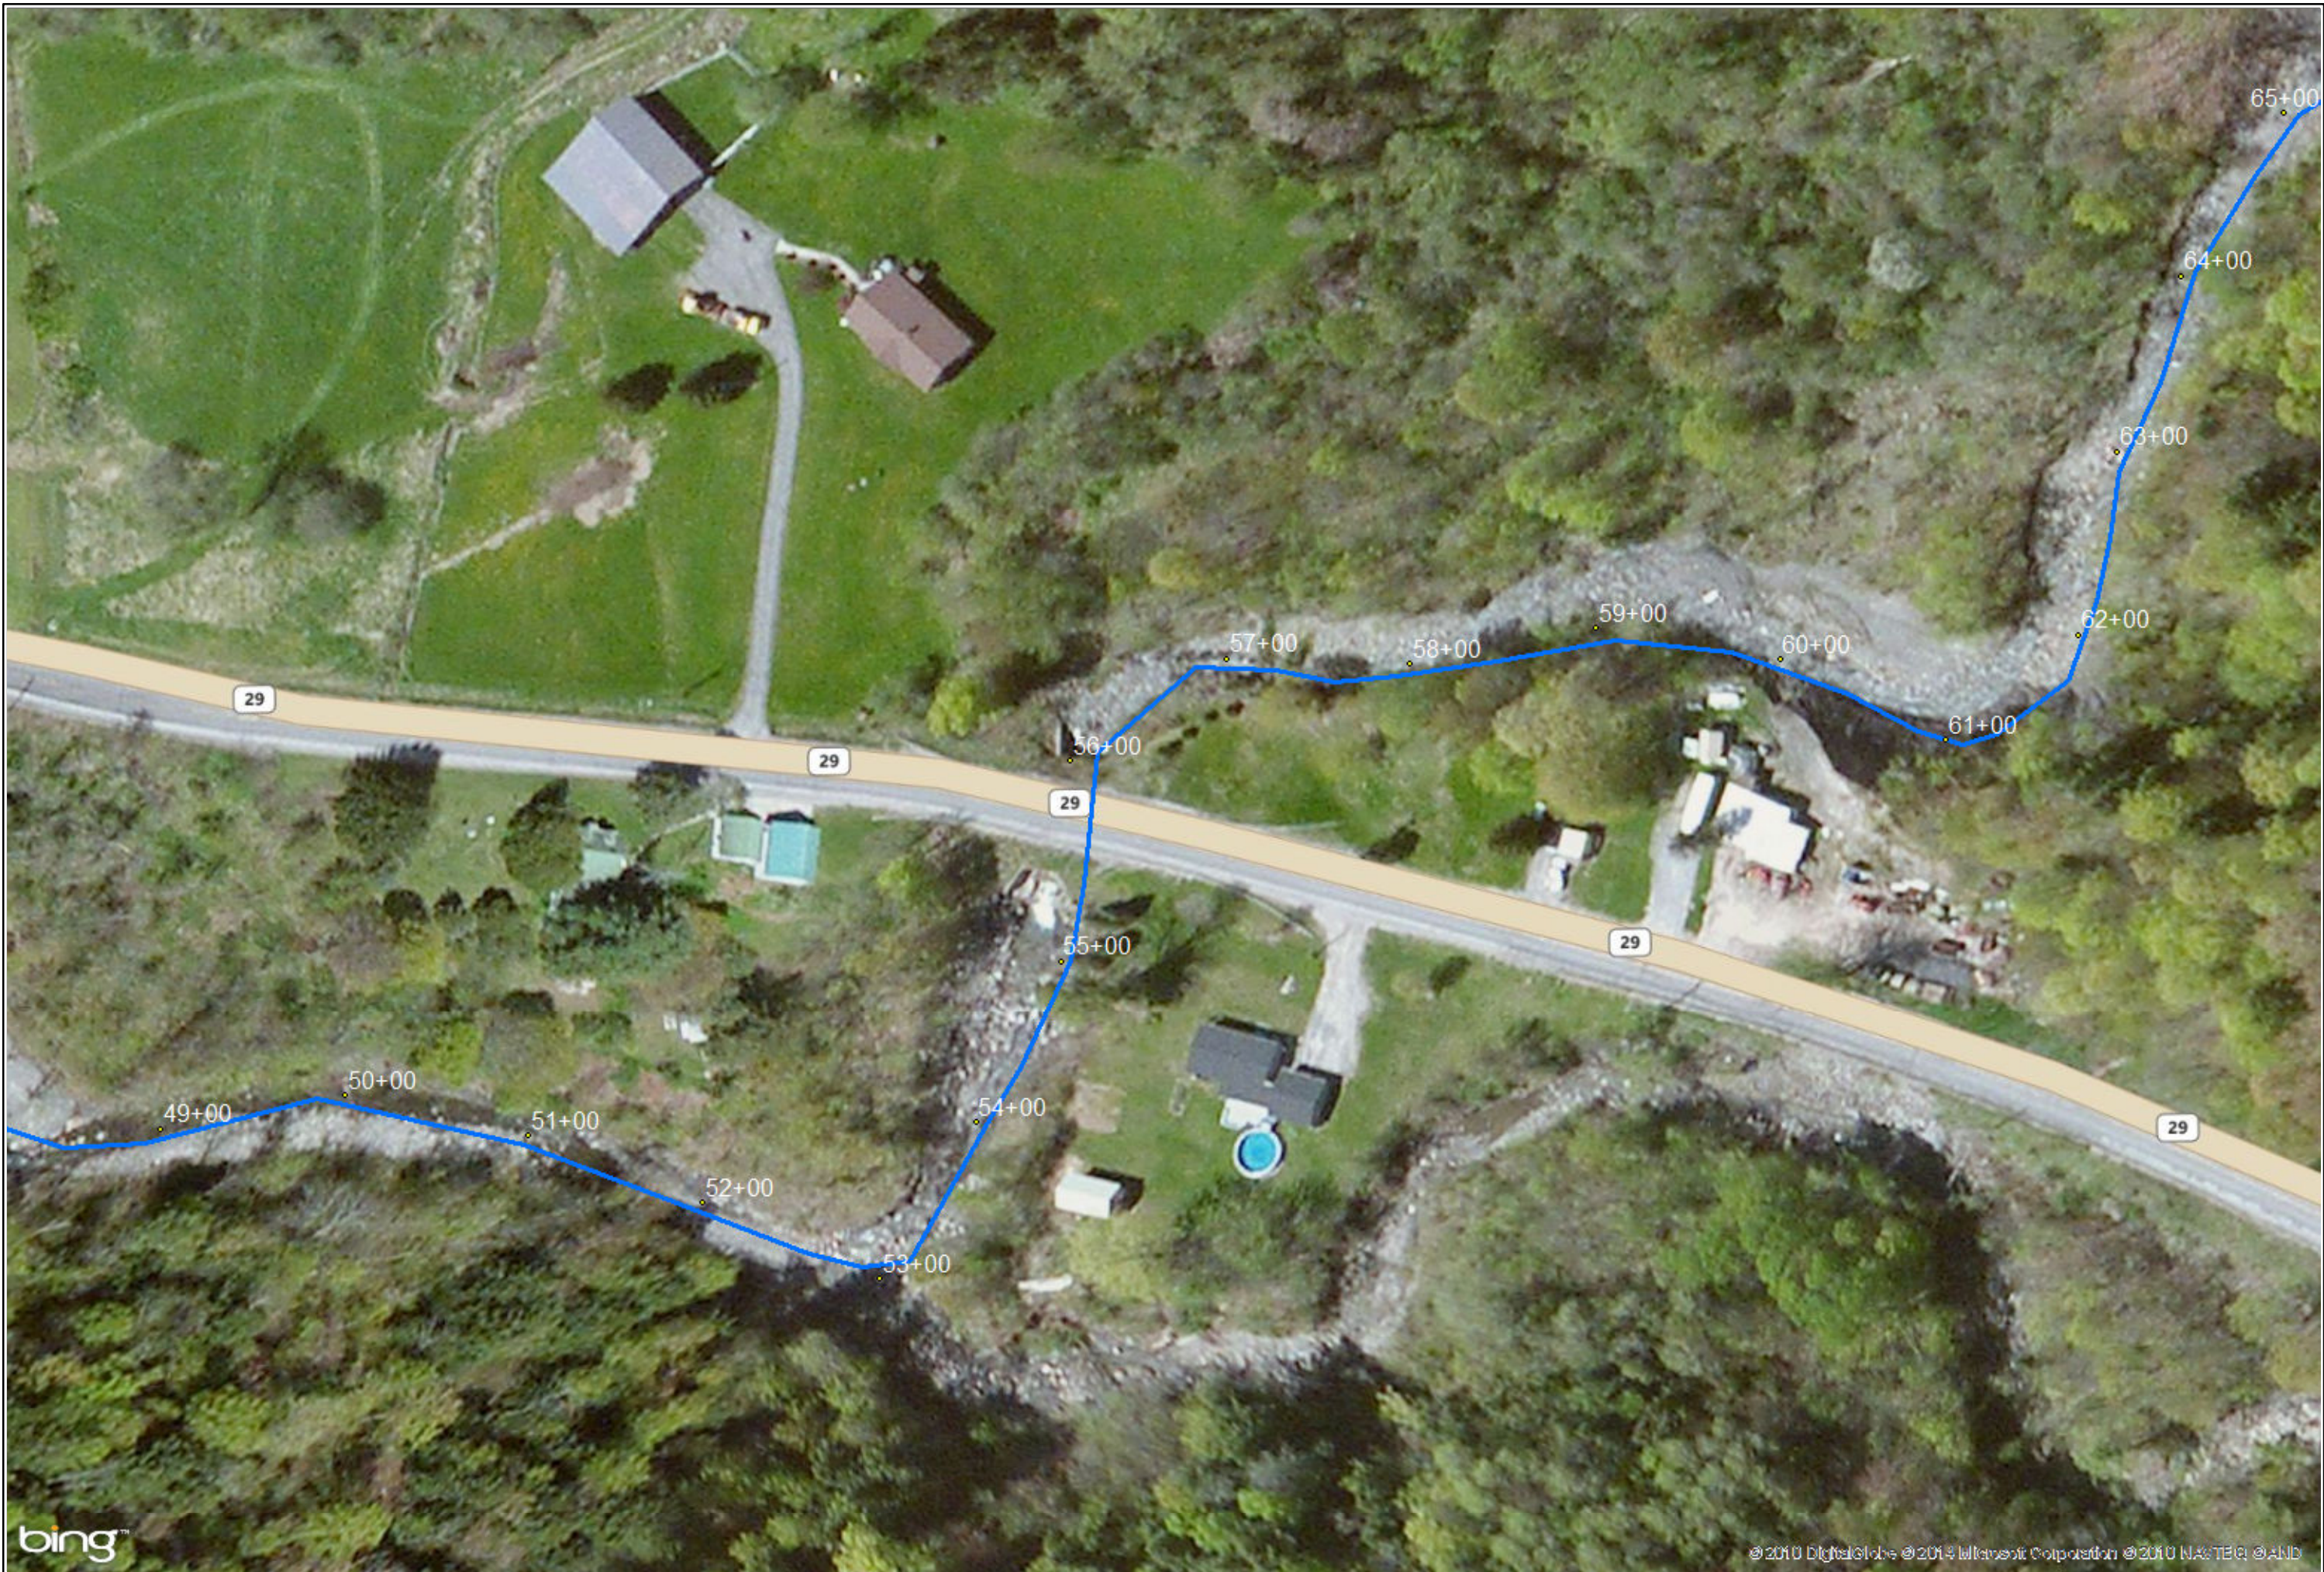
Figure 8 is a location plan of High Risk Area #3. Multiple bank failures occur in this reach, including bank slides between STA 52+50 and STA 50+00, between STA 45+00 and STA 40+50; a failure in the vicinity of STA 35+50; as well as bank slides between STA 35+00 and STA 32+50, and between STA 25+00 and STA 23+00. In addition, there are a number of bank slides along a tributary that joins Maltanner Creek at STA 53+00, just downstream of the Route 29 crossing.
