EMERGENCY TRANSPORTATION INFRASTRUCTURE RECOVERY WATER BASIN ASSESSMENT AND FLOOD HAZARD MITIGATION ALTERNATIVES

ORISKANY CREEK ONEIDA COUNTY, NEW YORK

April 2014

MMI #5231-01

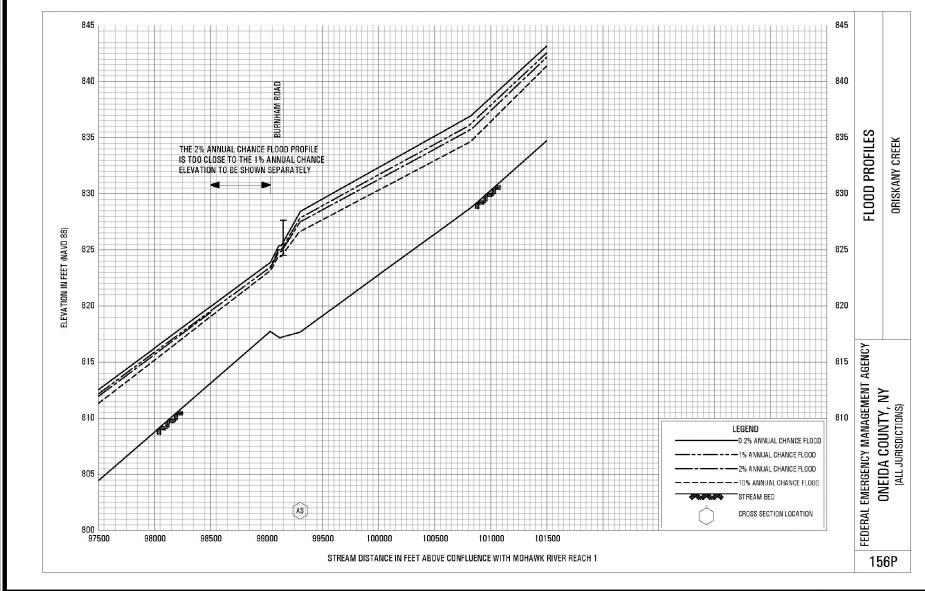
FIG. 10

The bridges where some of the most severe flooding to buildings and property has been reported are the Route 315 bridge (STA 936+50) and the Norton Avenue bridge (STA 554+00). The FEMA profiles showing these bridges are included as Figures 9 and 10.

Alternative 1-1: Prioritize the most severely floodprone, undersized bridges for replacement.

Tier 1: Replace undersized bridges at Route 315 (STA 936+50) and Norton Avenue (STA 554+00) with structures that are large enough to span the creek's bankfull width and convey flood flows without causing a hydraulic constriction. The Route 315 bridge is one of the bridges identified for replacement in Governor Cuomo's Scour Critical Bridge Replacement Program. According to the Governor's website, "This bridge carries NY Route 315 over Oriskany Creek in the Town of Marshall, Oneida County. The highway at this location carries an average of 1,980 vehicles a day. This 51 ft. span steel jack arch bridge on high concrete abutments founded on rock was constructed in 1930, connects Waterville with Deansboro. The bridge connects residential and business districts."

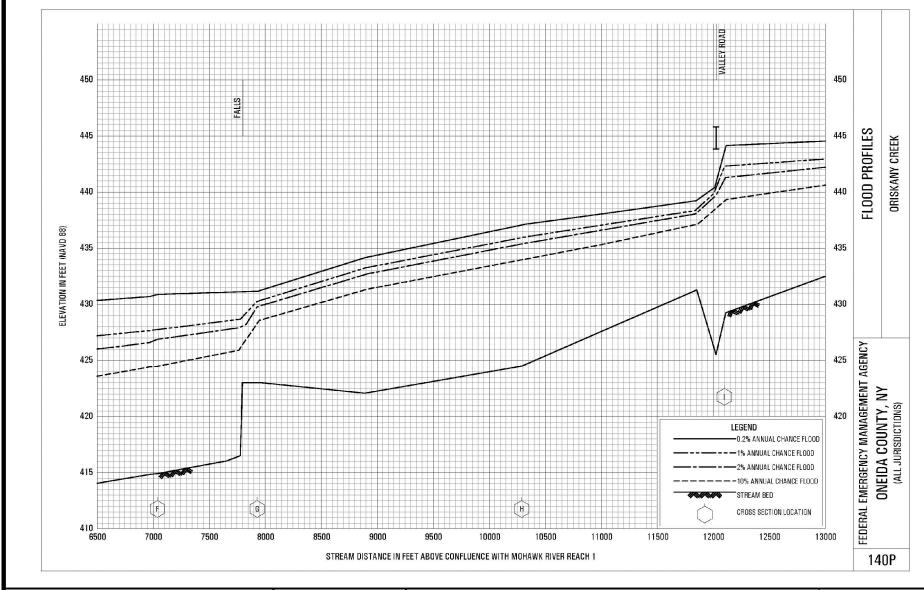
FEMA PROFILE IN HIGH RISK AREA #3 (1 OF 2)

Figure 15 is a location plan of High Risk Area #3. Flooding and damage to Valley Road (Route 32) has been reported in the vicinity of STA 81+50 upstream to STA 99+00 in the backwater area of the dam located at STA 81+50. According to the FEMA profile, the dam creates an increase in water surface elevation upstream of the dam by more than five feet during the 10-year flood event, which is contributing to flooding and flood-related damages to Valley Road.

In flood events larger than the 10-year frequency, the FEMA profile indicates that the backwater effect caused by hydraulic constrictions at the Utica Street bridge (at STA 56+50, approximately 2,500 feet downstream of the dam) reaches upstream of the dam and combines with the backwater effect of the dam to raise water surface elevations through this reach. The Erie Boulevard and railroad bridges (STA 53+50 and STA 43+50, respectively) also create a backwater effect that extends upstream from these bridges, contributing to increased water surface elevations from STA 43+50 to upstream beyond the dam at STA 81+50, including the Little League fields on the right bank. A recently constructed earthen levee between the Little League fields and the creek was observed during field investigations in October and November 2013. The FEMA profiles showing these bridges and the dam are included as Figures 16 and 17.

The dam at STA 81+50 does not appear to be serving a useful function at the present time. It appears that the original intent of the dam was to store water and direct it through a channel that runs approximately 2,000 feet along the west side of Valley Road from the dam to the Department of Public Works facility, where it returns to the creek. Removal or modification of this dam to reduce or eliminate the backwater effect would decrease water surface elevations upstream of the dam during flood events and would potentially reduce flooding and flood-related damages along Valley Road between STA 81+50 and STA 99+00.
