# **SAUQUOIT CREEK DRAINAGE STUDY FINDINGS OF 2019 HALLOWEEN STORM – HYDRAULIC MODELING**

Project name **Sauquoit Creek Drainage Study**  
Project no. **74959**  
Recipient **Sauquoit Creek Basin Intermunicipal Commission**  
Document type **Report**  
Version **1**  
Date **May 11, 2020**  
Prepared by **Ahintha H Kandamby, Ph.D., PE, CFM**  
Checked by **Shaun B. Gannon, PE, D.WRE, PH, CFM, PMP**

# 1. FINDINGS OF 2019 HALLOWEEN STORM EVENT – HYDRAULIC MODELING

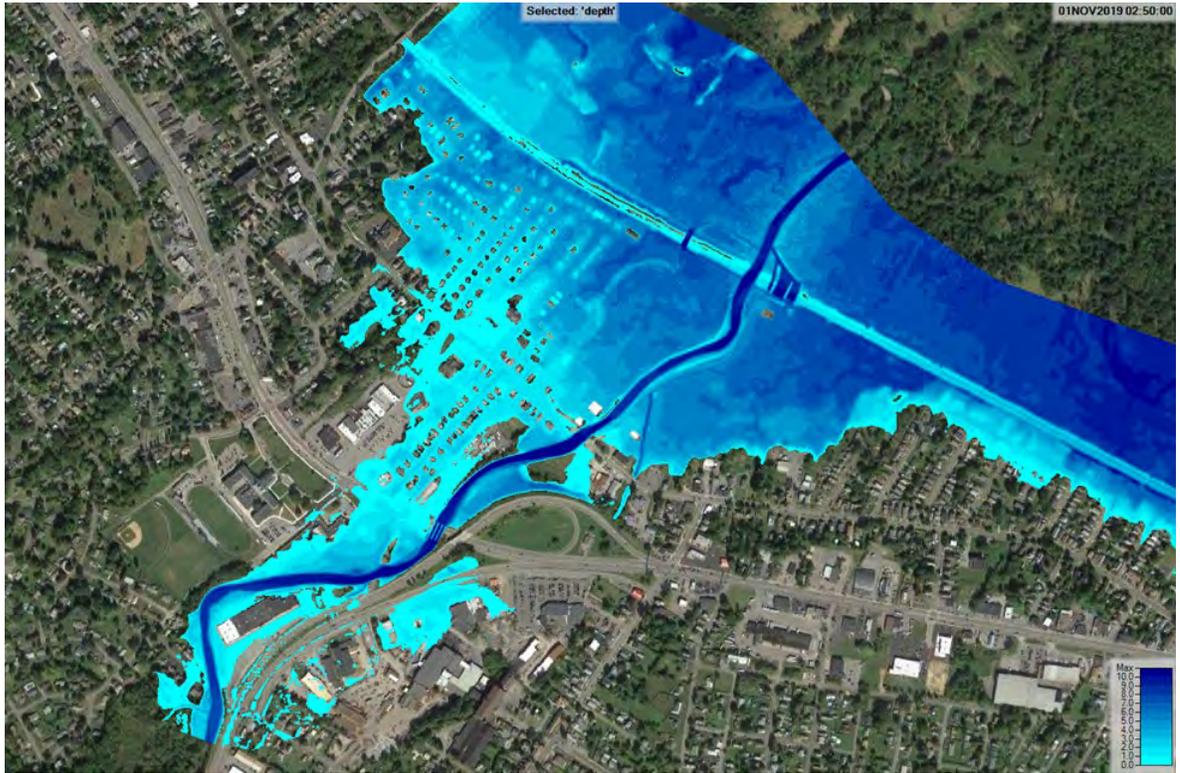
Figure 3. Sauquoit Creek - Peak flood during the 2019 Halloween Storm

Modeling indicated that the initial out-of-bank flooding begins as water stages upstream of the railroad crossing. Over the course of approximately 3.5 hrs. (215 minutes), approximately 75% of the overland area bordered by Oriskany Boulevard, Mohawk Street and CSX railroad were inundated to the peak depth (Figure 3). After which, from the peak it took approximately 25 hours for flooding to recede in the primarily residential area (Figure 4) and then another 49 hours (74 hours since the peak) to completely drain all overland flooding (Figure 5).

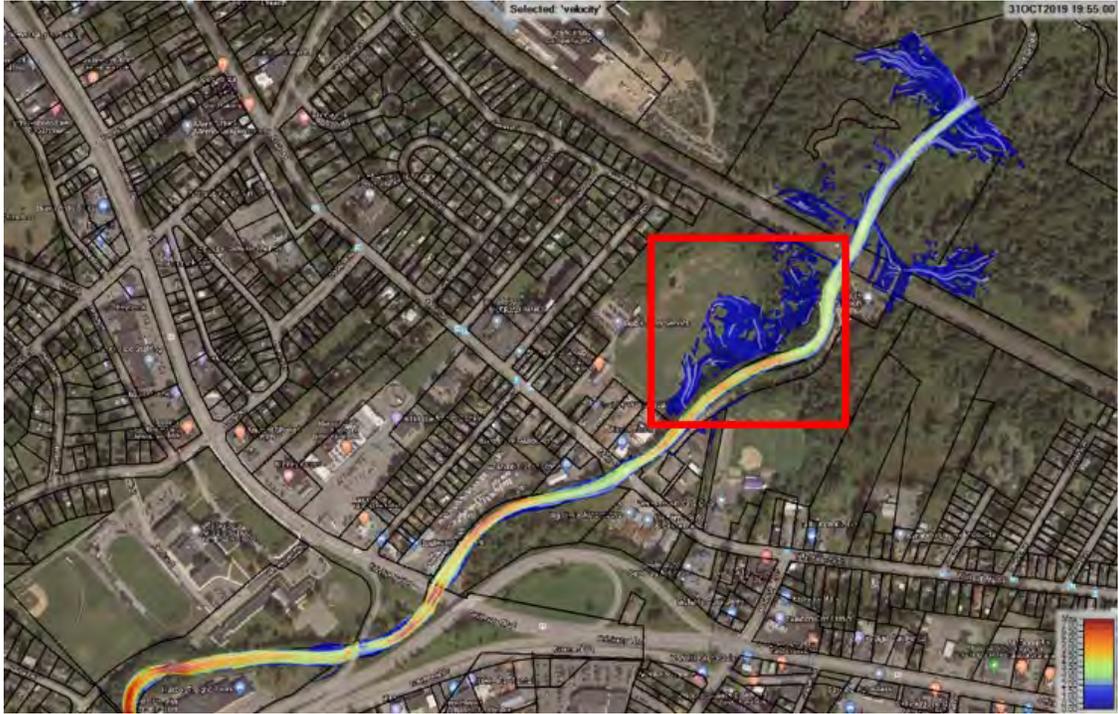
Figure 7. Flood development – (between Main Street and the railroad crossing)

To understand the velocities and their directions, the modeling software allows the user to visualize the pattern by displaying a series of “flow trace” lines. These lines are depicted in white on the following images. These lines indicate the direction of flow at each point during the storm. Figure 7 and Figure 8 show the development of flooding into the floodplain between Oriskany Boulevard. and the railroad crossing. Specifically, Figure 7 shows that overland flooding begins between Main Street and the railroad crossing in the vicinity of the proposed floodplain bench (Mauro parcel). As the storm continues to develop, Figure 8 shows how flooding starts to enter at Sauquoit St. and Ellis Avenue, and how overland flooding begins to develop at two additional locations, near the Whitesboro Elementary School onto Gardner Street and behind the Whitesboro Veterans of WWII building.

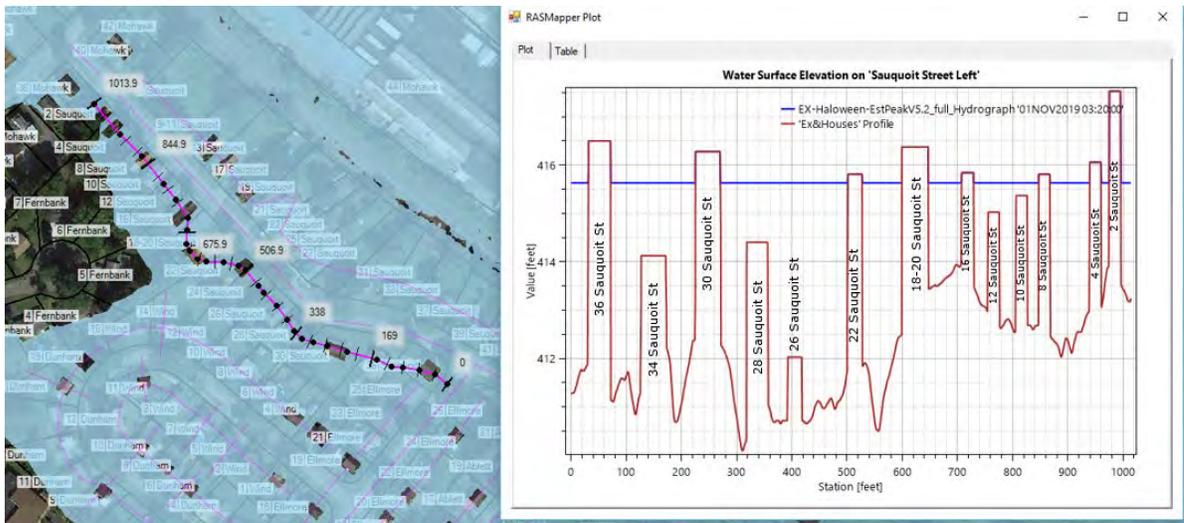
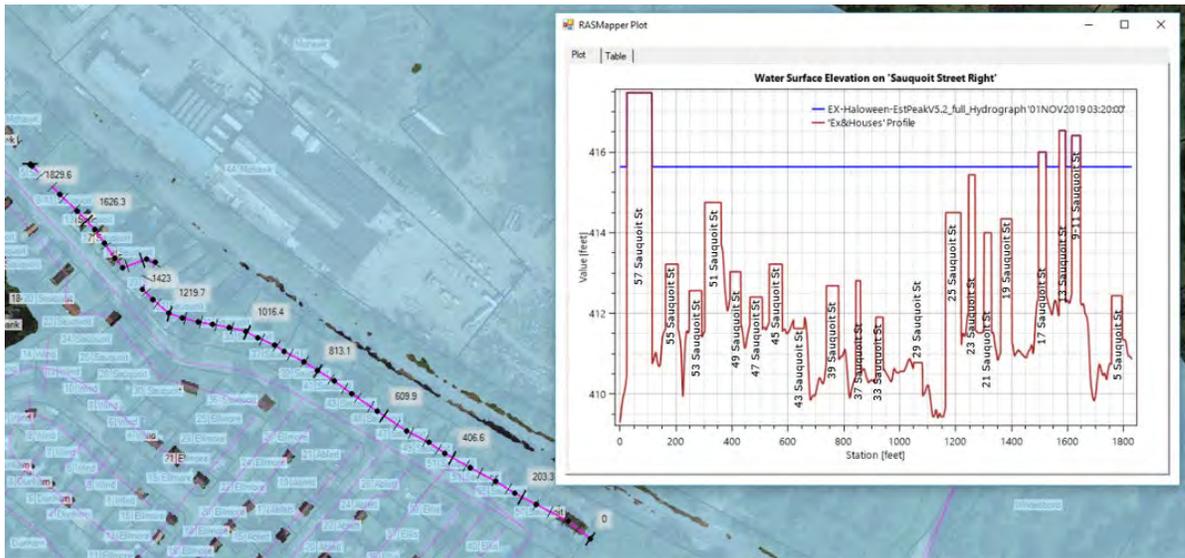
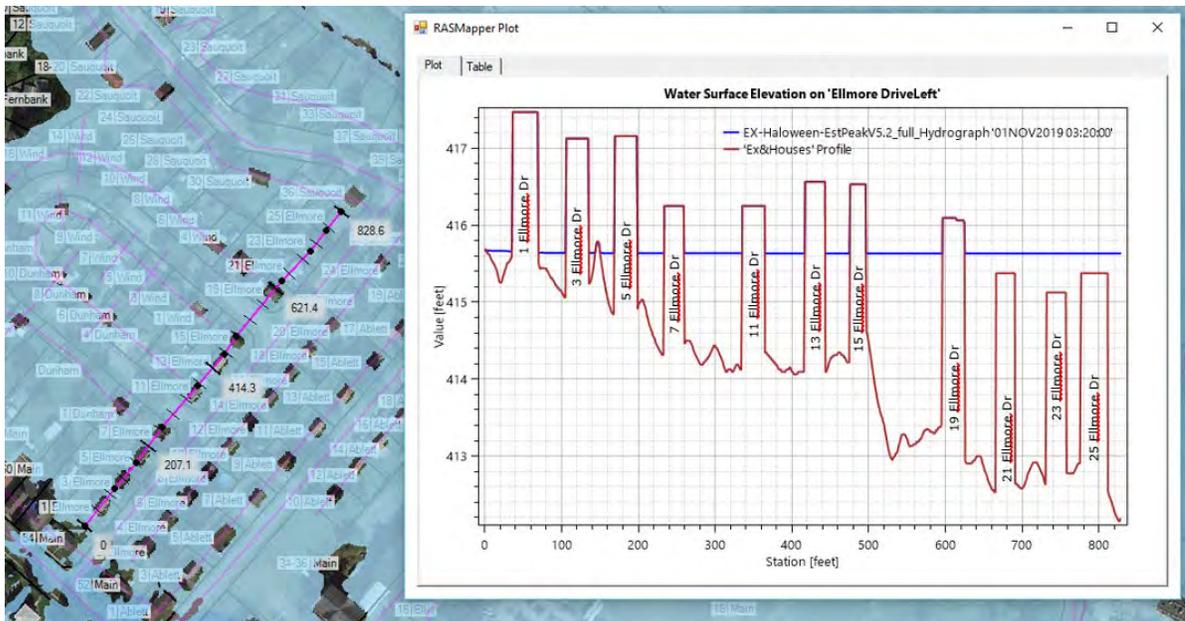
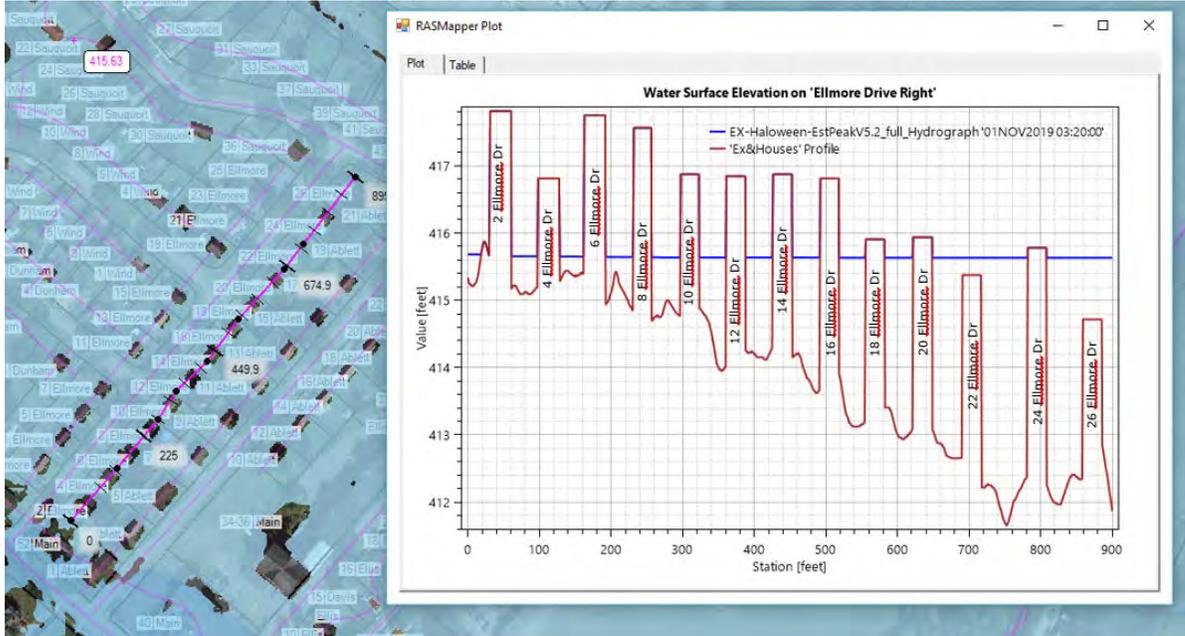
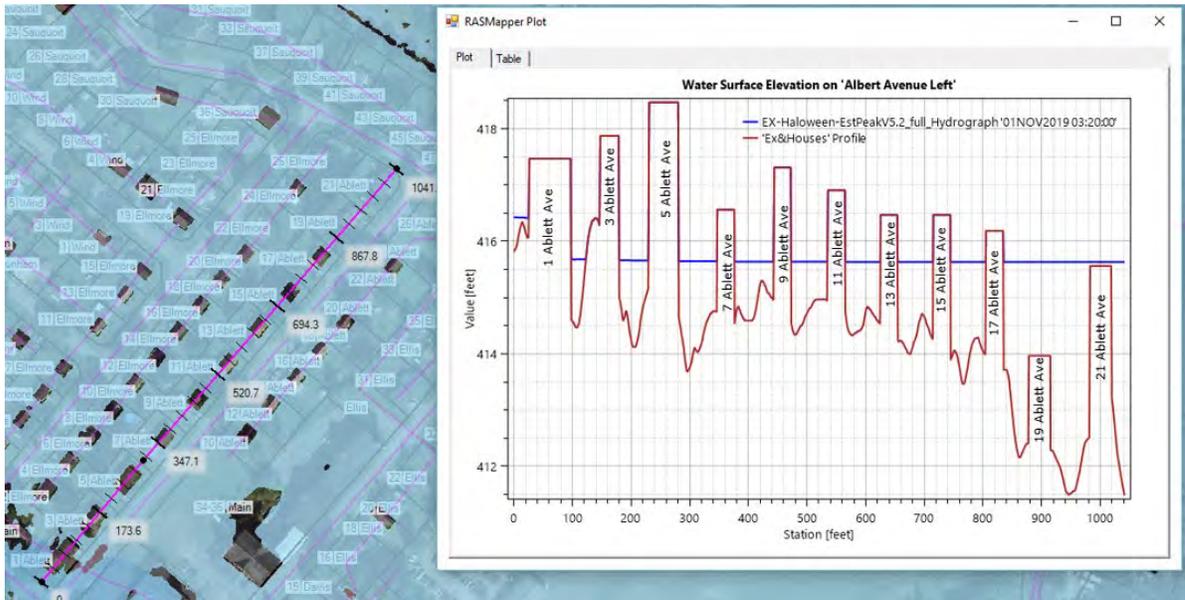
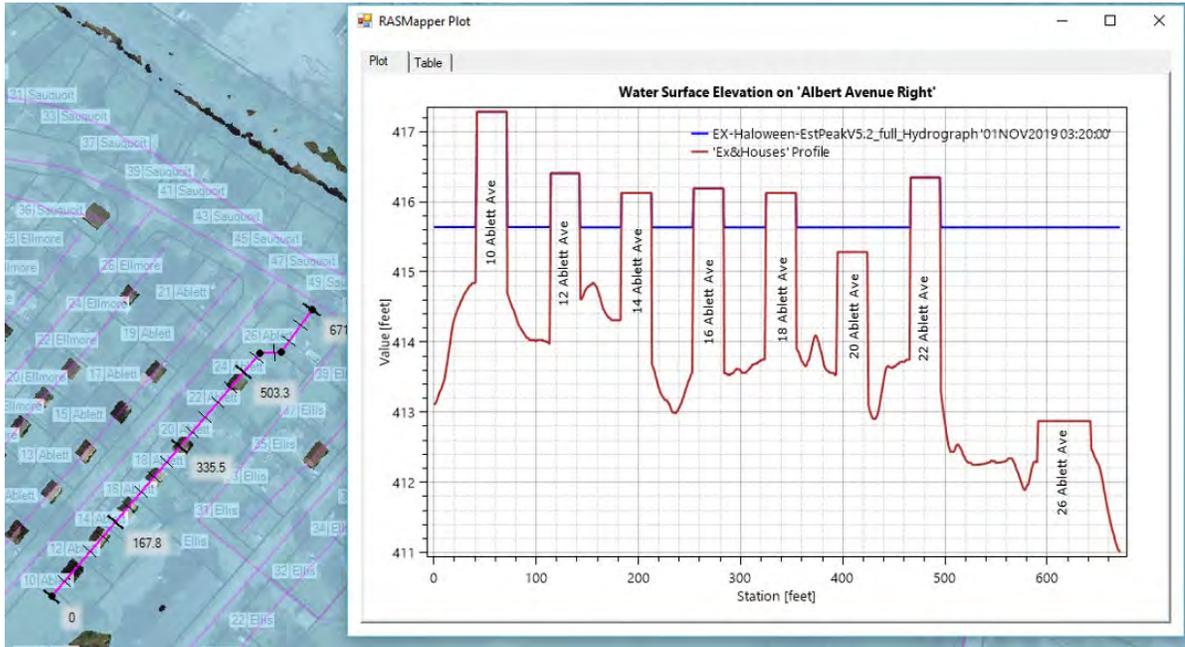
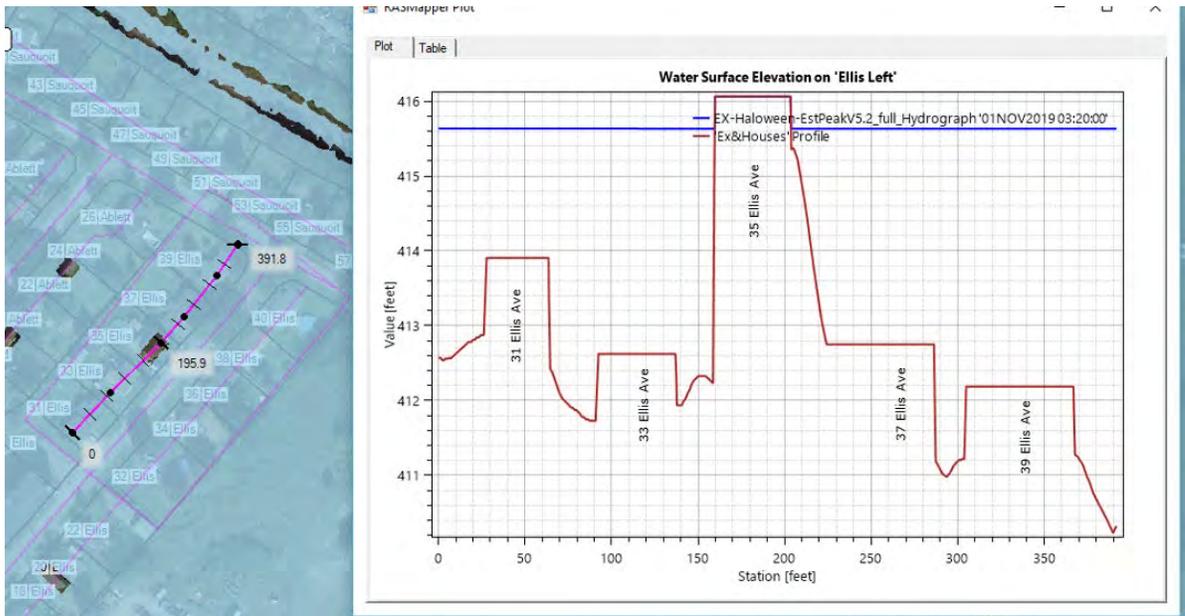
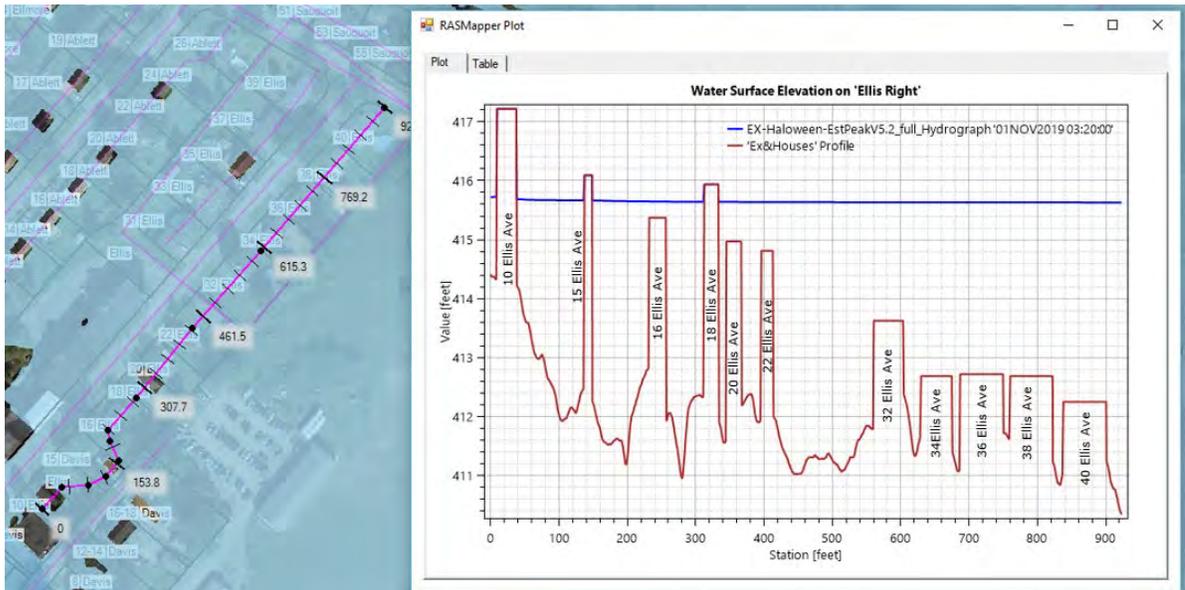
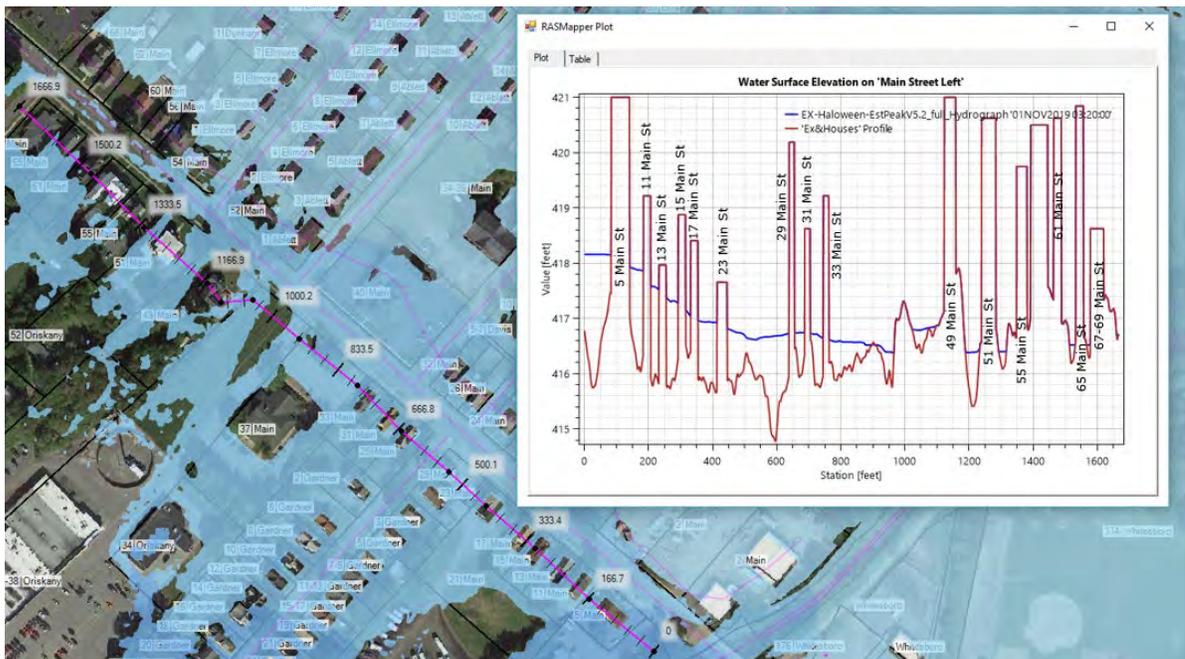
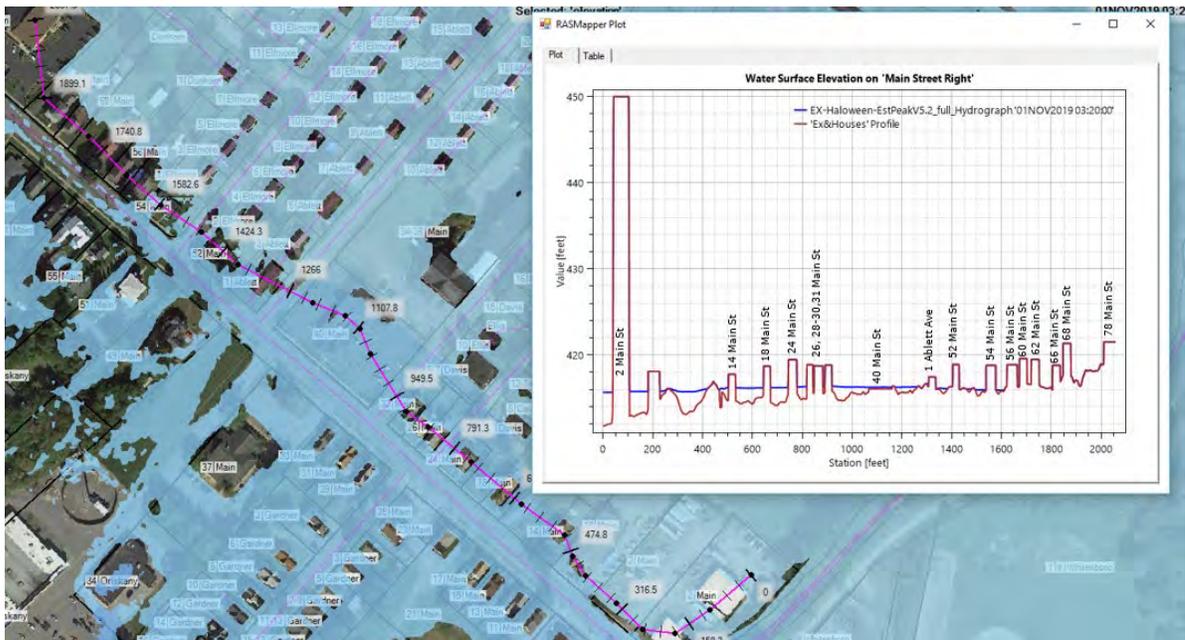
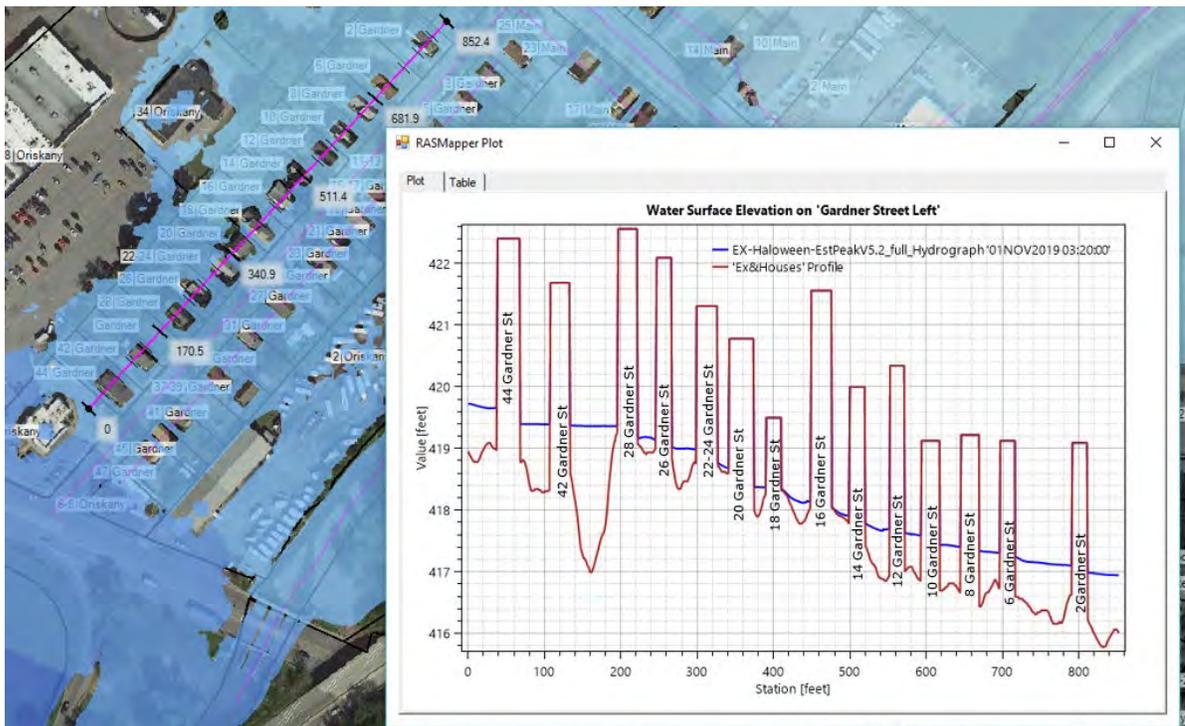
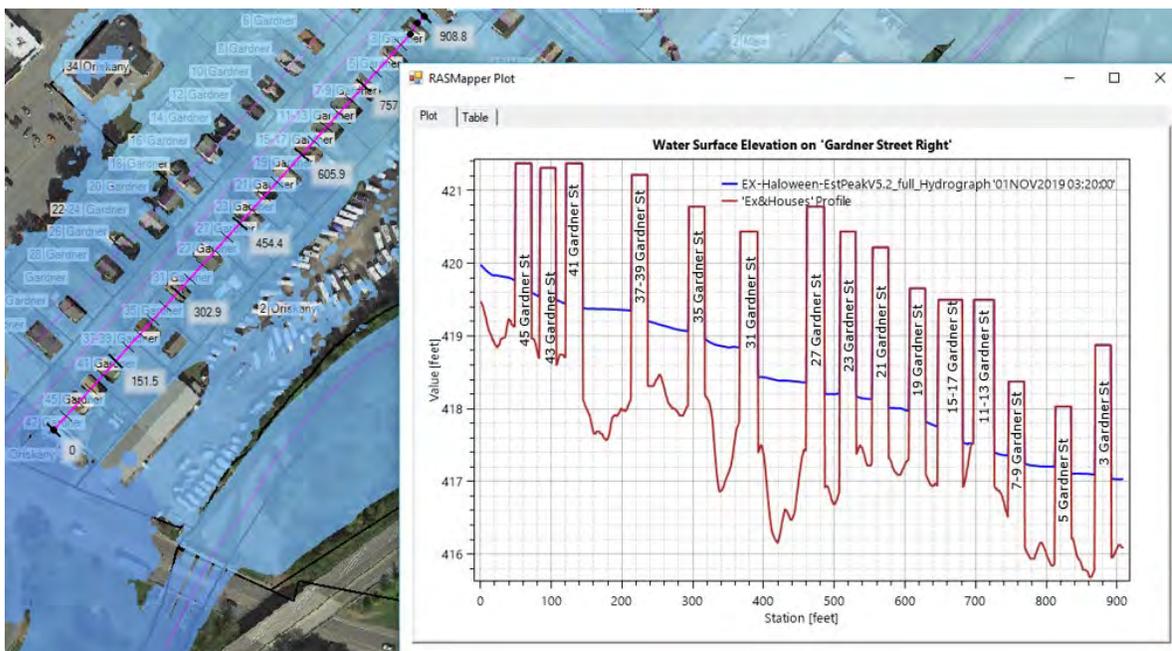
A summary table (Appendix B) for all the neighborhoods that experienced similar flooding during the 2019 Halloween storm, with the possible influencing factors on structural integrity, is presented along with the longitudinal profiles through the impacted neighborhoods. Figure 29 through Figure 40 show the Water Level longitudinal profile plots for Sauquoit Street, Ellmore Drive, Albert Avenue, Ellis Avenue, Main Street and Gardner Street, respectively.

The profile plot helps to depict the degree of potential hydrostatic pressure difference and the level of FFE inundation for these houses. An average flood residence time for each street representing a neighborhood is also summarized to show the degree of soil saturation, and to quantitatively illustrate the longevity of buoyancy effects on the buildings. The Appendix B summary table provides insight into potential for future storm event vulnerability within the study area from an event of similar magnitude, duration, and intensity.

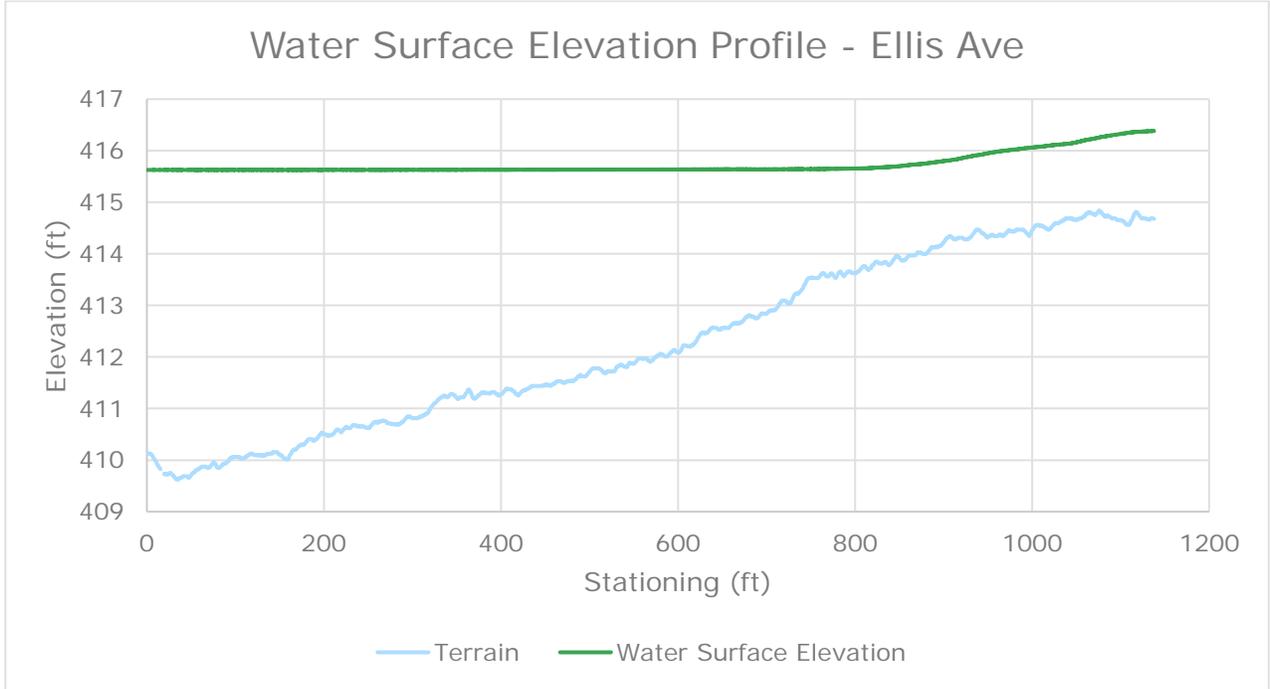
**Figure 2: Ellis Ave Profile Plot**

Figure 1 below shows the preliminary model flood inundation limits within the Village of Whitesboro, NY for the Halloween 2019 event along with a reference line on Ellis Ave (magenta line with stationing). Figure 2 shows the preliminary profile of the ground elevation and the model results along this reference line. Through observation of Figure 1, it is apparent that all of the structures along Ellis Ave were subject to potential inundation by the event. Observation of Figure 2 shows that, Ellis Ave slopes away from Main St. toward Sauquoit Street and at the intersection of Ellis Ave and Sauquoit Street the preliminary modeling shows approximately flood depth of feet above ground level. This suggest that structures closer to Sauquoit St. may have suffered greater inundation than those closer to Main St.

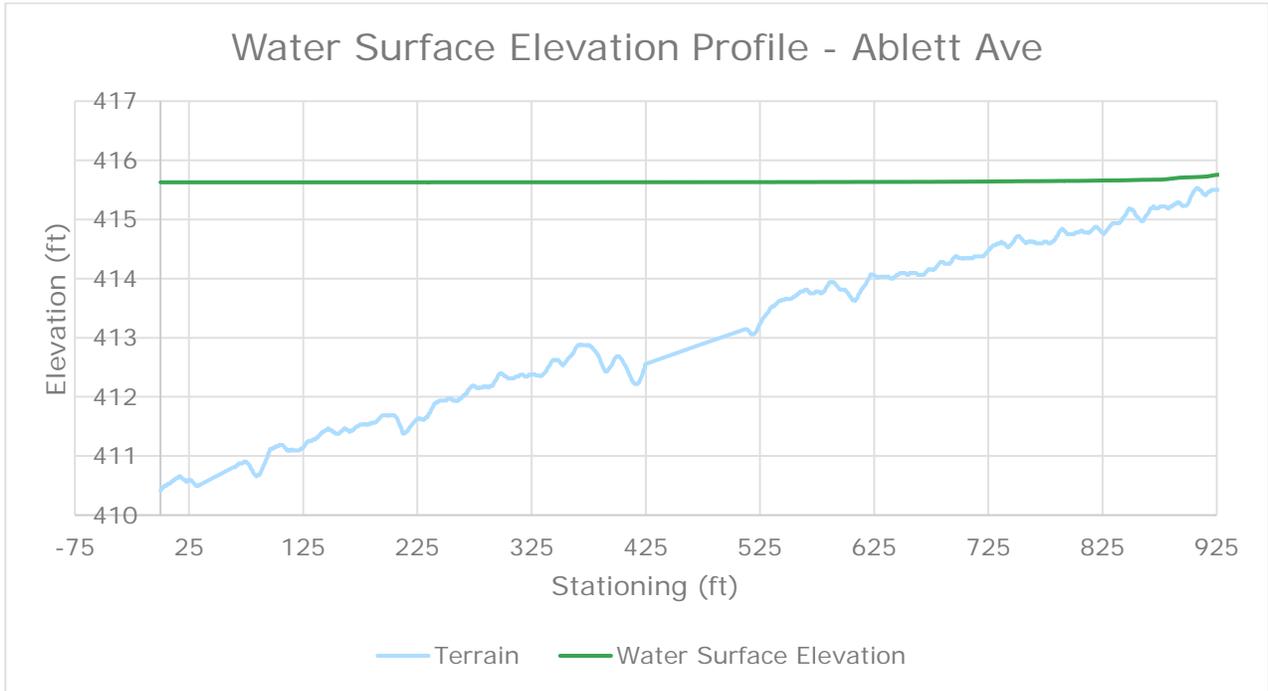
**Figure 4: Ablett Ave Profile Plot**

Figure 3 below shows the preliminary model flood inundation limits within the Village of Whitesboro, NY for the Halloween 2019 event along with a reference line on Ablett Ave (magenta line with stationing). Figure 4 shows the preliminary profile of the ground elevation and the model results along this reference line. Through observation of Figure 3, structures close to the intersection with Sauquoit St. were potentially inundated by the event. Observation of Figure 4 shows that, Ablett Ave slopes away from Main St. toward Sauquoit Street and at the intersection of Ablett Ave and Sauquoit Street the preliminary modeling shows approximately flood depth of feet above ground level. This suggests that structures closer to Sauquoit St. may have suffered greater inundation than those closer to Main St.

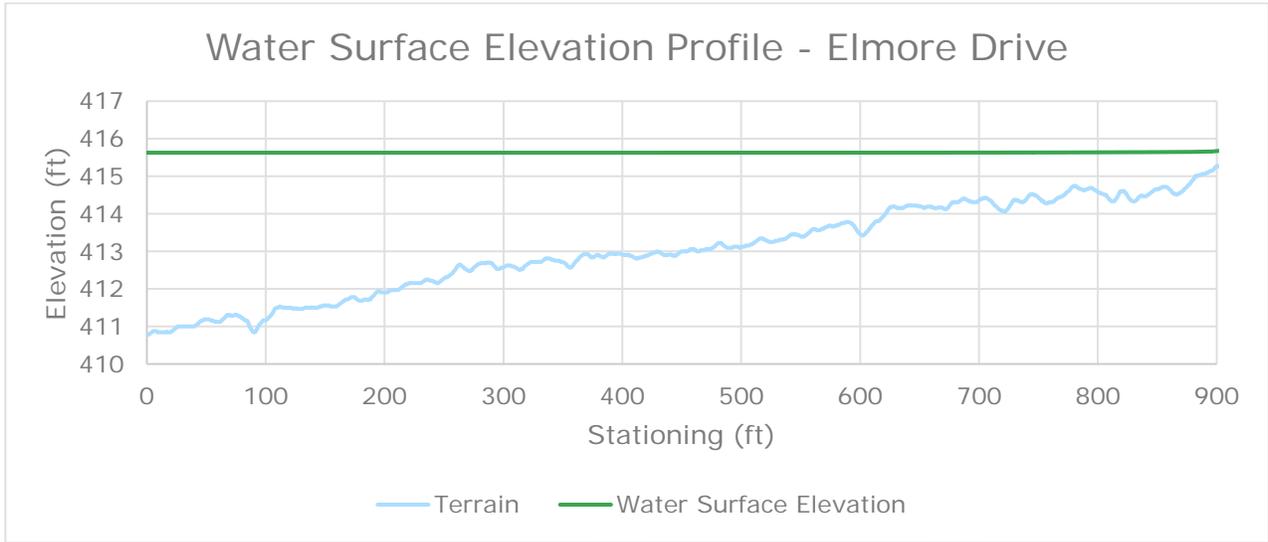
**Figure 6: Elmore Drive Profile Plot**

Figure 5 below shows the preliminary model flood inundation limits within the Village of Whitesboro, NY for the Halloween 2019 event along with a reference line on Ellmore Drive (magenta line with stationing). Figure 6 shows the preliminary profile of the ground elevation and the model results along this reference line. Through observation of Figure 5, structures close to the intersection with Sauquoit St. were potentially inundated by the event. Observation of Figure 6 shows that, Ellmore Ave slopes away from Main St. toward Sauquoit Street and at the intersection of Ellmore Ave and Sauquoit Street the preliminary modeling shows approximately flood depth of feet above ground level. This suggest that structures closer to Sauquoit St. may have suffered greater inundation than those closer to Main St.

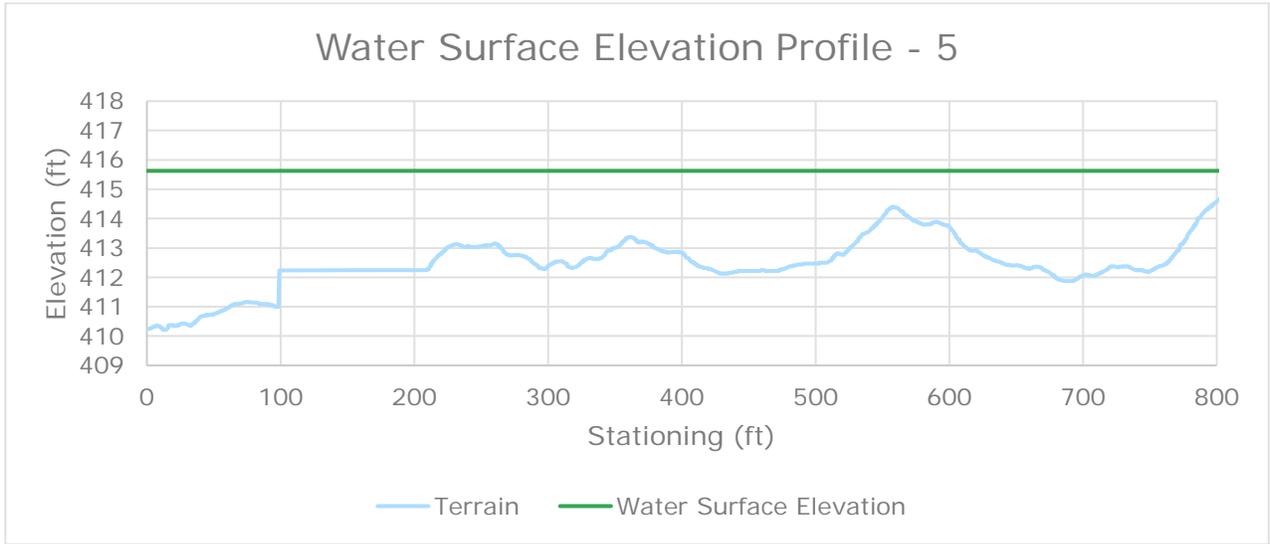
**Figure 8: Profile Perpendicular to Dunham and Winn Place**

Figure 7 below shows the preliminary model flood inundation limits within the Village of Whitesboro, NY for the Halloween 2019 event along with a reference line cut through the neighborhood of Dunham and Winn Place (magenta line with stationing). Figure 8 shows the preliminary profile of the ground elevation and the model results along this reference line. Through observation of Figure 7, it can be observed that structures along both Dunham and Winn Place potentially inundated by the event. Observation of Figure 8 shows that, were show that structures along Dunham Place were potentially subject to over 2 feet of inundation while those along Winn Place were podetial subject to over 3 feet of inundation. This suggest that structures closer to Sauquoit St. may have suffered greater inundation than those closer to Main St.

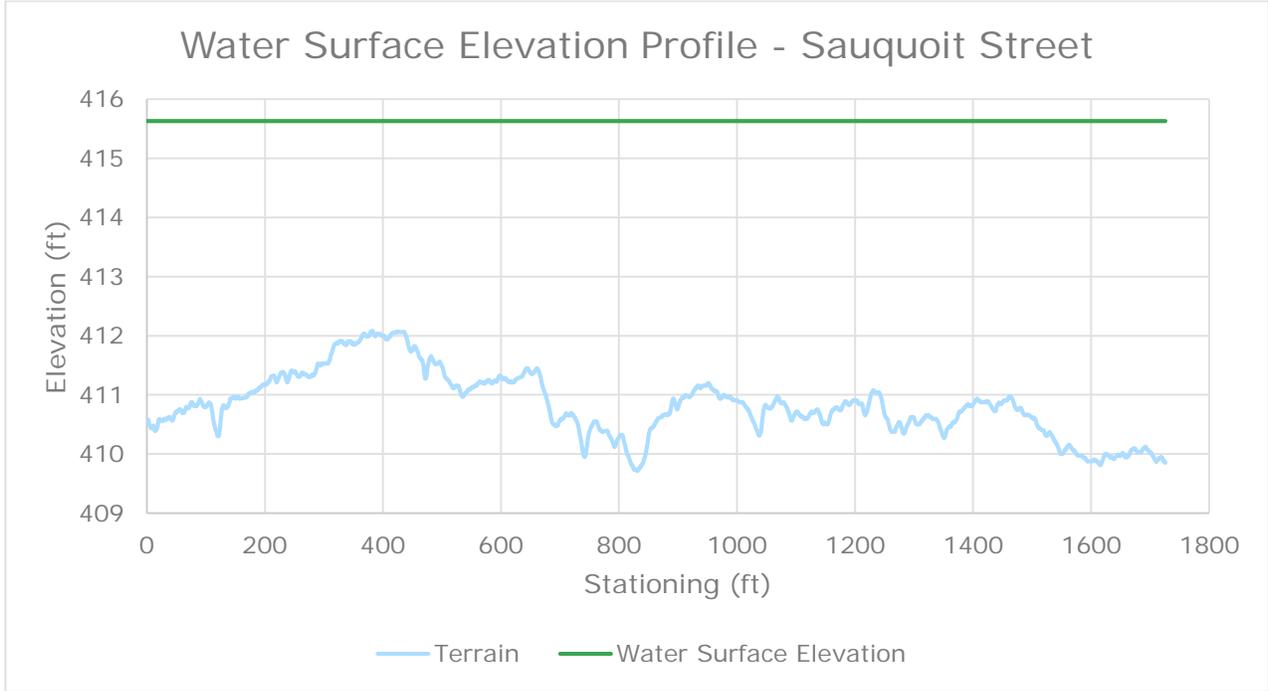
**Figure 10: Sauquoit Street Profile Plot**

Figure 9 below shows the preliminary model flood inundation limits within the Village of Whitesboro, NY for the Halloween 2019 event along with a reference line on Sauquoit St (magenta line with stationing). Figure 10 shows the preliminary profile of the ground elevation and the model results along this reference line. Through observation of Figure 9, all structures along the street were potentially inundated by the event. Observation of Figure 10 shows that, Sauquoit St. slopes gradually away from Old Mohawk St. towards Ellis Ave. with potential flood depths ranging from 5.5 ft to over 6 ft at the intersection of Sauquoit and Ellis. This suggests that structures closer to Ellis St. may have suffered greater inundation than those closer to Old Mohawk St.
