Oriskany Creek Watershed Sediment & Debris Management Study

Oriskany Creek, Oneida County, New York

Project name **Oriskany Creek Watershed Sediment & Debris Management Study**
Project no. **1940104636**
Recipient **Oriskany Creek Watershed Commission**
Document type **Report**
Version **01**
Date **August 23, 2024**
Prepared by **Kadir Goz, CFM and Alyssa Flint**
Checked by **Nicole Del Monaco, PE, CFM, ENV SP**
Approved by **Shaun Gannon, P.E., D.WRE, CFM, P.H.**

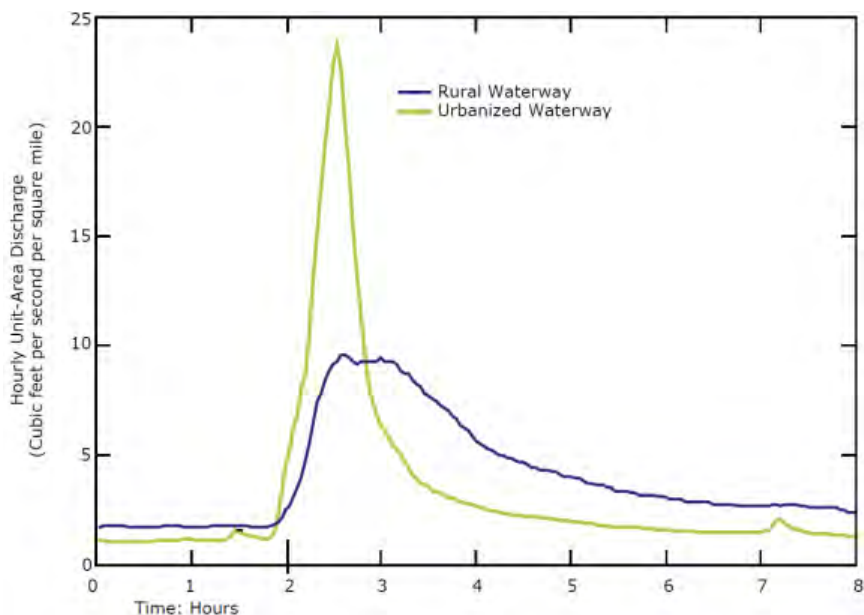
Figure 4-7. Idealized hydrograph comparing streamflow rates of a rural and urbanized waterway (adapted from USGS 2003).

The discharge of a waterway will vary greatly over time depending on the weather within its watershed. As a precipitation event begins, the discharge of a river will not instantaneously increase. It takes time for the rain to reach the river. The delay between when rainfall occurs and when the discharge of the river increases is known as lag time. Lag times will vary depending on characteristics of the watershed. Urbanized waterway basins tend to have large amounts of impermeable surfaces, such as roof tops and parking lots, which restrict infiltration into the soil. Surface runoff travels quicker to waterways, which produces higher discharges and increases the potential for flooding. Rural waterway basins, on the other hand, tend to have large, vegetated areas, which allow precipitation to infiltrate into the soil and travel towards waterways at a slower rate. As a result, discharges are lower and the potential for flooding is reduced (USGS 2003).

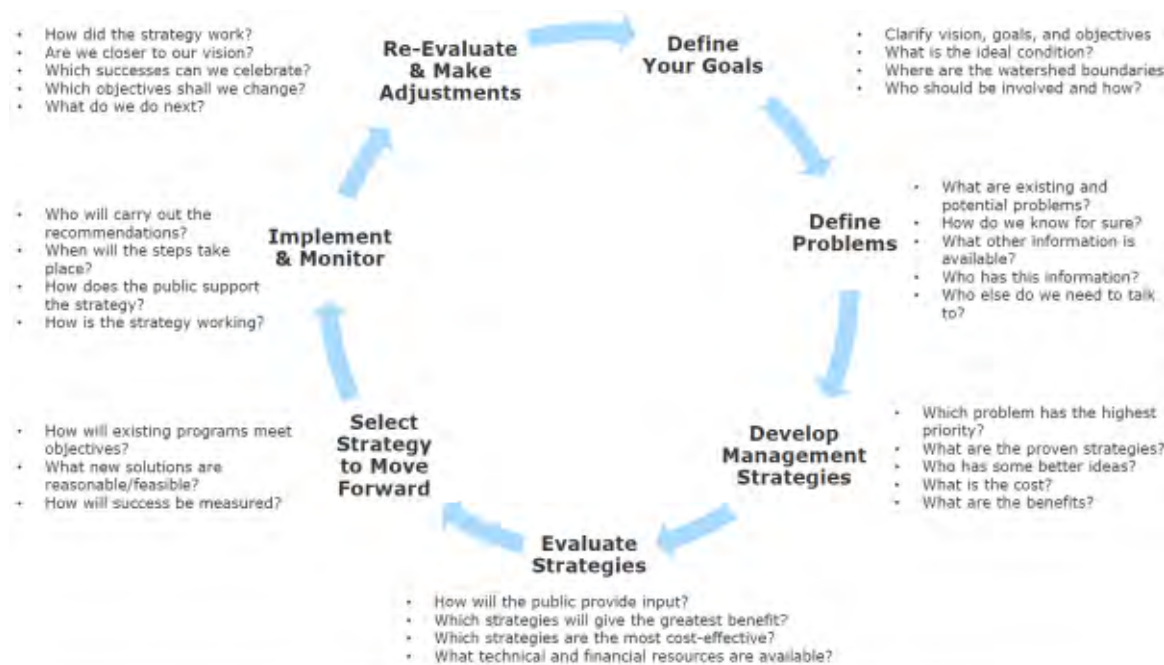
Figure 7-1. Oriskany Creek Sediment and Debris Management Planning Process (adapted from HOCCPP 1997).

The Oriskany Creek Sediment and Debris Management Plan should be a fluid document that incorporates the input and vision of all interested parties, including stakeholders, local and state officials, environmental groups, etc. The management plan should include a watershed planning process to help define the current goals and objectives, but also the future direction for the watershed. Figure 7-1 depicts general guidelines for developing, assessing, and revising watershed management strategies (HOCCPP 1997).

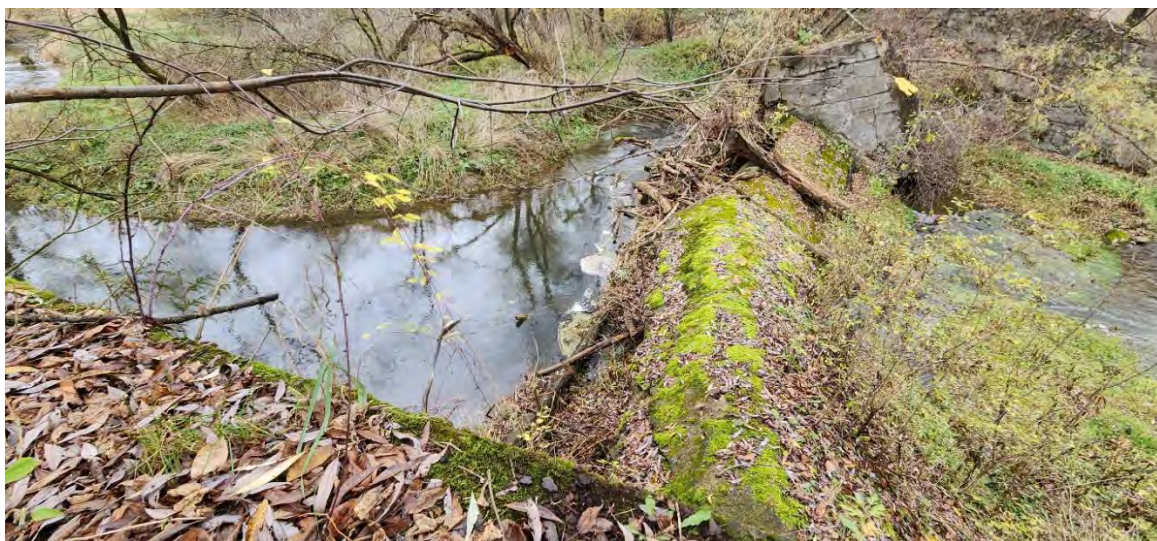
Figure 8-1. Woody debris collection upstream of the Madison Power Company Dam, Town of Madison, NY.

The abandoned dam located upstream of Solsville Road in Oriskany Creek is owned by Madison Power Company and is no longer maintained (NYSDEC 2024b). This dam is collapsed in the channel and restricts the natural flow of water while collecting woody debris upstream of the dilapidated dam (Figure 8-1). Remnants of the dam are located downstream in the channel. Water flows through the middle cracks of the damaged dam where one side of the dam is raised more than the other side (Figure 8-2). Originally, the dam was built in 1926, almost 100 years old, for the purposes of hydroelectric. The spillway height is approximately 10-ft to 14-ft, and its width is 62-ft (NYSDEC 2024b).

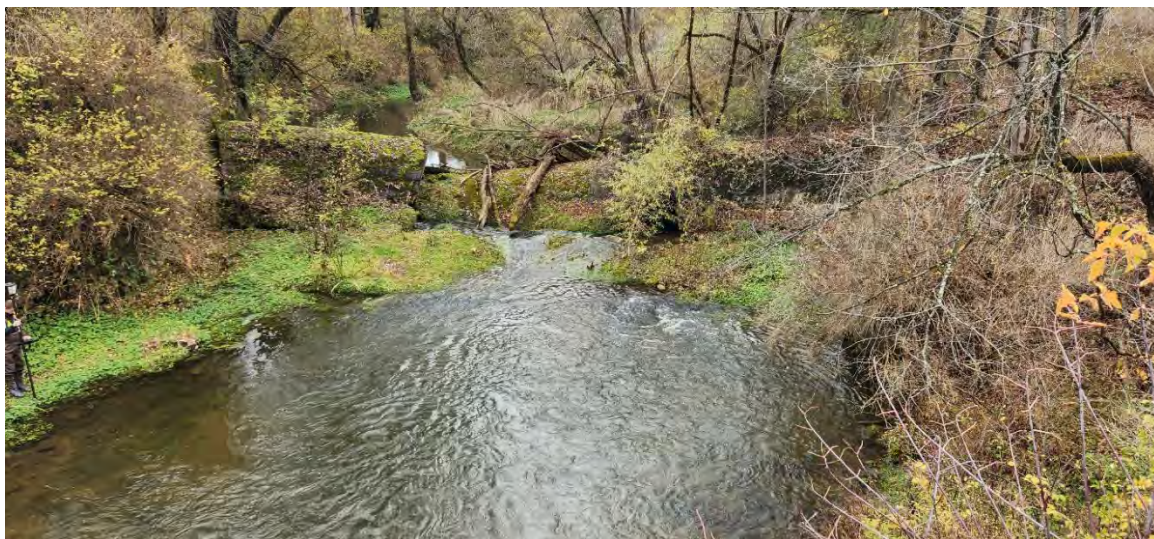
Figure 8-2. Madison Power Company Dam upstream of Solsville Road, Town of Madison, NY.

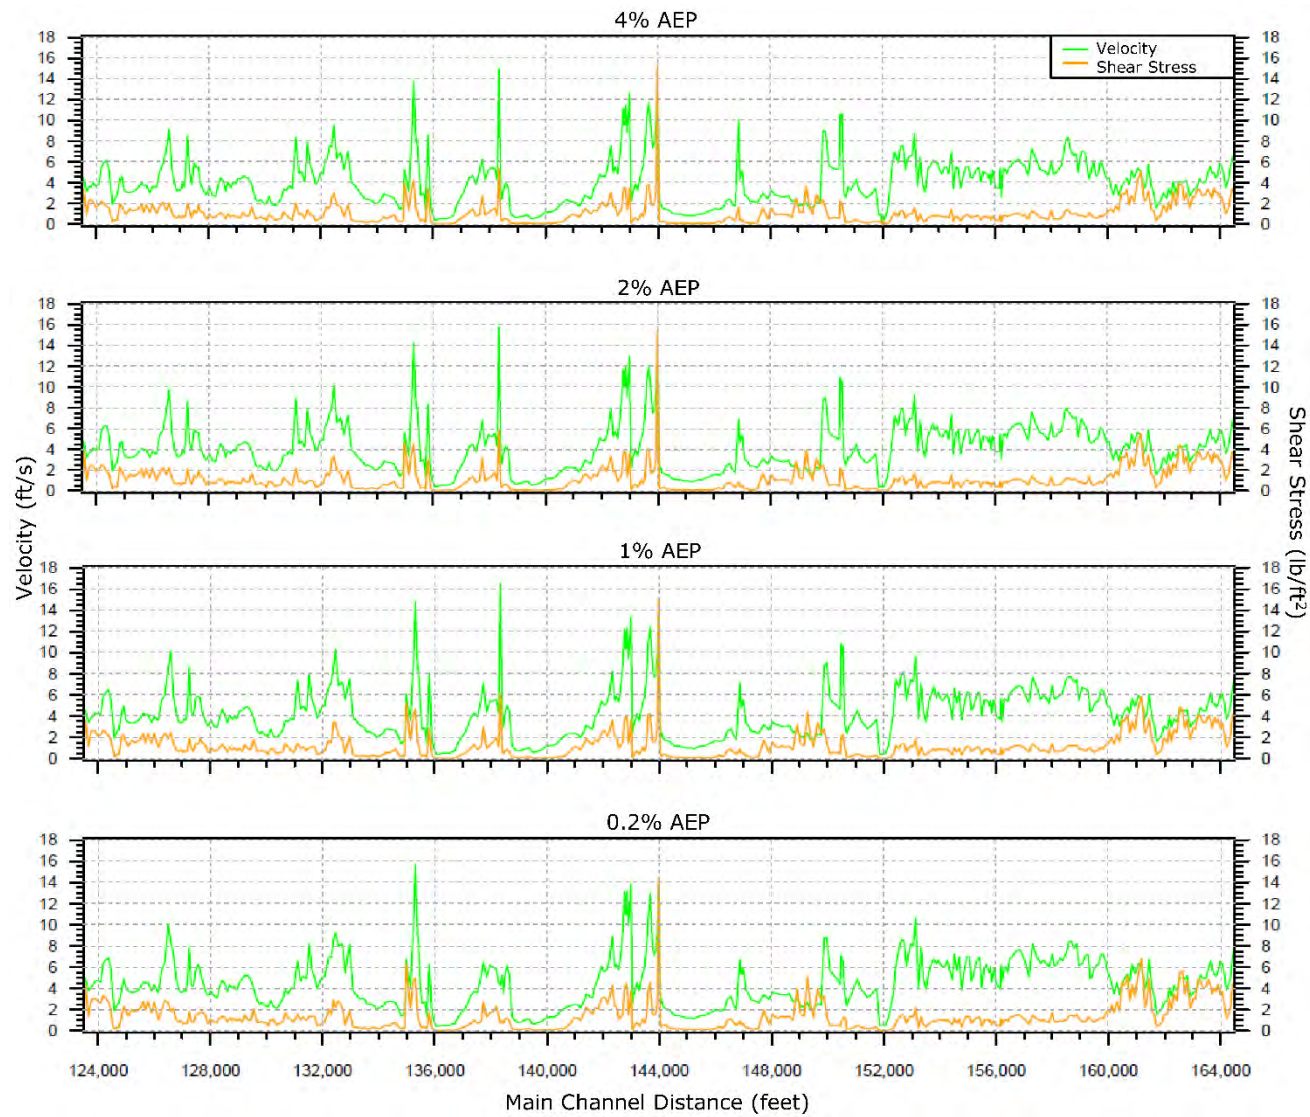
Figure 8-5. Analysis of velocity (ft/s) and shear stress (lbs/sq ft) based on the HEC-RAS model results for Zone 1.

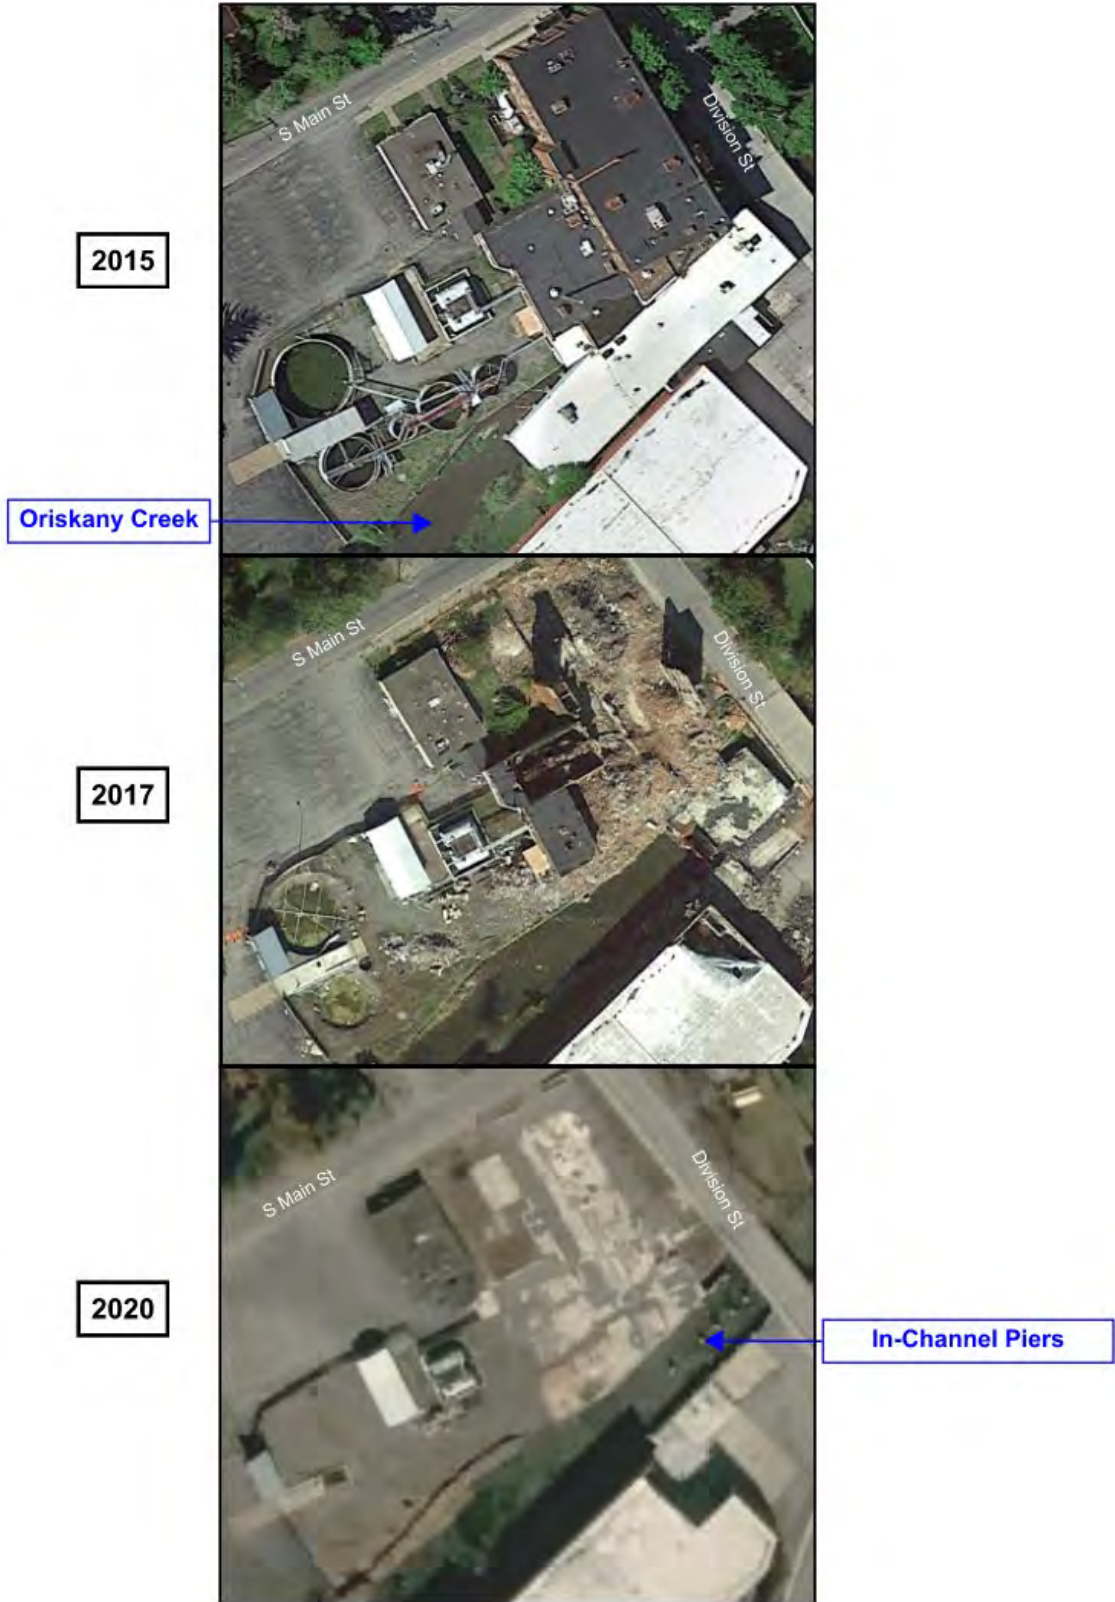
Afterwards, NYSDEC assigned TRC Engineers, Inc. to monitor and sample the site in April through May of 2021 (NYSDEC 2021). Figure 8-6 represents aerial imagery from Google Earth from the years 2015 (prior to the site fire), 2017 (remnants of the destruction caused by the fire), and 2020 (after USEPA cleaned up the site and the current state of the site).

Figure 8-6. Image capture dates of the site upstream of Division Street, Village of Oriskany Falls, NY.

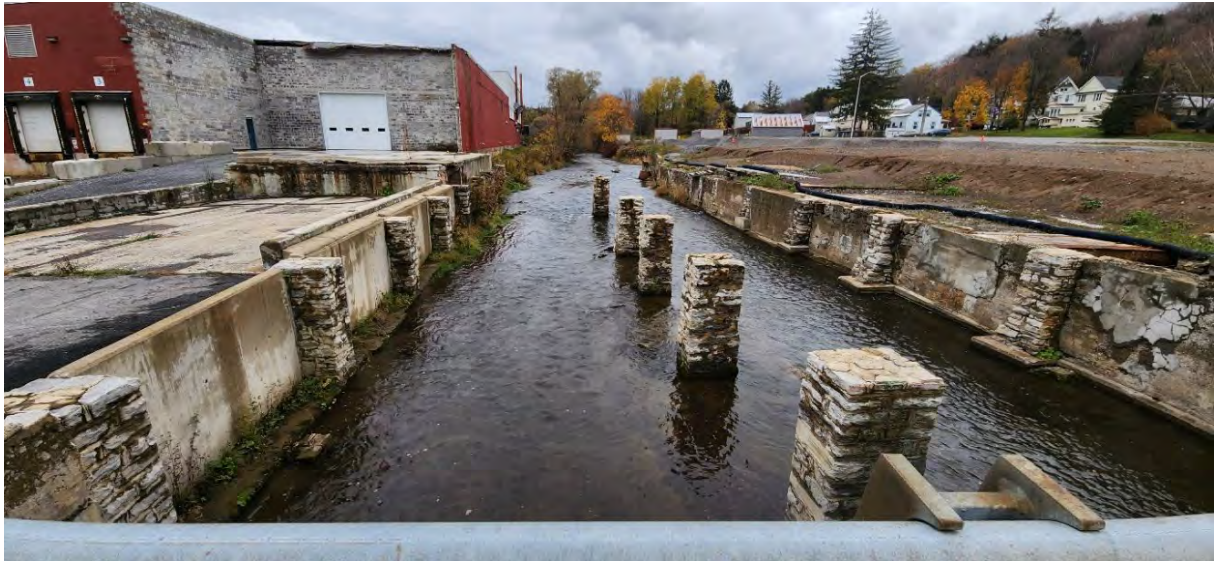
Figure 8-7. In-channel piers upstream of Division Street in Oriskany Creek.

The analysis will show if flood risk is reduced when the piers are removed to the natural state of the floodplain.

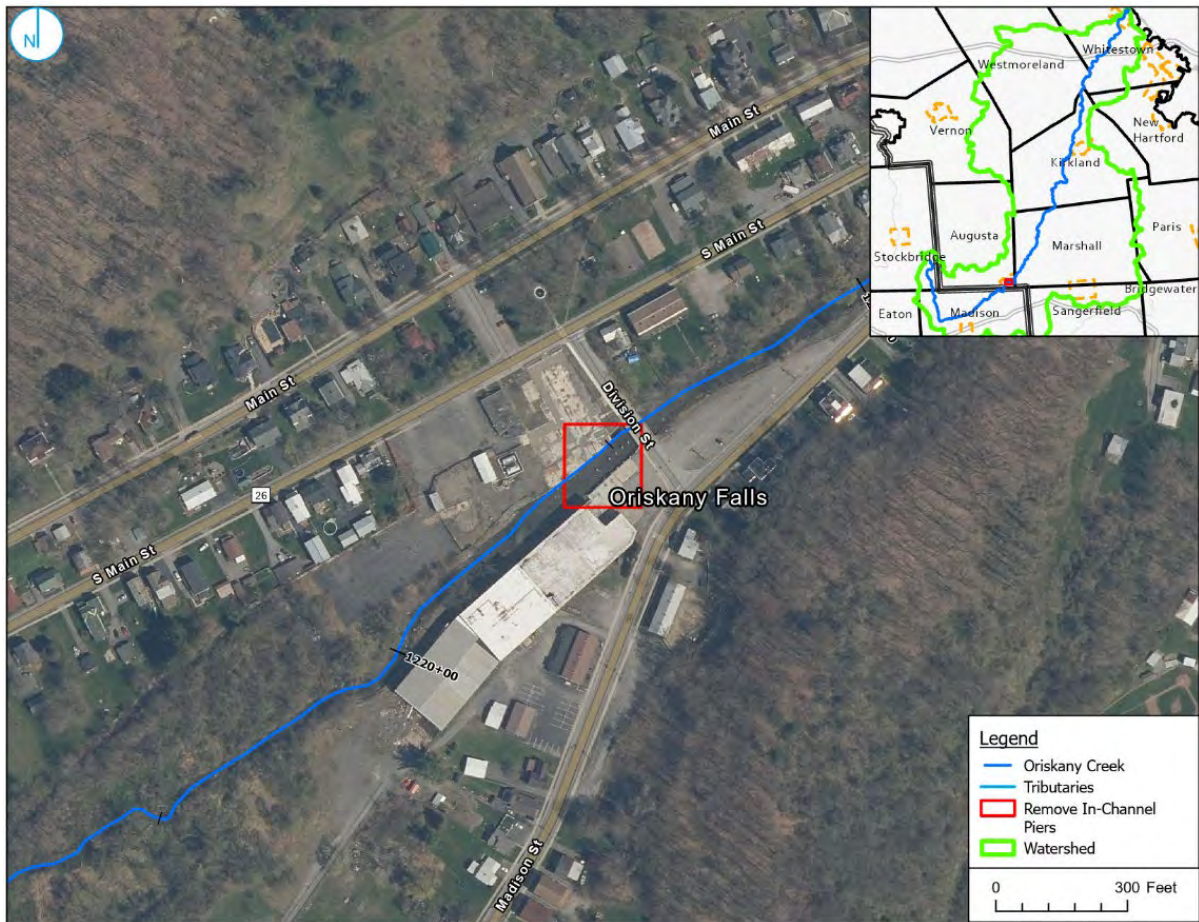
The removal of the in-channel piers alternative is located at RS 1214+80 to 1215+00 (Figure 8-8). The project would involve removing all the concrete and stone aggregates in the channel, and, if possible, along the banks to ensure natural flow in Oriskany Creek.

Figure 8-8. Location map of in-channel pier removal.

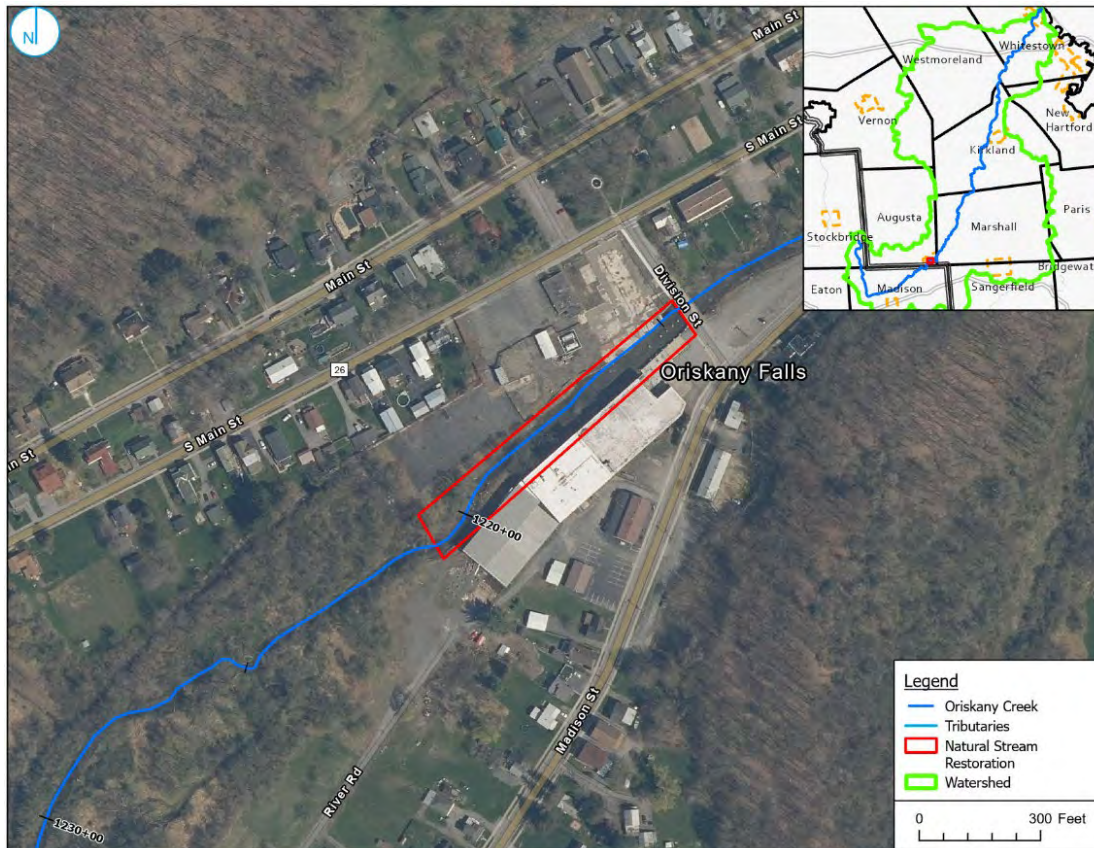
This mitigation strategy proposes restoring the channel of Oriskany Creek upstream of Division Street to a natural stream employing restoration techniques discussed to reduce sediment aggradation and flood risk for downstream areas of Oriskany Creek (Figure 8-10).

Figure 8-10. Location map for proposed stream restoration upstream of Division Street, Oriskany Falls, NY.

The primary benefits of restoring the channel geometry of Oriskany Creek in this reach would be to increase the flow capacity through the bridge structure and help prevent debris and ice from catching on sediment bars and large debris that have accumulated in this reach.

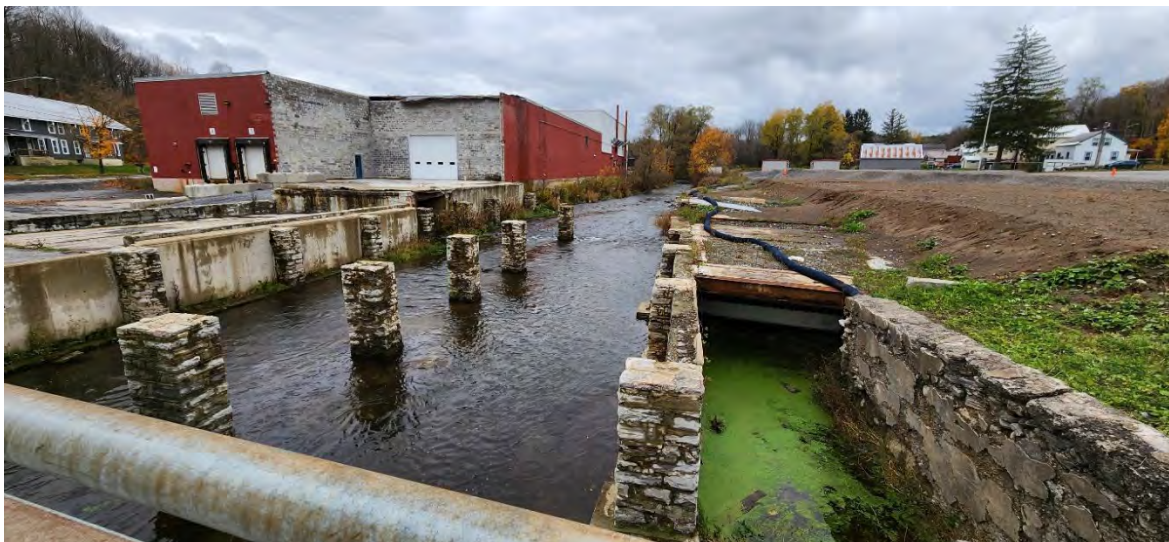
Figure 8-12. Current conditions of the property looking upstream of Division Street.

Two flood bench alternatives were modelled for Alternative #2-3. Both benches are preliminarily designed to be the same size, approximately 2.3-acres, and they are both located between RS 1214+80 to 1220+70 (Figure 8-11). Flood bench A is designed to the adjacent areas on the left bank of Oriskany Creek. The design of flood bench B includes the same area and the removal on the in-channel piers. The current conditions of the property are shown in Figure 8-12. The image is taken from Division Street in the Village of Oriskany Falls.

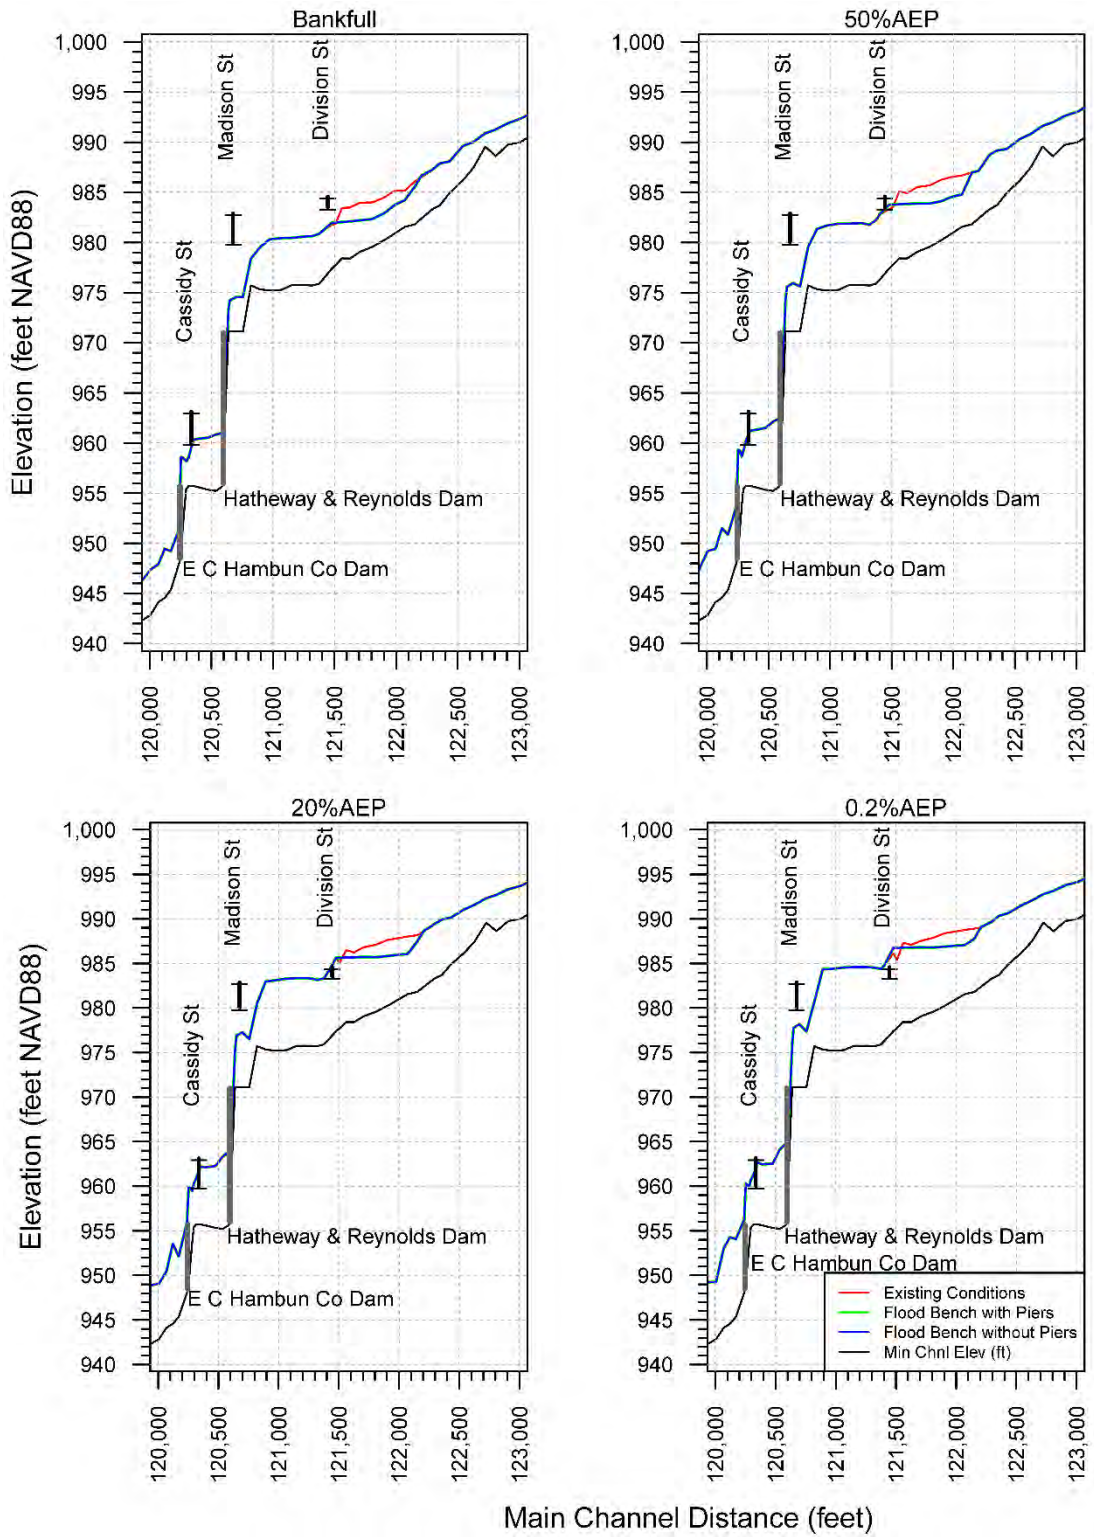
Figure 8-13. HEC-RAS model simulation output results for Alternative #2-3 for the existing condition (red) and proposed alternative (blue) scenarios.

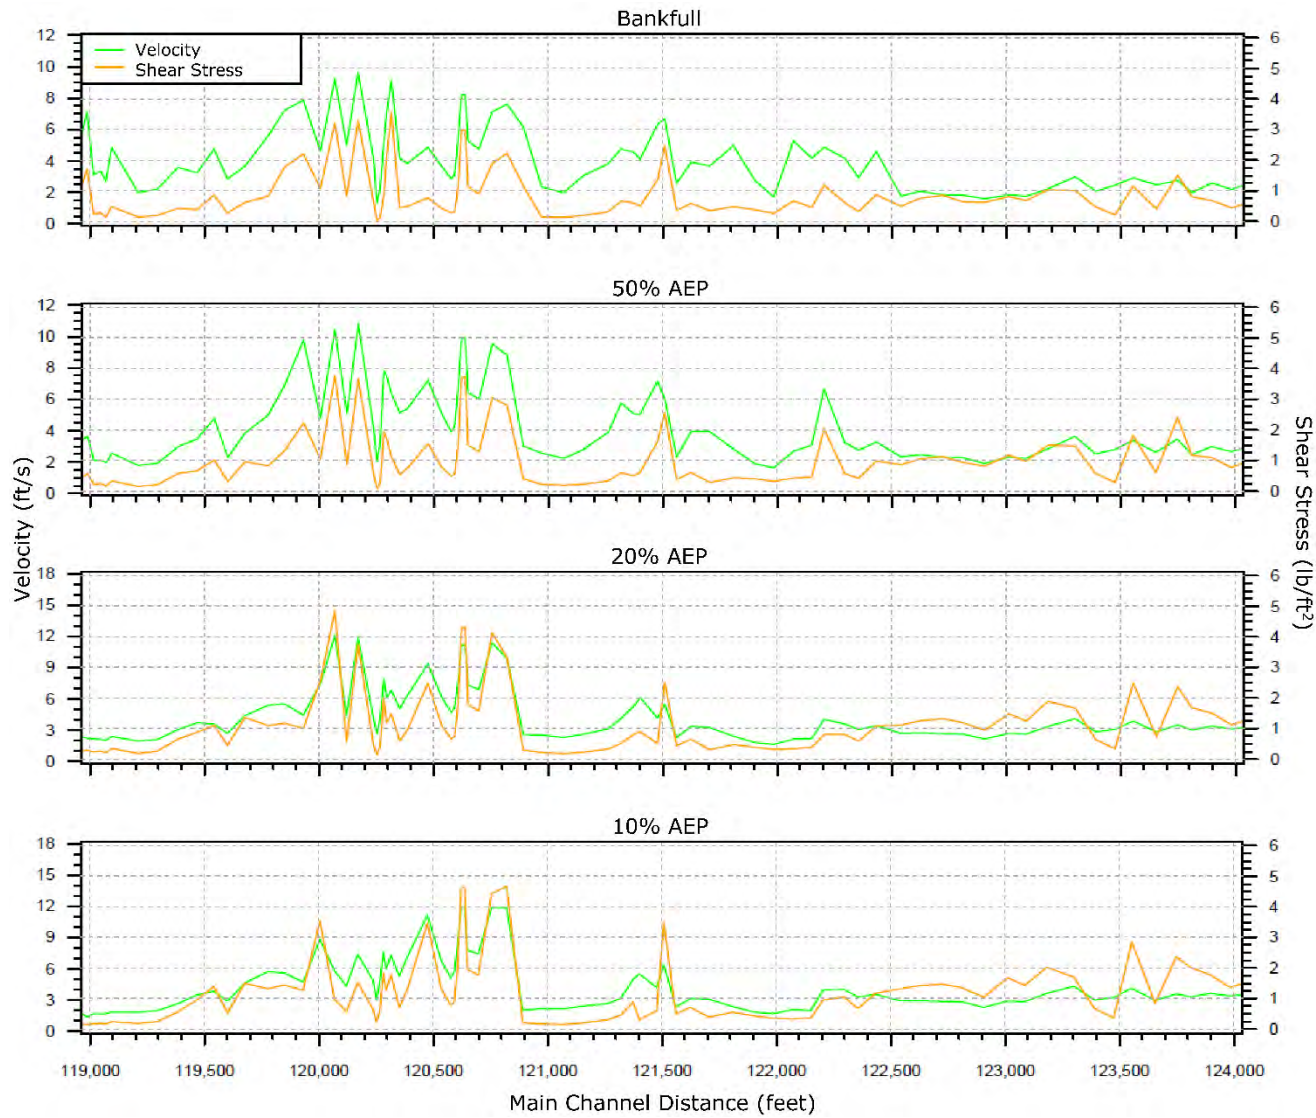
Figure 8-14. Analysis of velocity (ft/s) and shear stress (lbs/sq ft) based on the HEC-RAS model results for Zone 2.

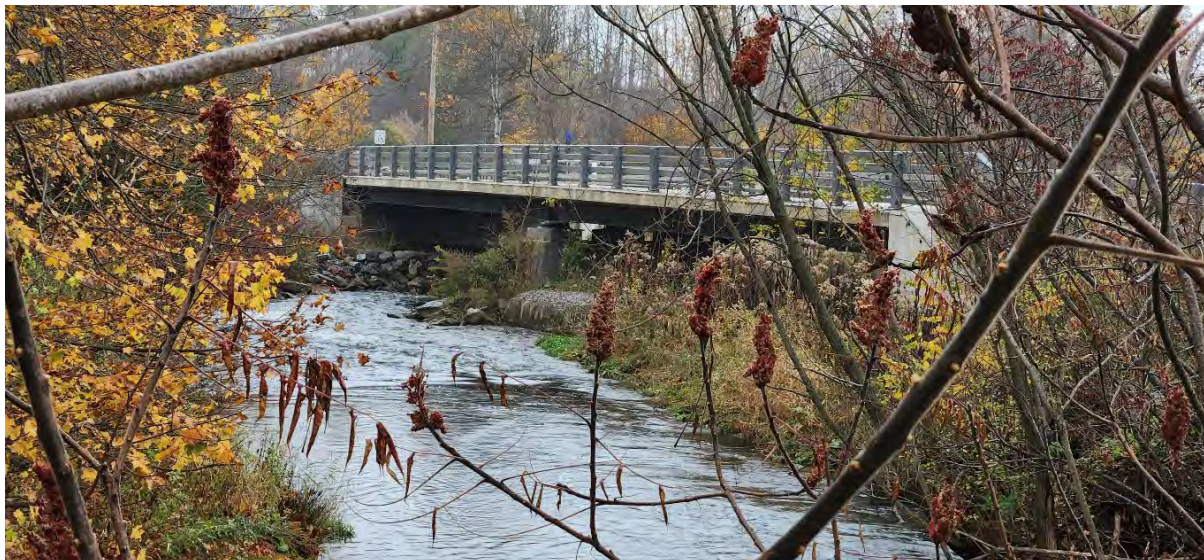
Figure 8-17. Upstream view of Oriskany Creek under the NY-315 Bridge in the Town of Marshall, NY.

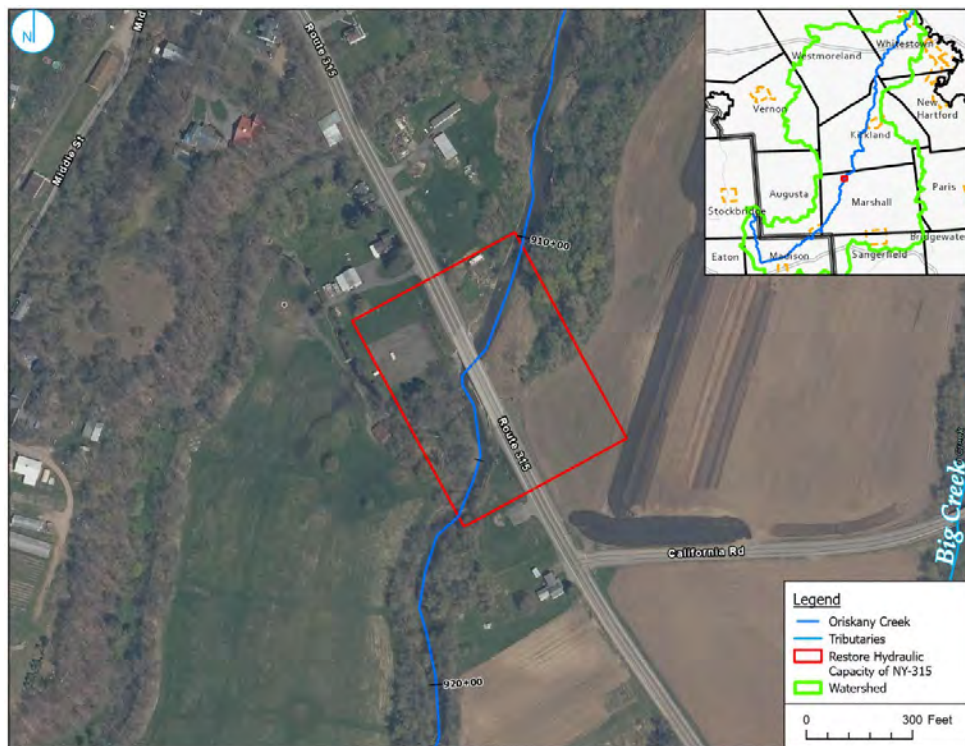
The H&H modeling incorporates blocked obstructions to simulate the blockage of the stream halfway through the bridge. The model for the proposed alternative is a scenario where the blocked obstruction under the bridge is removed. No adjustments were made to the bridge dimensions in this scenario. By eliminating the blocked obstruction, the cross-sectional flow area of the channel will increase at RS 913+00 (Figure 8-18).

Figure 8-18. Location Map of NY-315 bridge for Alternative #3-3.

The existing conditions model shows the 10%, 4%, 2%, 1% and 0.2% ACE WSELs do not successfully pass under the NY-315 bridge. Additionally, the bridge and the blocked obstructions in the channel act as a catchpoint for large sediment and debris. Restoring the cross-sectional flow area of the channel under the bridge will increase movement of water during high-flood events and decrease the potential for sediment and debris to accumulate, thereby reducing flood risk to areas adjacent to and immediately upstream of the bridge.

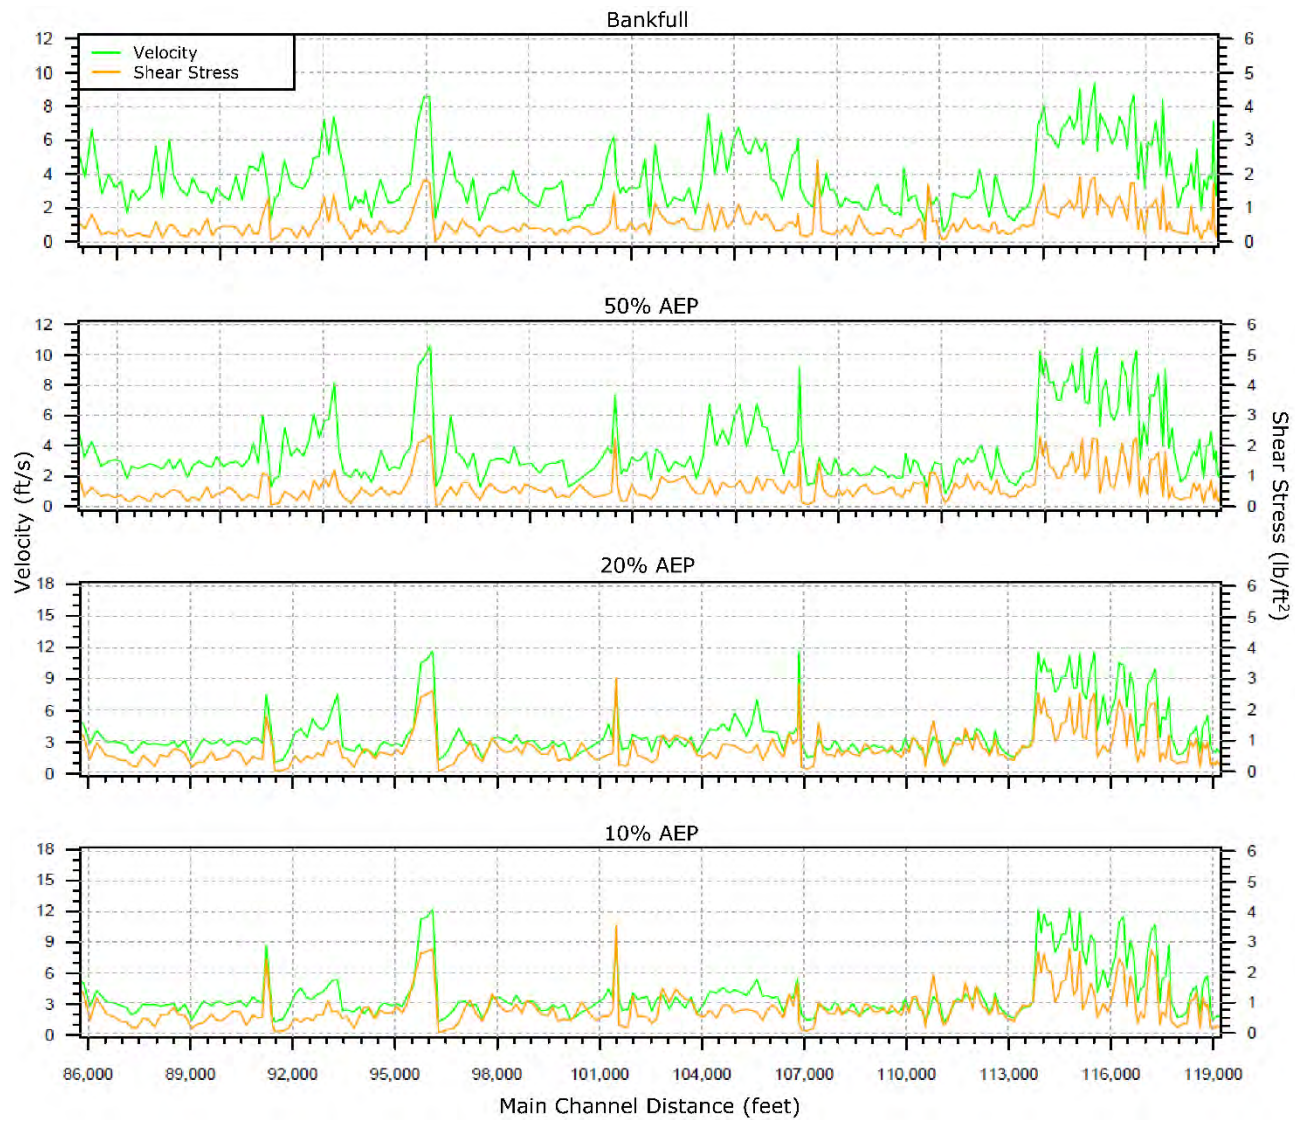
Figure 8-20. Analysis of velocity (ft/s) and shear stress (lbs./sq ft) based on the HEC-RAS model results for Zone 3.

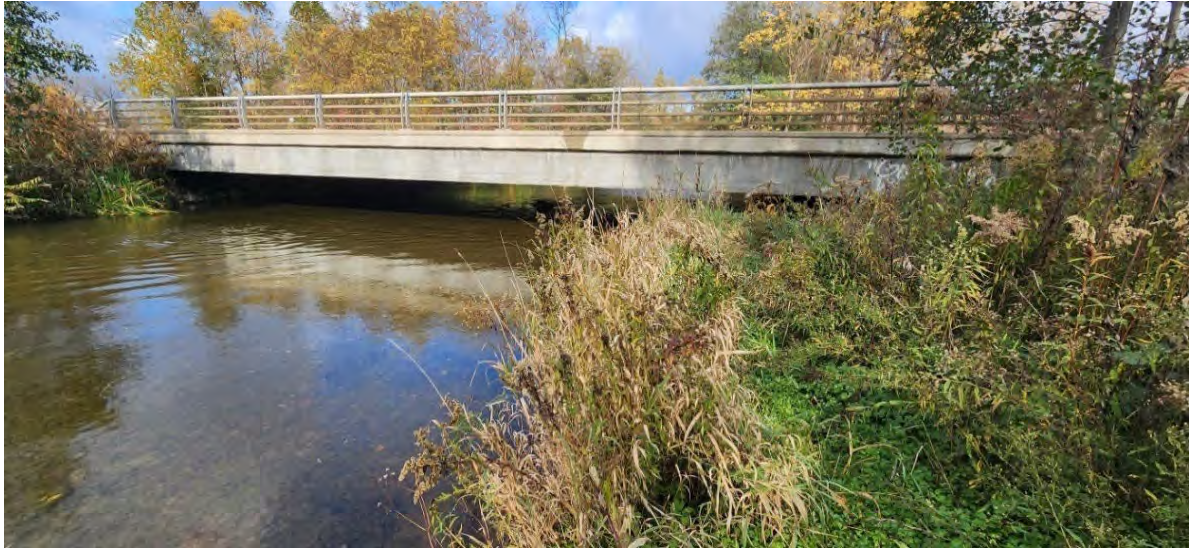
The NY-5 bridge (BIN #1002200) that crosses Oriskany Creek is owned by NYSDOT and built in 1998. The right bank is heavily vegetated with grasses, brush, and trees on a sediment pile. This vegetation blocks the opening of the bridge at the right bank as shown in Figure 8-22, and limits the cross-sectional flow in this area. The NY-5 bridge is located at RS 913+00 (Figure 8-23).

Figure 8-22. Upstream view of Oriskany Creek under the NY-5 Bridge in the Town of Marshall, NY.

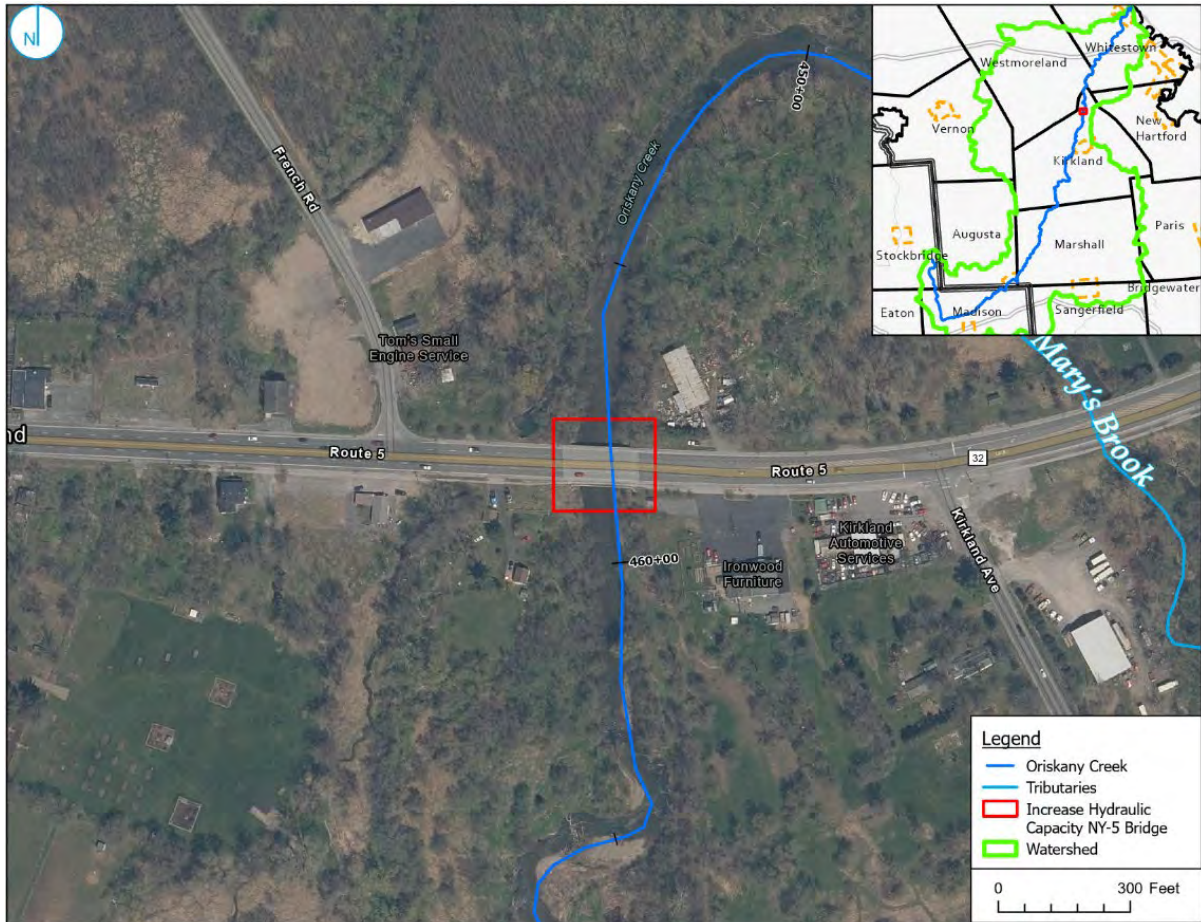
Figure 8-23. Location Map of NY-5 bridge for Alternative #4-2.

The existing high chord to low chord height of the structure is 4.6 with a span length of 100-ft. The model for this proposed alternative incorporates adjusting the road elevation height by 0.5-ft, decreasing the high chord to low chord height by 2.3-ft, and increase the span length of the bridge by 40-ft. Clearing the cross section from vegetation and sediment to increase flow is also modelled in this alternative.

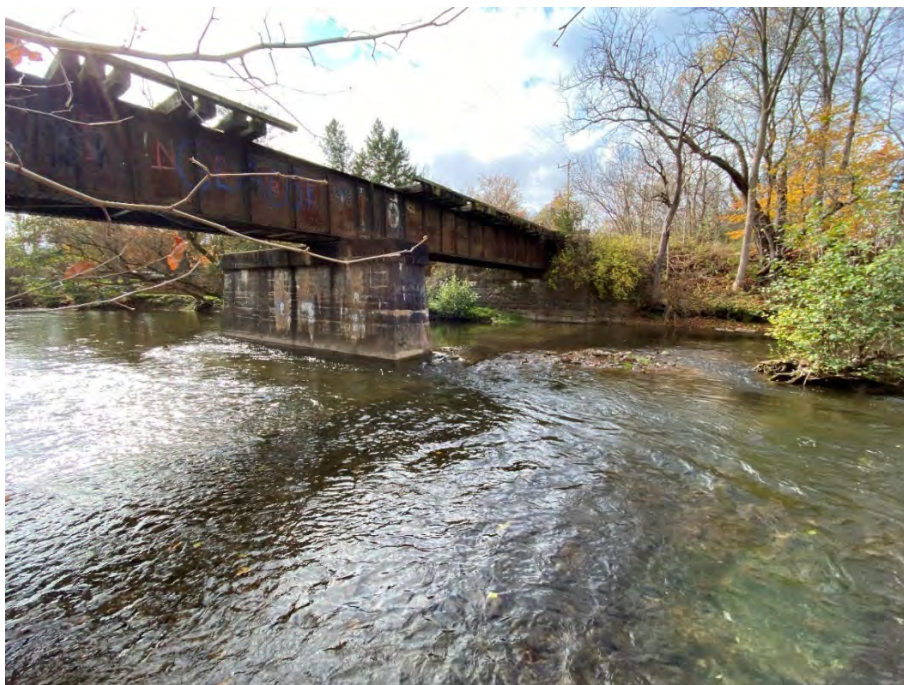
Figure 8-28. Existing conditions of the abandoned railroad bridge in Village of Clarks Mills, Kirkland, NY.

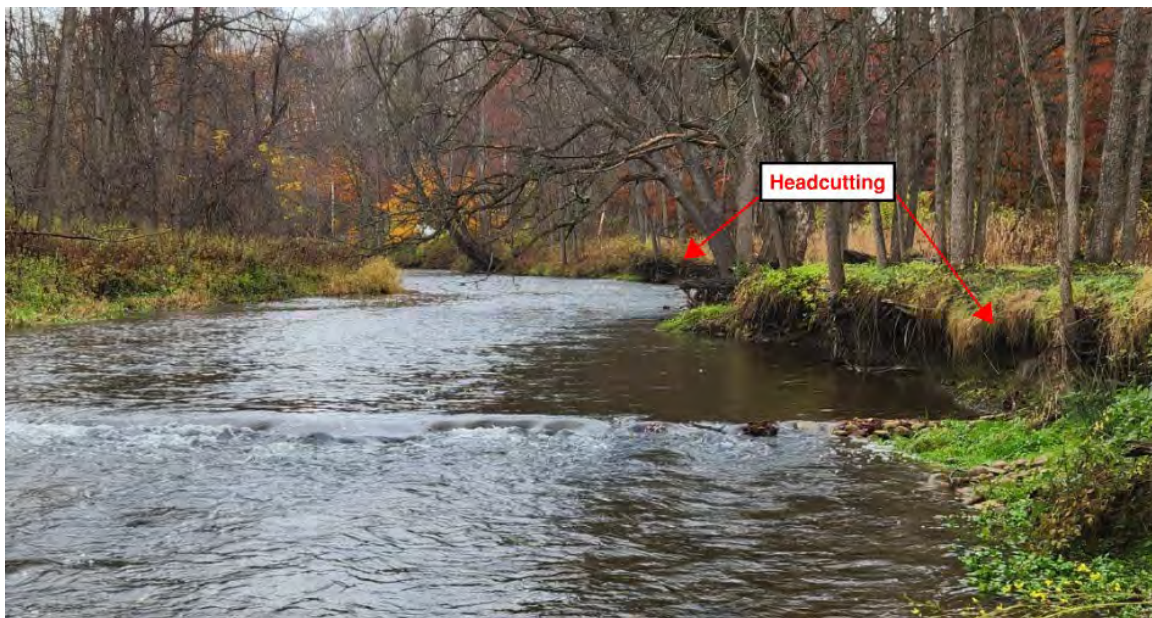
Figure 8-30. Headcutting upstream of Lombard Road at RS 742+00.

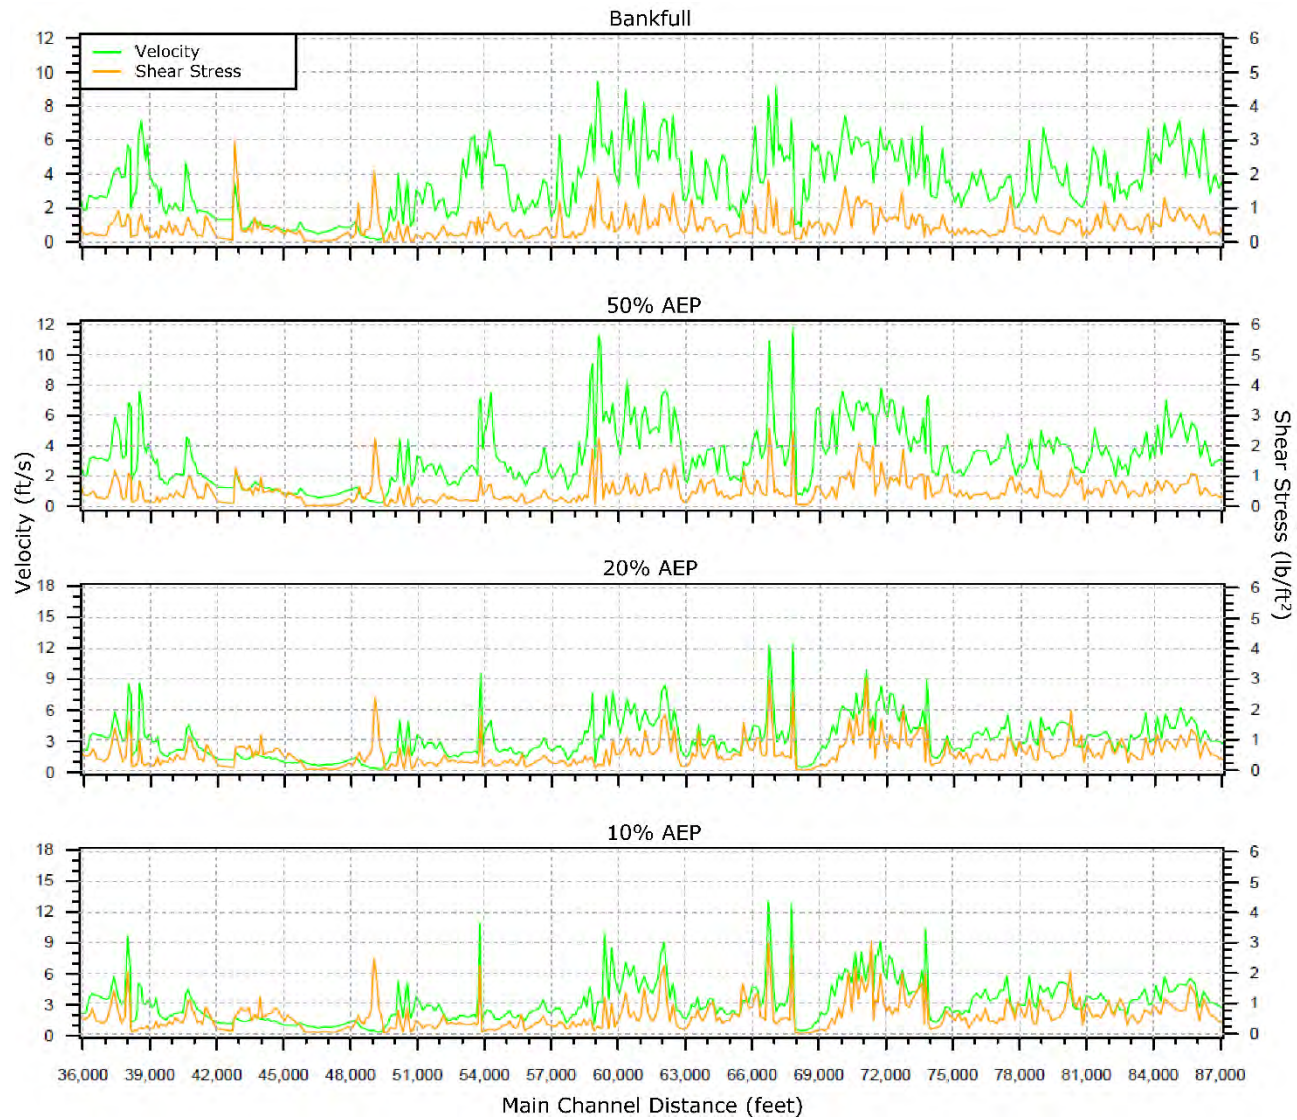
Figure 8-31. Analysis of velocity (ft/s) and shear stress (lbs./sq ft) based on the HEC-RAS model results for Zone 4.
