Oriskany Creek Watershed Sediment & Debris Management Study

Oriskany Creek, Oneida County, New York

Project name **Oriskany Creek Watershed Sediment & Debris Management Study**
Project no. **1940104636**
Recipient **Oriskany Creek Watershed Commission**
Document type **Report**
Version **01**
Date **August 23, 2024**
Prepared by **Kadir Goz, CFM and Alyssa Flint**
Checked by **Nicole Del Monaco, PE, CFM, ENV SP**
Approved by **Shaun Gannon, P.E., D.WRE, CFM, P.H.**

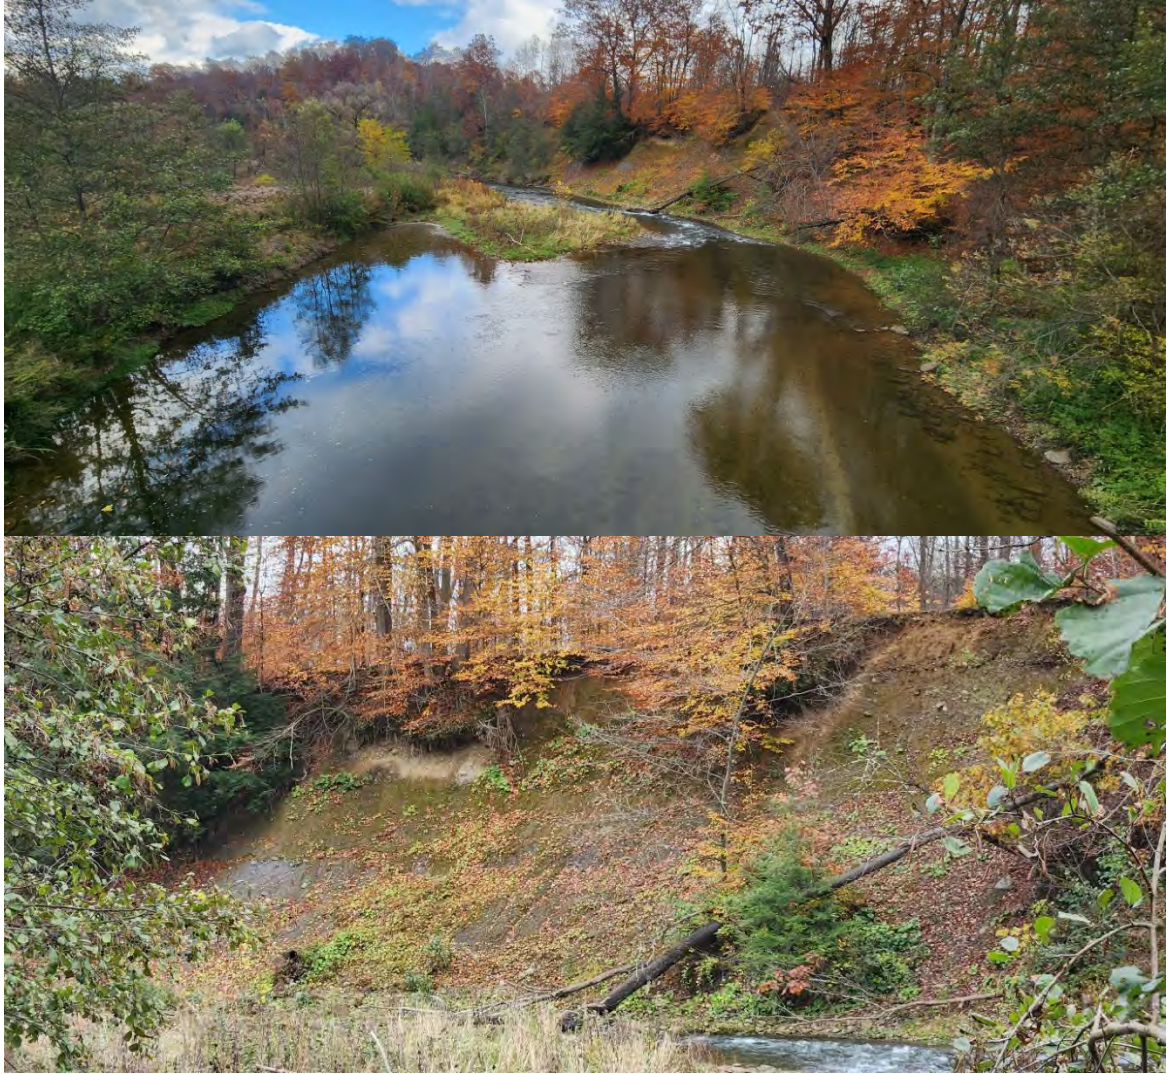
Figure 8-32. Bank erosion downstream of Valley Road, Town of Whitestown, NY.

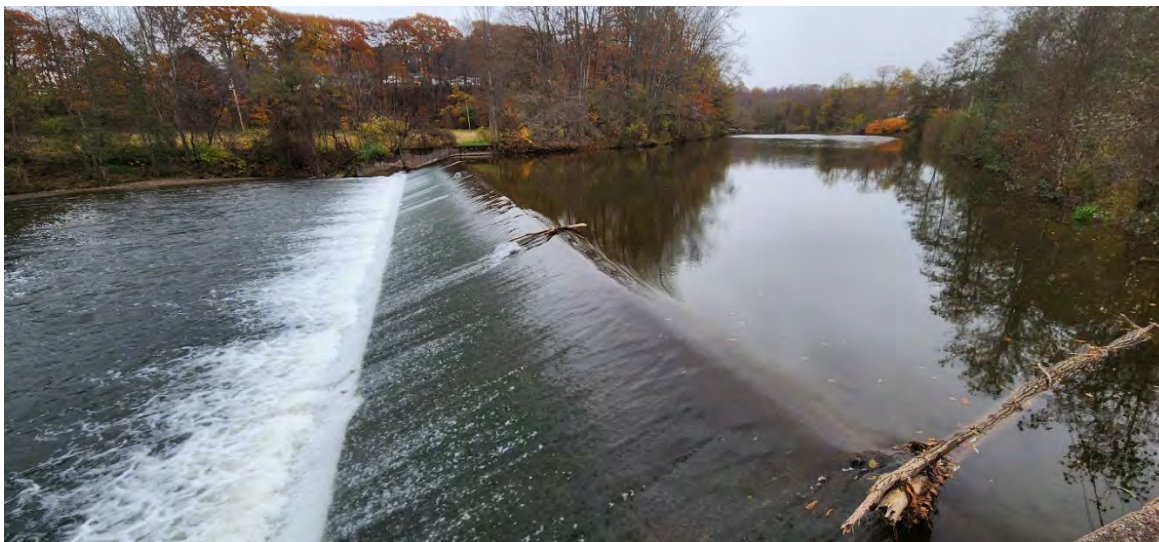
Figure 8-34. Oriskany Falls Dam in the Town of Whitestown, NY.

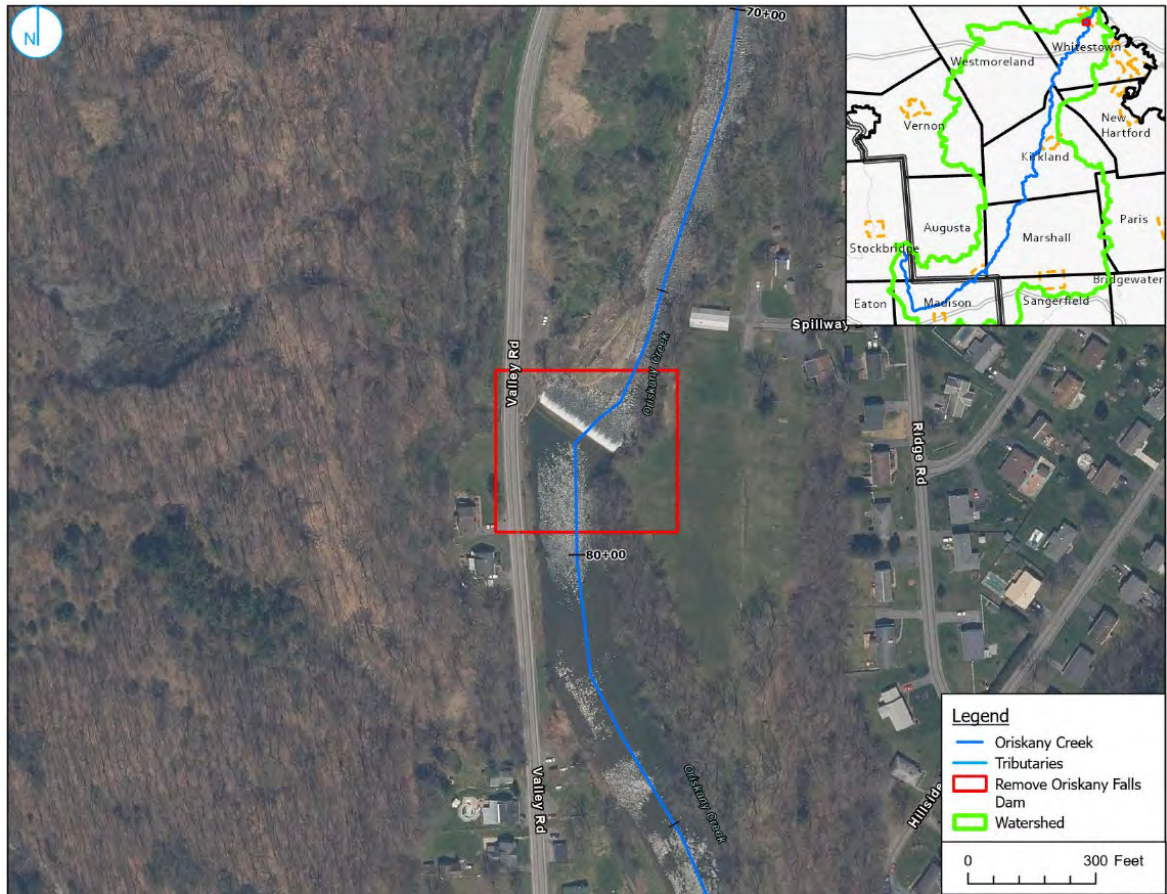
Removal of the dam has been selected to be analyzed at a base level of modelling and to determine the flooding impacts downstream of Oriskany Creek. The removal of the dam alternative is located at RS 78+00-ft (Figure 8-35). The project would involve removing all or partially remove the rock spillway from the channel to ensure natural flow in Oriskany Creek. Removal of woody debris or other debris should be performed during this project. Further investigation will be needed to fully access this alternative which includes field surveys of dam measurements, soil testing for suitability, dam removal modelling, etc. The base-level analysis will show if flood risk is reduced when the dam is removed to the natural state of the floodplain.

Figure 8-35. Location map of proposed dam removal for Alternative #5-2.

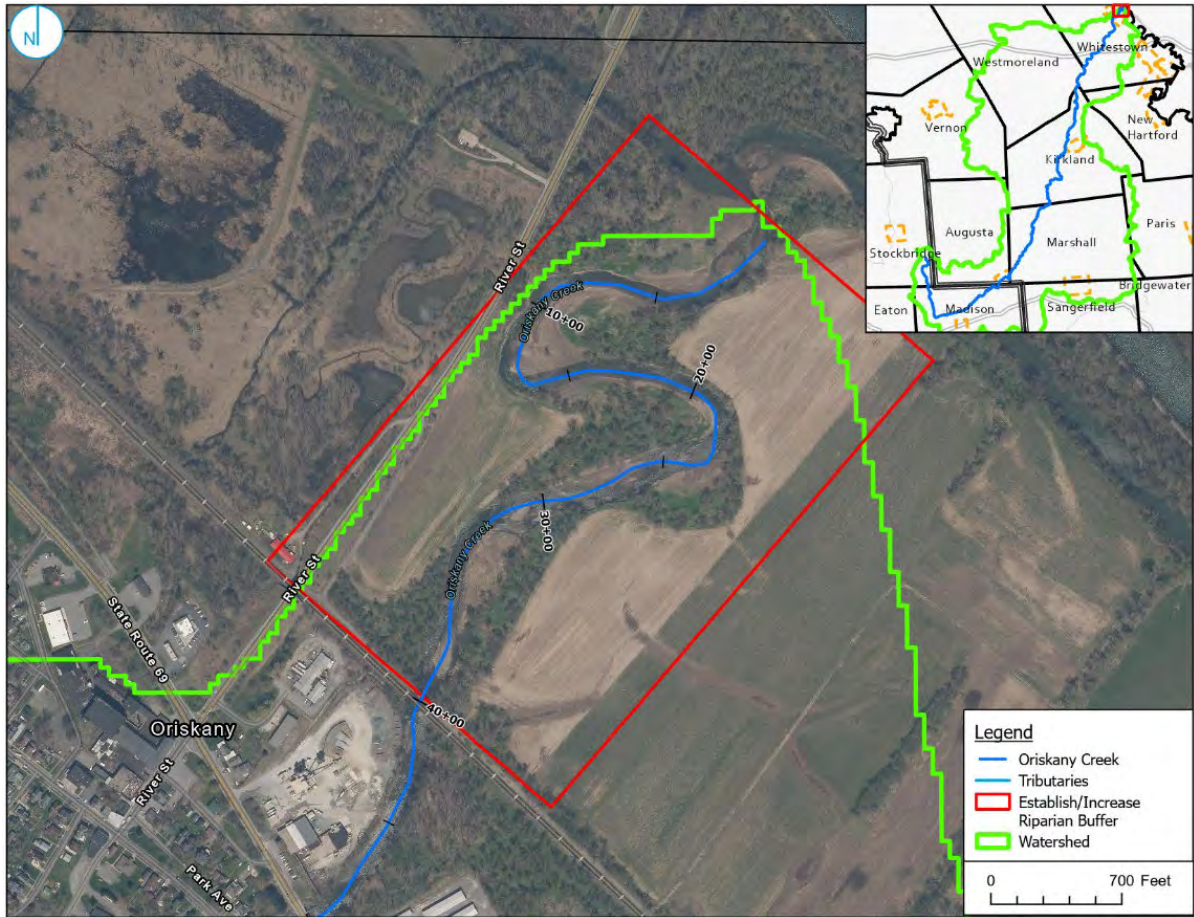
Figure 8-37 shows these reaches have little to no buffer that prevents runoff, sediment, and/or pollutants from directly entering the creek. By installing a riparian buffer with all three zones along this reach, the runoff from the agricultural fields will be reduced. Additional consideration would also be required to determine the most appropriate riparian buffer vegetation and range of zones.

Figure 8-37. Location map for riparian buffer along Oriskany Creek for Alternative #5-3.

- 0+00 to 39+00
- 40+00 to 50+00 (Between NY-69 and CSX Railroad Bridge at the Clemente Fane Concrete property)
- 246+00 to 266+00
- 285+00 to 293+00

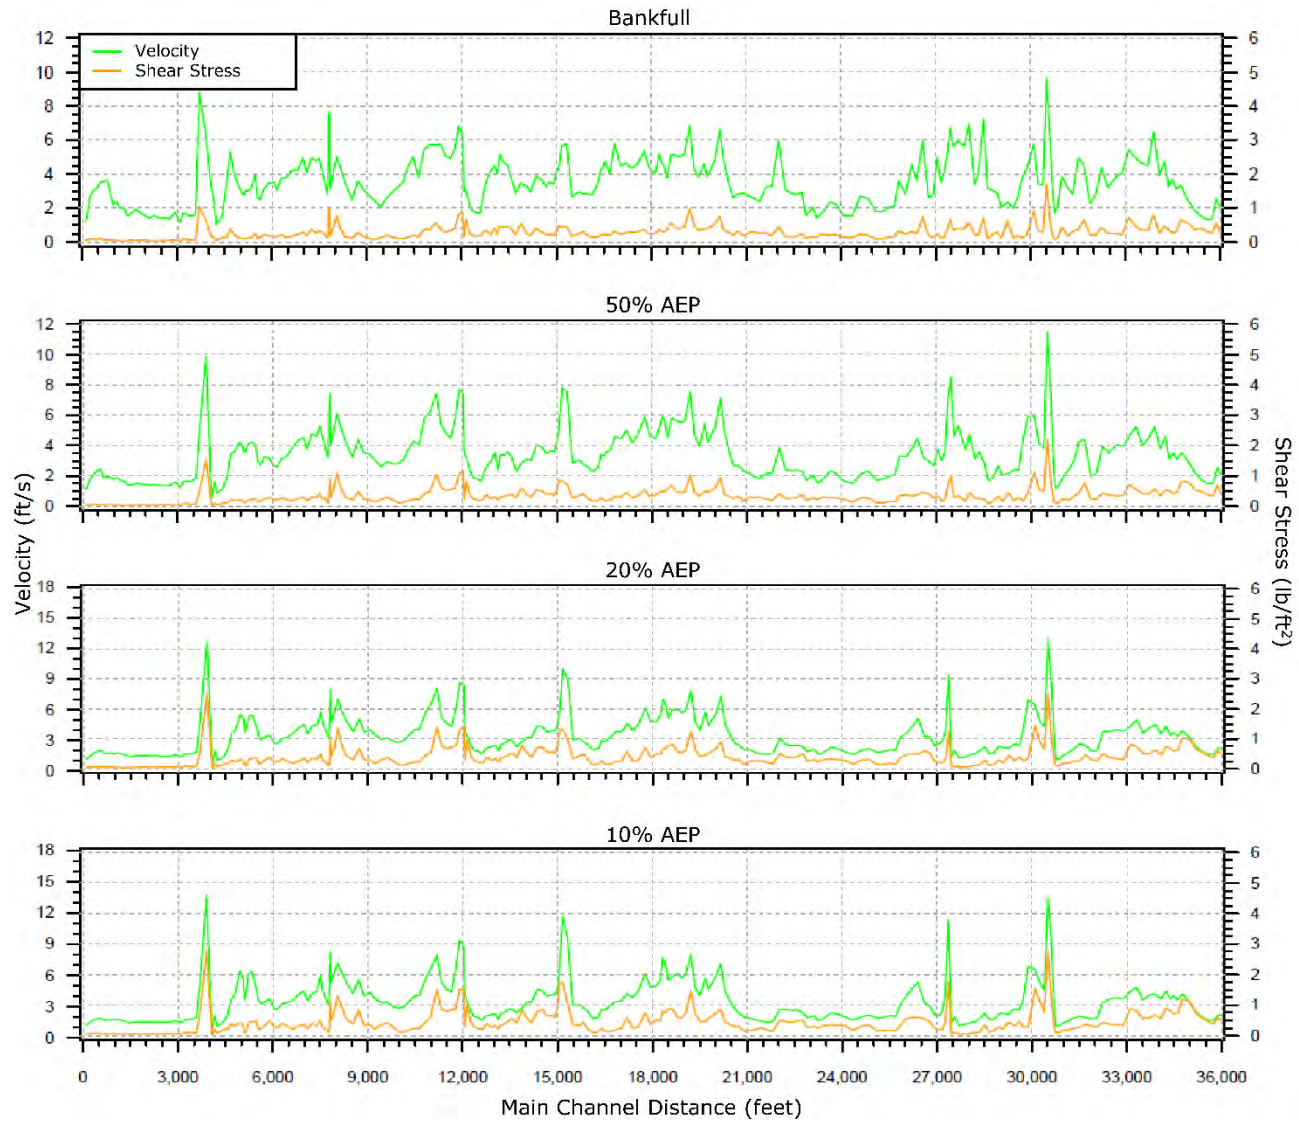
Figure 8-38. Analysis of velocity (ft/s) and shear stress (lbs./sq ft) based on the HEC-RAS model results for Zone 5.

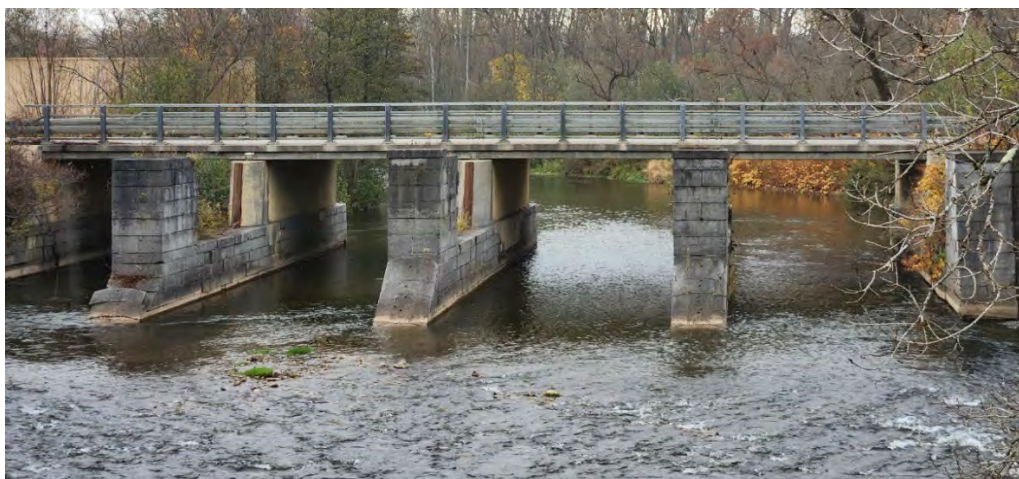
Figure 8-39. In-channel piers at NY-69/Erie Boulevard in the Town of Whitestown, NY.
